PROJECT MEMORANDUM PG&E – TRI-VALLEY 2002 CAPACITY INCREASE PROJECT

To: Jensen Uchida, CPUC
From: Vida Strong, Aspen Project Manager
Date: September 22, 2006
Subject: Weekly Report #125: September 10, 2006 – September 16, 2006
CPUC Environmental Monitor (EM): Anne Sweet Coronado

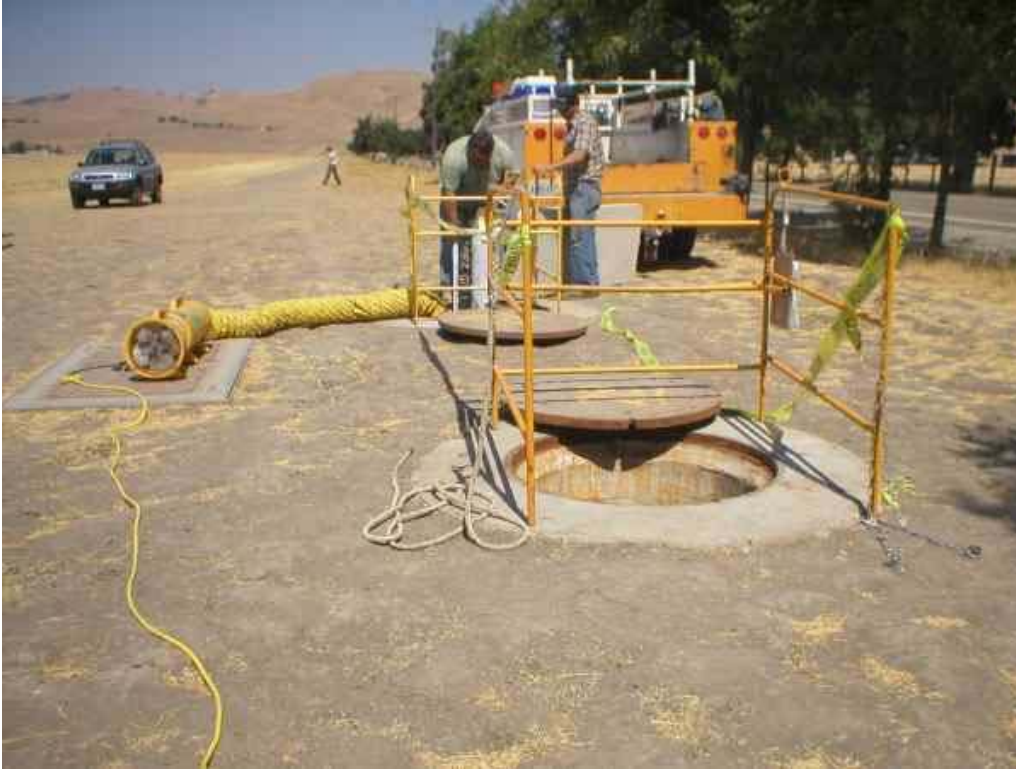
Figure 1 – Wilson crews cleaned and stenciled inside of vaults, September 13, 2006.

All underground cable pulling work is now complete across the project. Cable splicing and testing was finished by Nexans crews during the subject week. Wilson crews attached jumpers and conducted grounding at the Cayetano Substation. A PG&E line crew worked on drops at the Cayetano Substation. Wilson crews cleaned and stenciled inside of the vaults (see Figure 1).

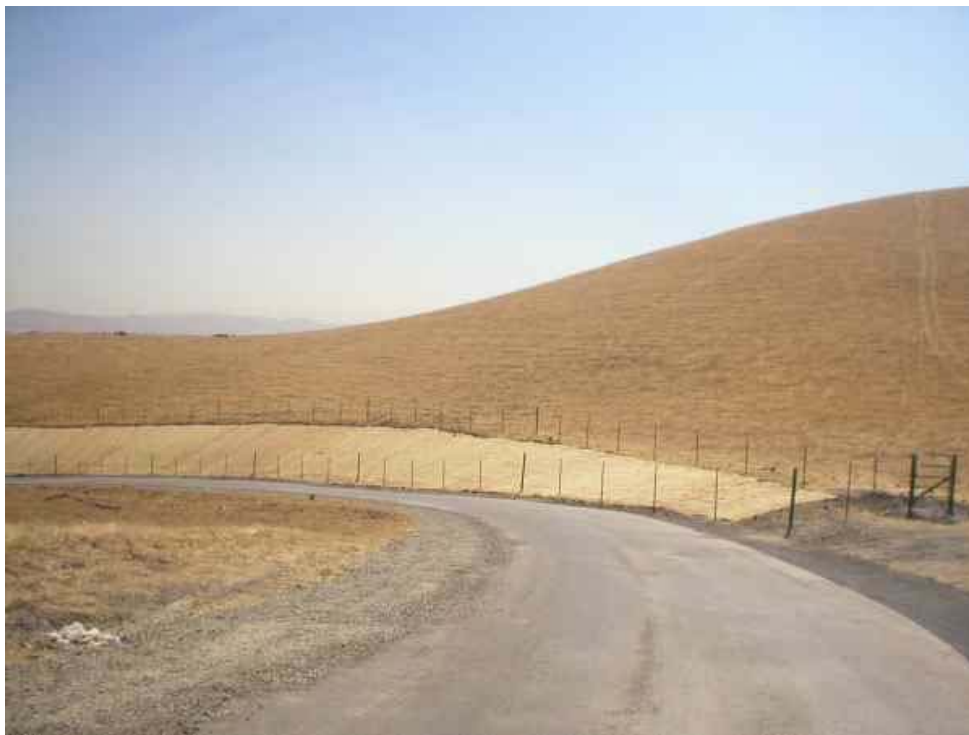
Figure 2 – NVC crews fenced around the side slope restoration area along Road 6, September 13, 2006.

NVC crews completed restoration of the cut slope areas above Road 6 and hydro-seeded the area during the previous week. In addition, they placed geotextile matting over the seeded areas. The matting was inspected and does not contain the mono-filament mesh that is prohibited by the U.S. Fish and Wildlife Service (USFWS) Biological Opinion (BO). During the subject week, NVC crews installed fencing around the area (see Figure 2).

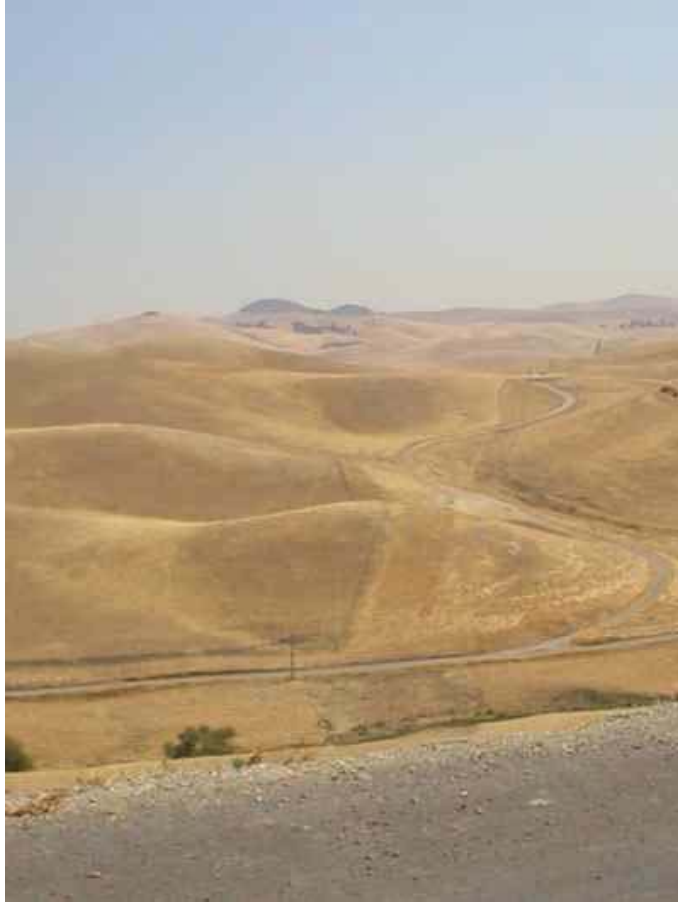
Figure 3 – View of the underground alignment along Road 7. Note the areas devoid of grass growth, September 13, 2006.

Grass seeding had occurred last year after installation of the underground line. However, some areas currently appear to need additional seeding prior to the rainy season in October of 2006 (see Figure 3).

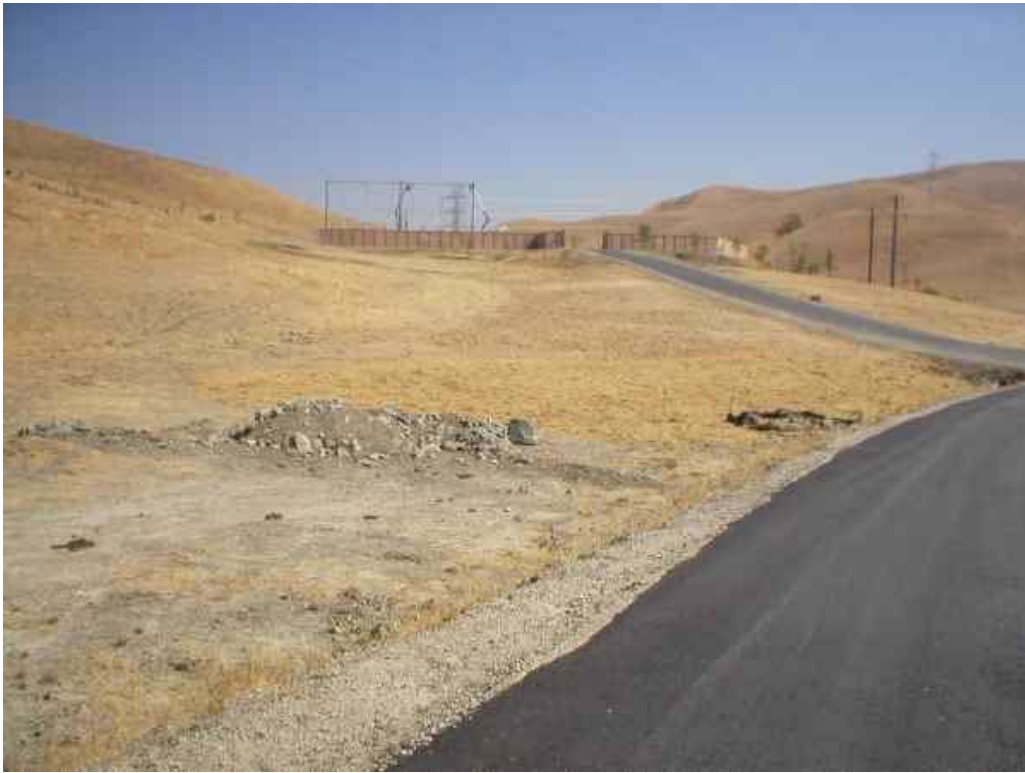
Figure 4 – Spoils pile located along Moller Road which is slated for removal, September 13, 2006.

Along Moller Road, NVC completed the restoration on the Tassajara Creek bank stabilization area. Crews hydro-seeded and placed geotextile matting over the area. The matting was inspected and does not contain the mono-filament mesh that is prohibited by the USFWS BO. NVC also fenced off the area. NVC finished repair work on culverts located along Moller Road and replaced rock in the inlets and outlets. In addition, NVC crews removed previously installed erosion controls which are no longer necessary, including sand bags and straw wattles. Some additional work is still outstanding, including removal of rocks and spoils along Moller Road (see Figure 4), as well as removal of remaining erosion controls.

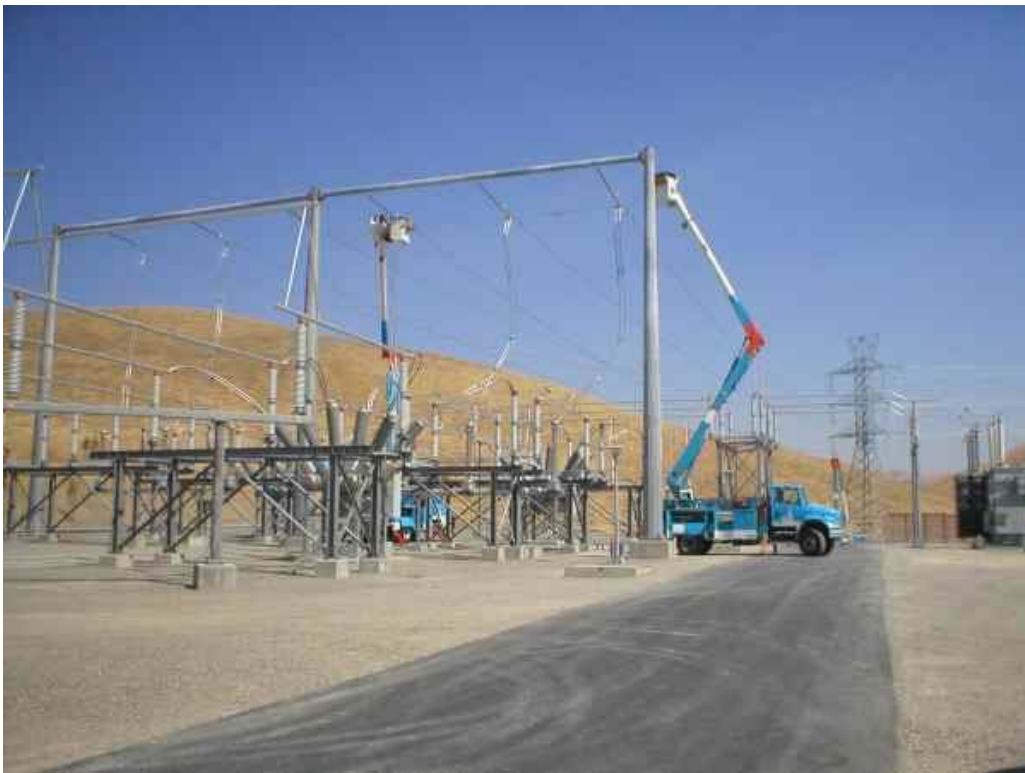
Figure 5 – PG&E crew working on the frame structure at the North Dublin Substation, September 7, 2006.

At the North Dublin Substation, PG&E crews reinstalled frame attachments (see Figure 5). Per Opus, an AT&T crew conducted work within the Substation and a PG&E telecom crew worked in the switchgear building.
