PROJECT MEMORANDUM
PG&E – TRI-VALLEY 2002 CAPACITY INCREASE PROJECT

To: Jensen Uchida, CPUC
From: Vida Strong, Aspen Project Manager
Date: September 28, 2006
Subject: Weekly Report #126: September 17, 2006 – September 23, 2006
CPUC Environmental Monitor (EM): Anne Sweet Coronado

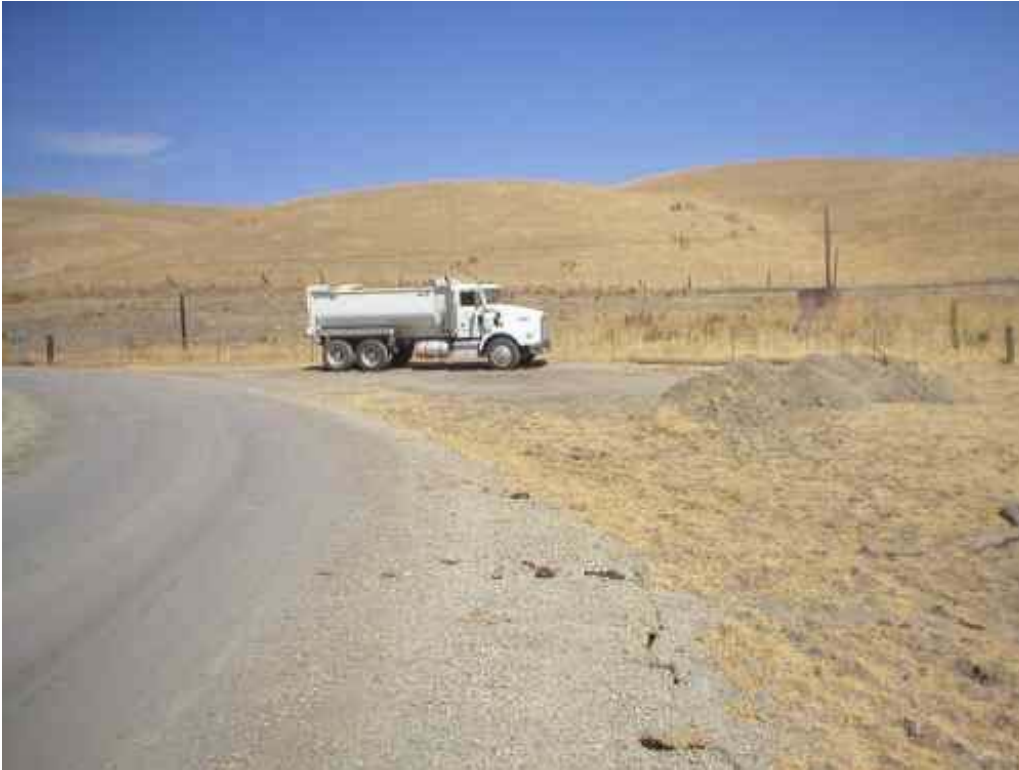
Figure 1 – Turnaround area being created by NVC as requested by the landowner, September 18, 2006.

Along Road 5, previous road widening created loose dirt along the entire road length. Road 5 runs parallel to Cayetano Creek where repeated sightings of California red-legged frog (CRLF) have occurred. On September 18th the CPUC EM noted that soils were being removed and/or compacted along the roadside. However, NVC was depositing the spoils and compacting them adjacent to the base of Road 6 in order to create a new turnaround area at the request of the land owner (see Figure 1). The area occurs approximately 50 feet from Cayetano Creek. The CPUC EM had not been informed of the work prior to encountering the construction in the field. The PG&E EI confirmed that PG&E planners were aware

of the work requested by the landowner. On September 22, the CPUC EM sent an e-mail to Opus and PG&E with notification that a retroactive variance may be required for the work. The e-mail also requested additional information including the turnaround area dimensions and all potential impacts. Opus responded to the email by telephone; however a formal response with work specifics has not yet been submitted.

1. Complete the compaction and seeding adjacent to Road 5 where the road widening work had occurred.
2. Resolve issues related to construction of the turnaround area requested by the land owner. A retroactive variance may be necessary or de-compaction and restoration of the area.
3. Remove last year's installed erosion controls including copious amounts wattles and sediment fence. For the wattle removal, NVC plans to cut the wattle, remove the mesh and leave the straw in place.
4. Hydro seed areas across the project which had been seeded last year, but continue to show poor growth.
5. Remove remaining spoils piles.
6. Complete well drilling for irrigation of landscaping at the North Dublin Substation.

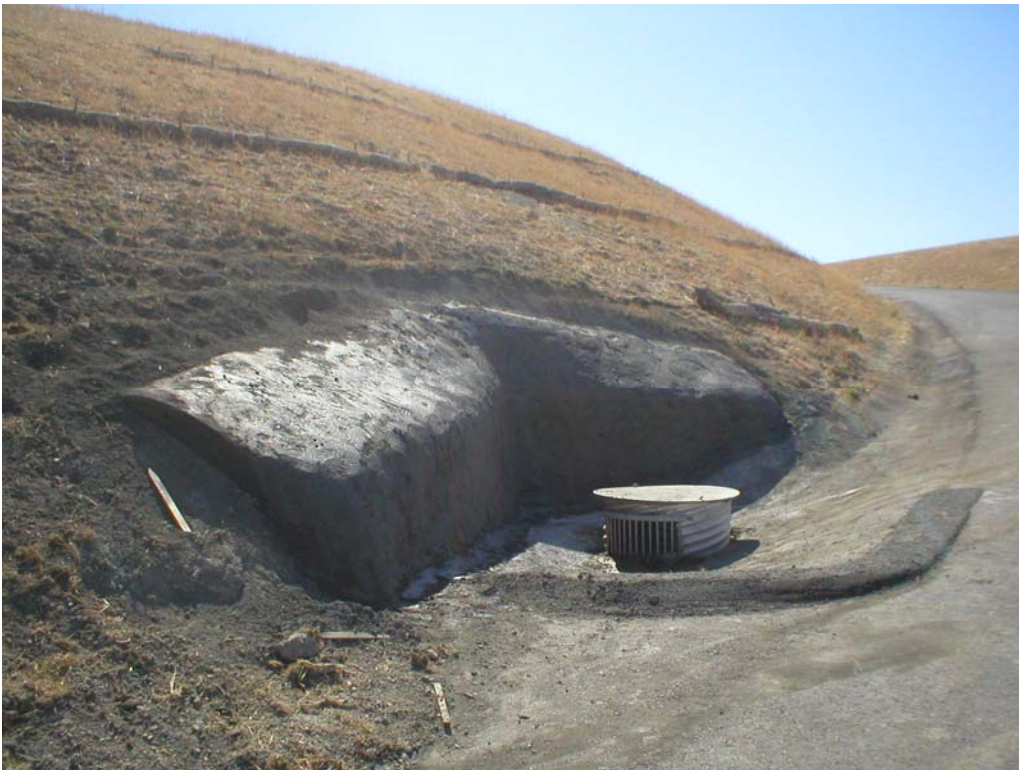
During the subject week, NVC crews set asphalt around rebar installed at a culvert inlet area along Road 6 (see Figure 2).

Figure 2 – NVC crews placed asphalt around the rebar installed at a culvert area along Road 6, September 18, 2006.
