## **PROJECT MEMORANDUM PG&E – TRI-VALLEY 2002 CAPACITY INCREASE PROJECT**

**To:** Jensen Uchida, CPUC  
**From:** Vida Strong, Aspen Project Manager  
**Date:** July 14, 2005  
**Subject:** Weekly Report #66: July 3, 2005 – July 9, 2005  
**CPUC Environmental Monitor (EM):** Anne Sweet

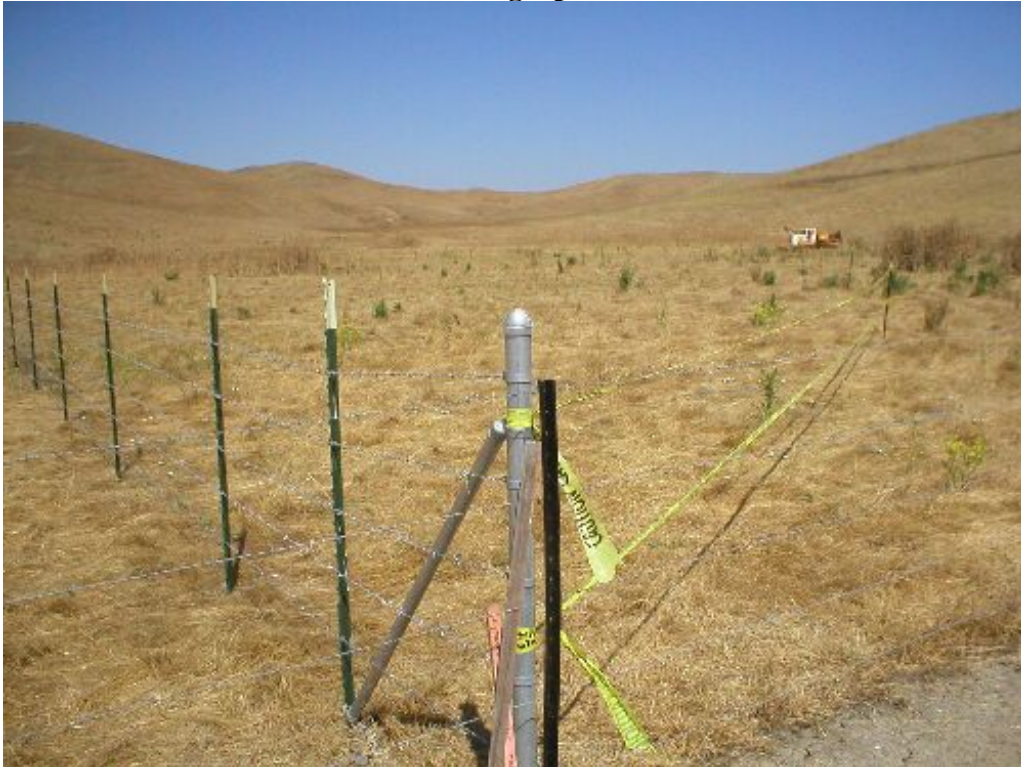
The CPUC EM and PG&E Planner toured Doolan Canyon Road. The helicopter laydown area was first evaluated. During on-going surveys a borrowing owl nest was identified outside of the laydown area. Therefore, an area greater than the required 250-foot exclusion buffer was fenced off within the yard (see Figure 1).

**Figure 1** – Helicopter laydown area located along Doolan Canyon Road, Phase Three. Please note the yellow caution tape which delineates the burrowing owl nest exclusion buffer.

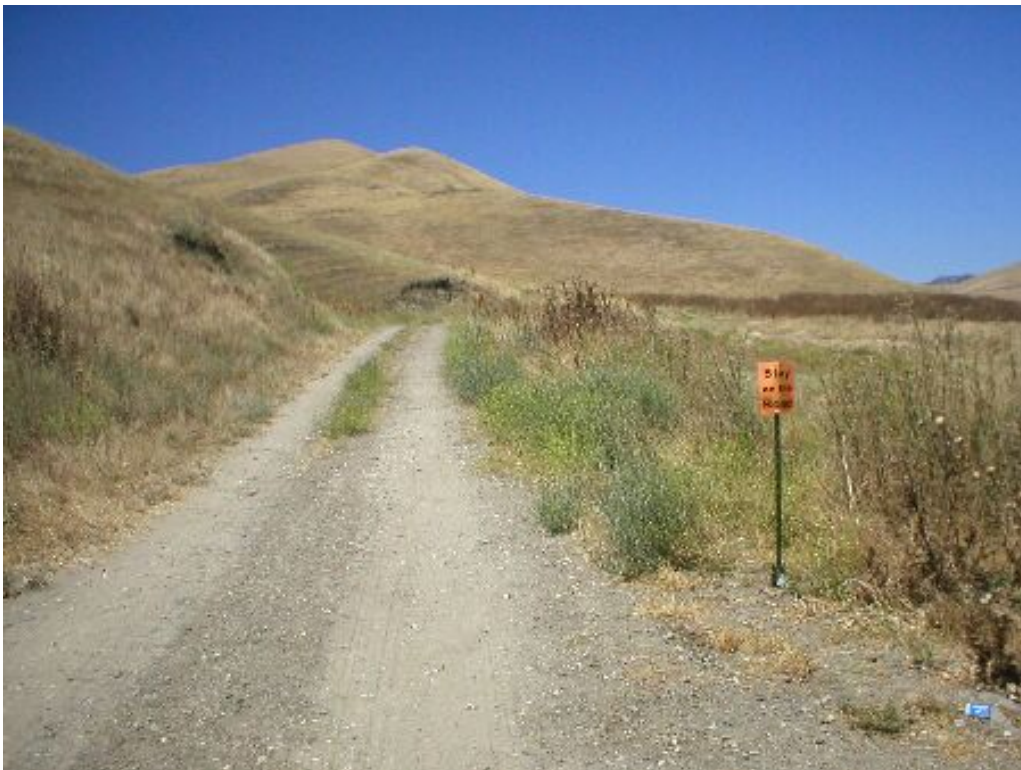
Doolan Canyon Road is a paved and/or graveled existing project access road that extends north from the laydown area. Cottonwood Creek (currently dry) runs adjacent to Doolan Canyon Road on the eastern side and serves as potential breeding habitat for the California tiger salamander (CTS) and California red legged frog (CRLF). Exclusion signage has been placed along the length of the road every 100-feet. In addition, the grade drops off sharply along the paved road thus physically limiting vehicle access (see Figure 2). A confirmed CLRF breeding pond (see Figure 3) occurs east of the roadway. It occurs uphill from the access road and construction fencing has been placed around the resource. Finally, a cluster of borrows which serve as potential aestivation habitat were identified along the access road near this area. The CPUC EM requested that all clusters of borrows be fenced off per the USFWS BO recommendations.

**Figure 2** – Doolan Canyon Road, Phase Three. Note the exclusion signage.

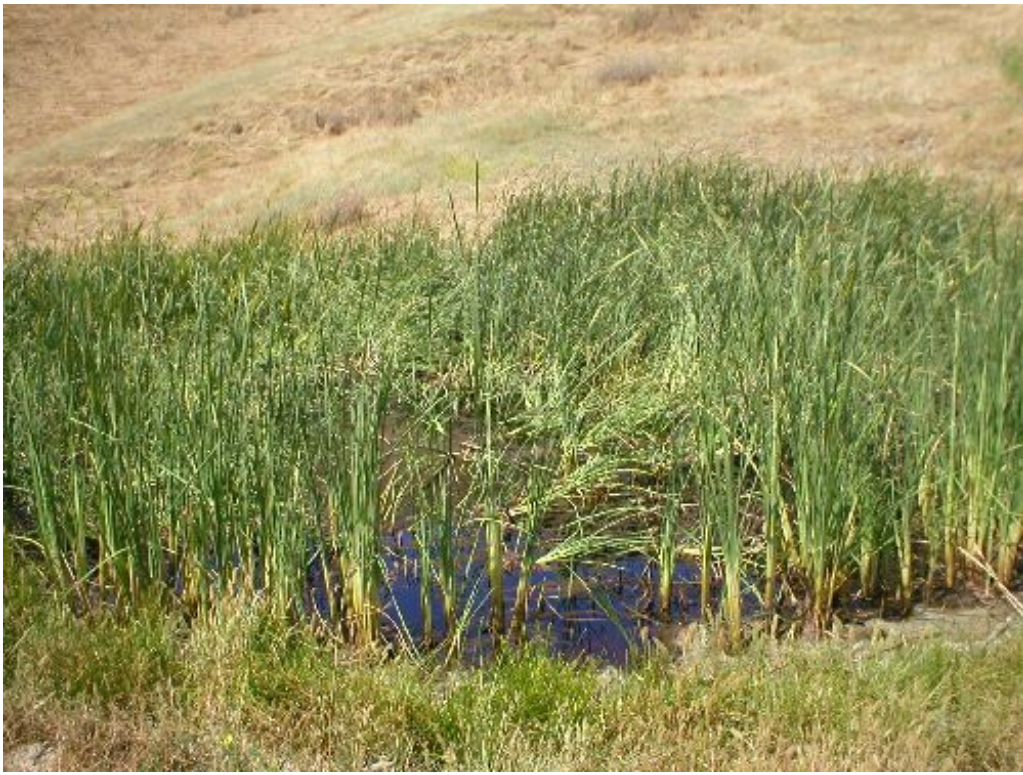
**Figure 3** – CRLF breeding pond which occurs east of Doolan Canyon Road, Phase Three.

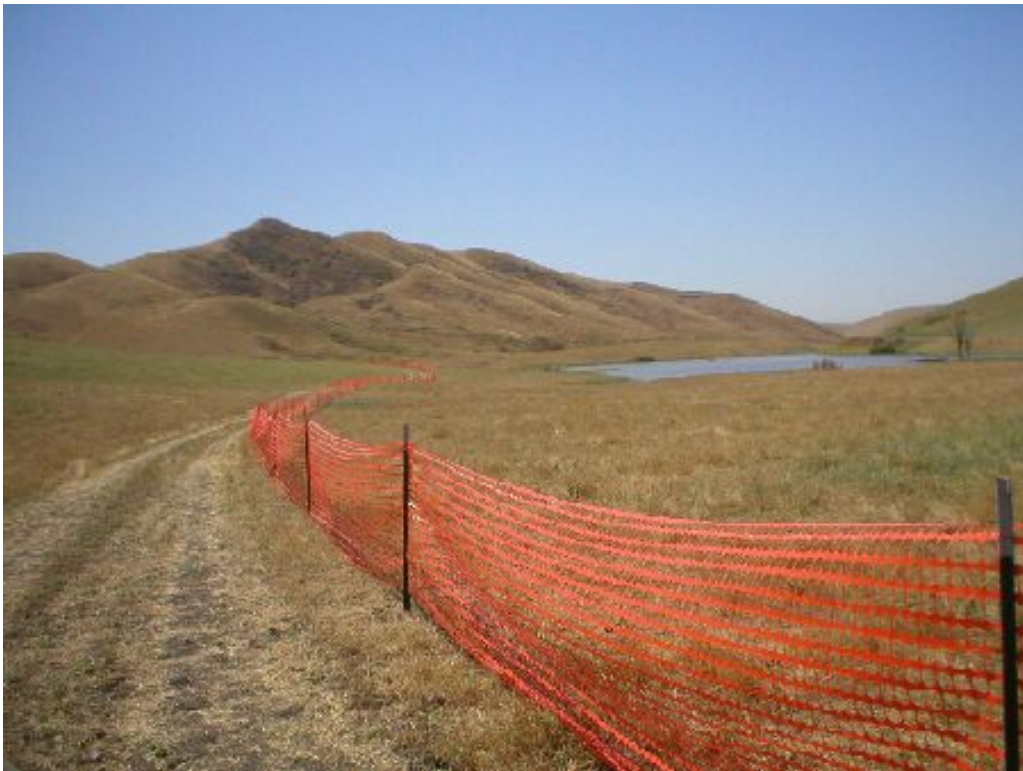
Extending north and to the east of Doolan Canyon Road lies an overland travel route for access to Towers 37 and 38. Part of the route borders potential CTS and CRLF breeding habitat. The route has been fenced per the USFWS BO requirements (see Figure 4).

**Figure 4** – Overland access area adjacent to CRLF and CTS potential breeding habitat, Phase Three

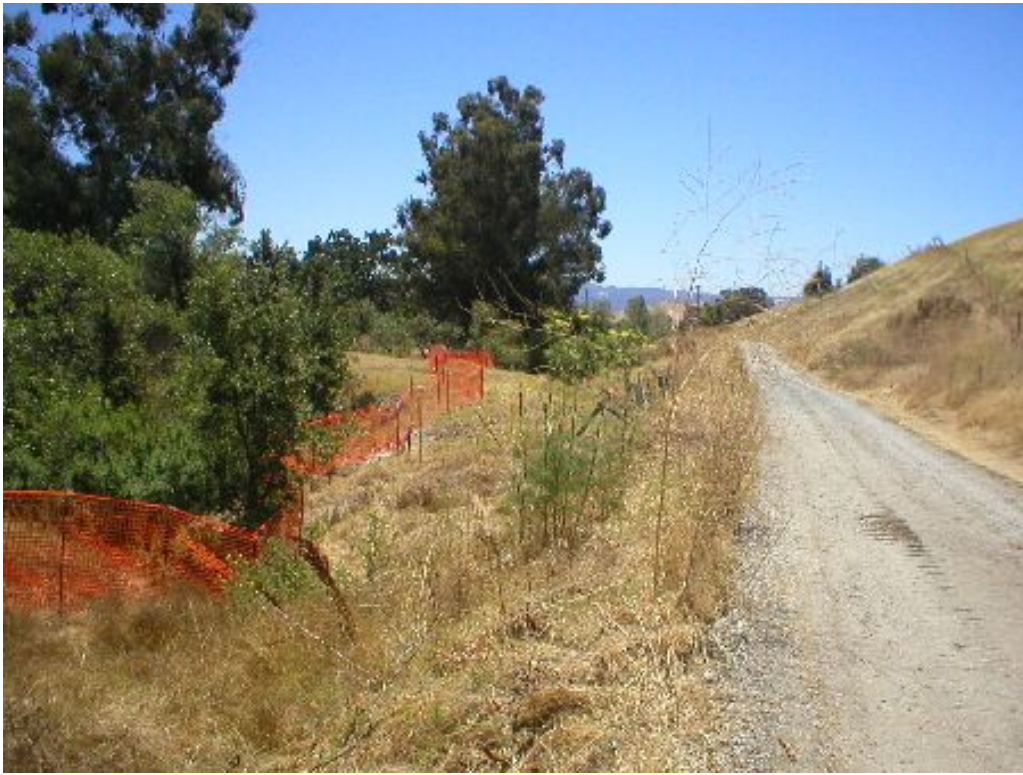
The CPUC EM and PG&E Planner toured the Moller access road. The Tassajara Creek bank stabilization will occur south along this area. Crews were installing exclusion fencing (see Figure 5) as well as sediment fencing in areas with potential for spoils to slide in to sensitive areas (see Figure 6). While driving through the dirt road area, the CPUC EM and PG&E Planner witnessed Granite Construction vehicles driving above the 10 mile per hour speed limit, kicking up a lot of dust. The PG&E Planner pulled the contractor and Foreman aside and told them to keep speeds down. Along the Moller access road, PG&E has designated numerous staging and laydown areas which extend outside of the project right-of-way. The CPUC EM told the PG&E Planner that a Variance Request will need to be prepared to allow use of the locations.

**Figure 5** – Moller access road exclusion fencing, Phase Three.

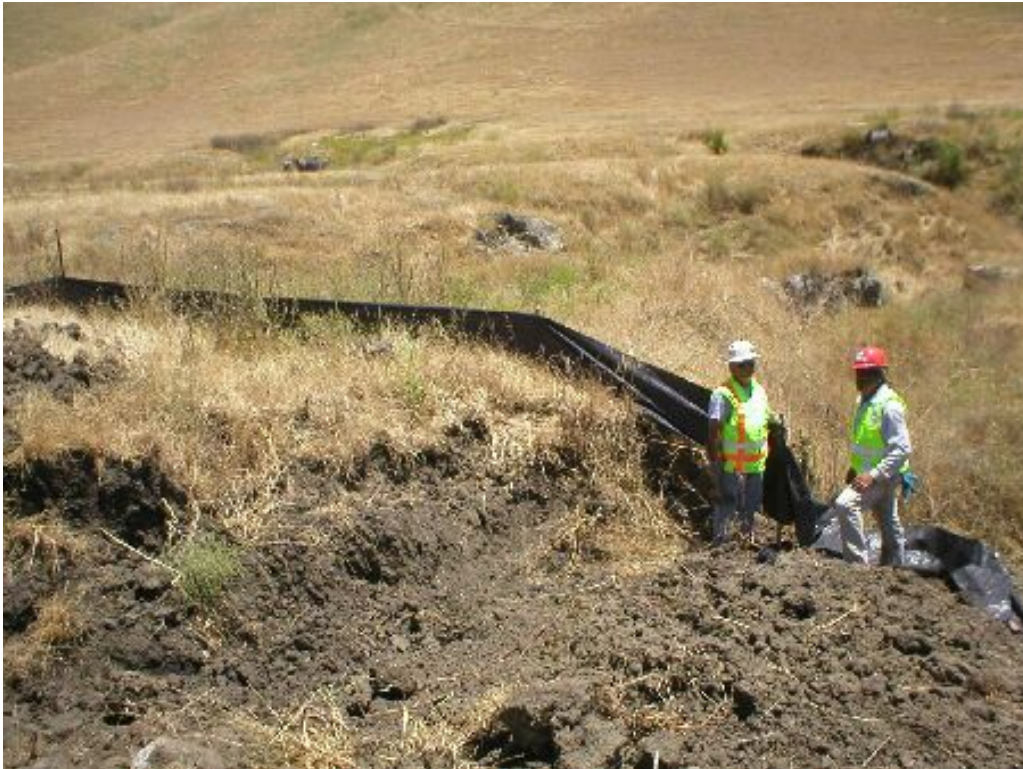
**Figure 6** – Moller access road sediment fence installation, Phase Three.
