## **PROJECT MEMORANDUM PG&E – TRI-VALLEY 2002 CAPACITY INCREASE PROJECT**

**To:** Jensen Uchida, CPUC  
**From:** Vida Strong, Aspen Project Manager  
**Date:** November 23, 2005  
**Subject:** Weekly Report #85: November 13, 2005 – November 19, 2005  
**CPUC Environmental Monitor (EM):** Anne Sweet

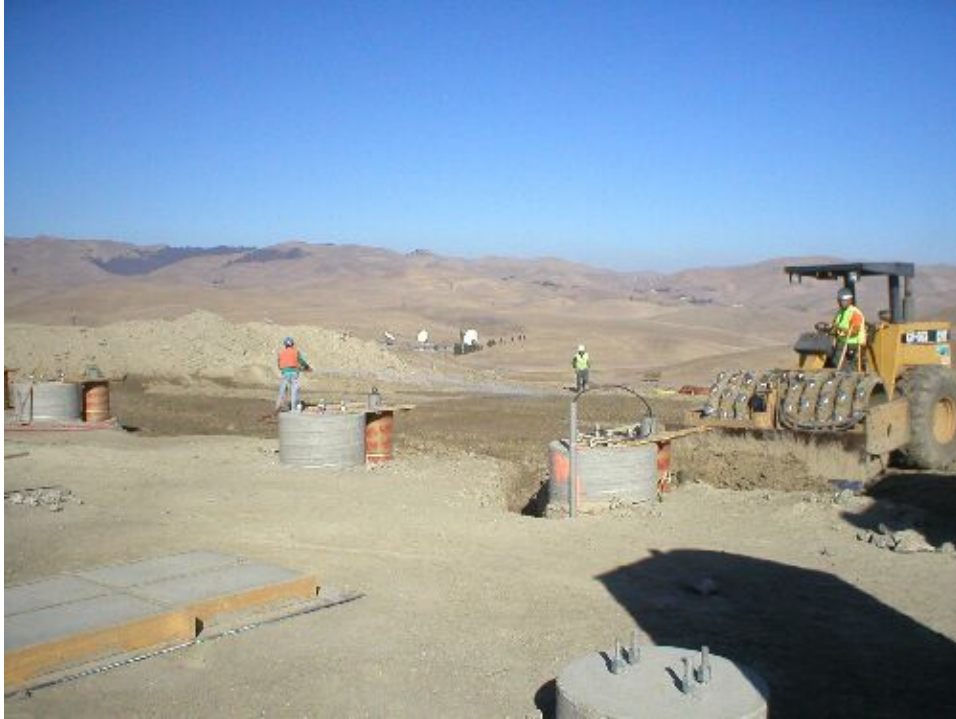
**Figure 1** – Transition Station. November 18<sup>th</sup>.

Underground construction included conduit proofing, mandrill pulling, and erosion control installation. Crews continued work at the Transition Station (see Figure 1). During the site tour on November 18, the CPUC EM noted that the trench line which extends along Road 7 still needs additional water flow dissipation controls such as straw wattles or water bars, and additional erosion controls including mulching and seeding (see Figure 2). A call was put into PG&E and the independent SWPPP contractor, North Valley Construction, installed jute wattles and hydro-seeded the area on Saturday, November 19. Per Opus, the cows in the area investigated the wattles, but it appears that they are not eating them as has been a continual problem along portions of the project.

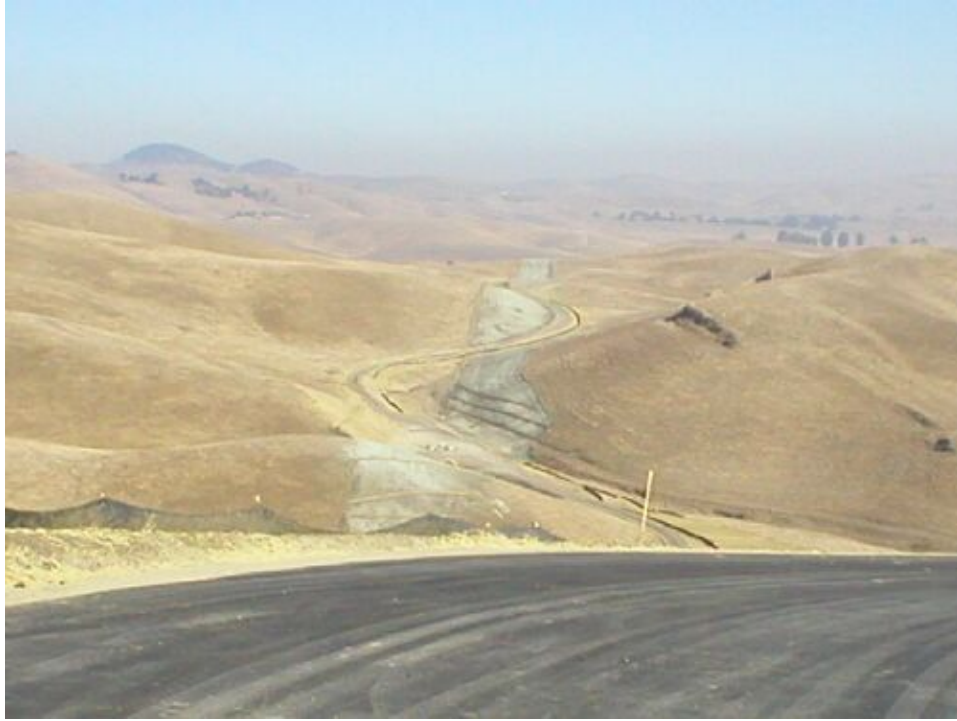
**Figure 2** – Road 7 and trench line, November 18. Note the lack of erosion controls over the trench line.

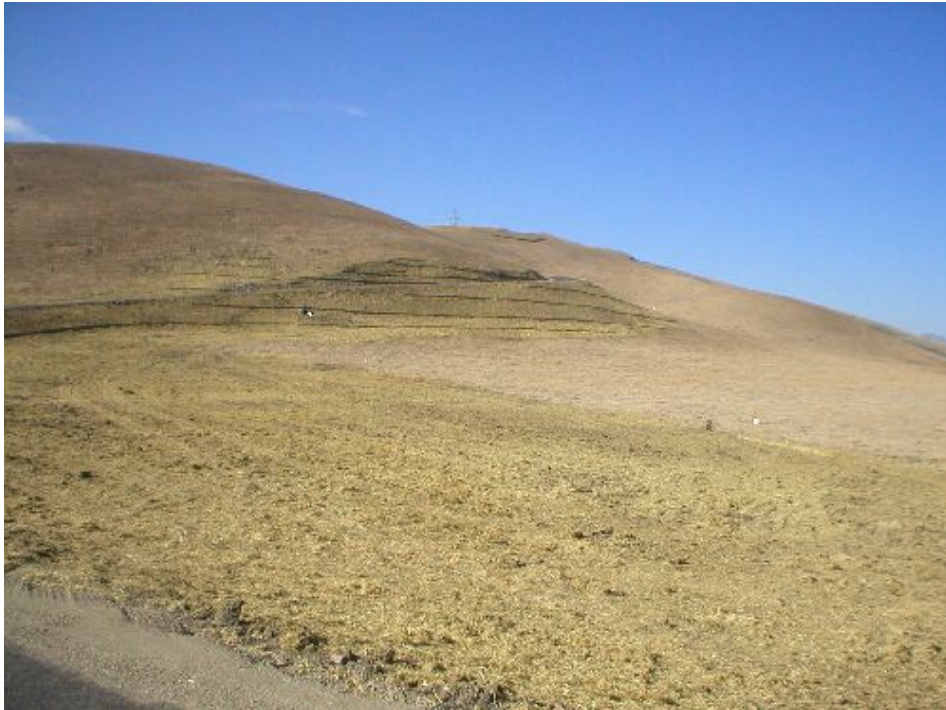
The staging areas and temporary access road along Road 6 have been vacated and the area has been restored and reseeded (see Figure 3).

**Figure 3** – Staging area along Road 6 has been vacated and the area has been restored and reseeded, November 18<sup>th</sup>.

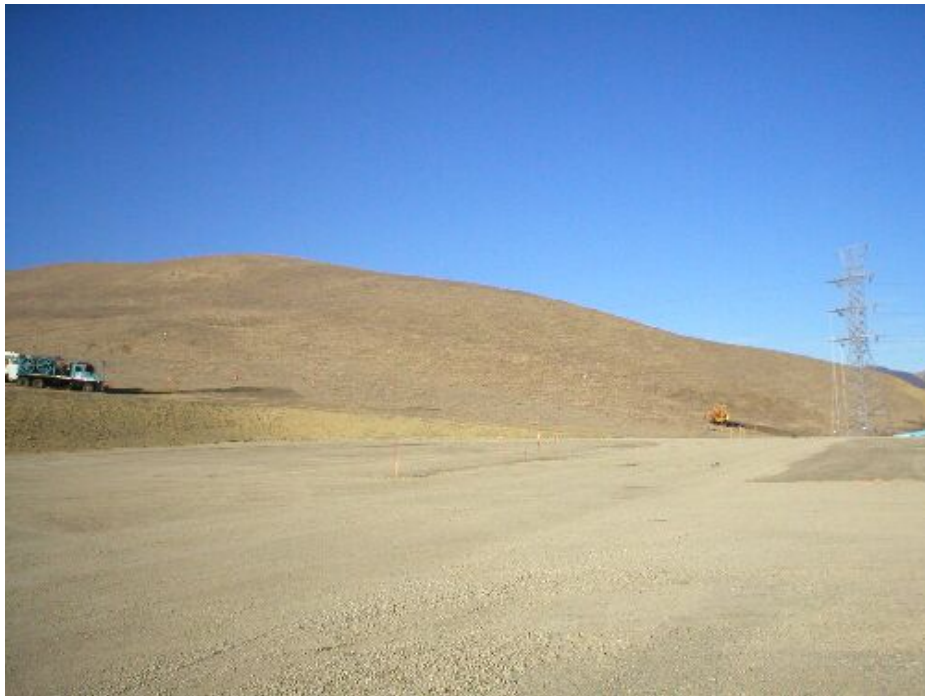
The PG&E line crews are using helicopters to pull rope and sock line through the towers. Spools of line are placed near the Substation pad in order to pull through Tower 1 (see Figure 4) to the other towers ending at Tower 13 which will connect to the Transition Station (see Figure 5).

**Figure 4** – Line pulling next to the Substation, November 17<sup>th</sup>.

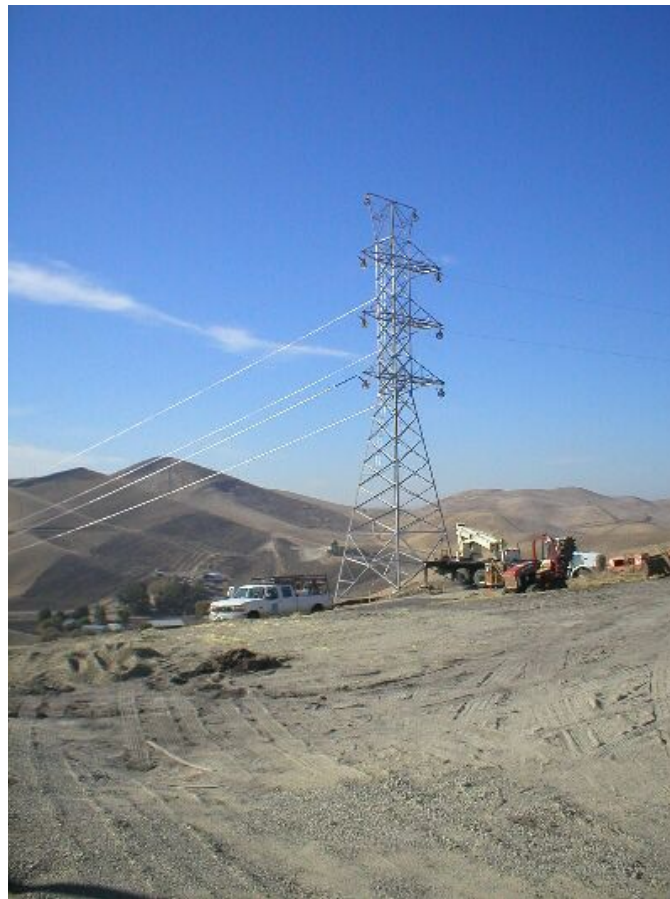
**Figure 5**– Line pulling at tower 13 next to the Transition Station, November 17<sup>th</sup>.
