## **PROJECT MEMORANDUM PG&E – TRI-VALLEY 2002 CAPACITY INCREASE PROJECT**

**To:** Jensen Uchida, CPUC  
**From:** Vida Strong, Aspen Project Manager  
**Date:** December 1, 2005  
**Subject:** Weekly Report #86: November 20, 2005 – November 26, 2005  
**CPUC Environmental Monitor (EM):** Anne Sweet

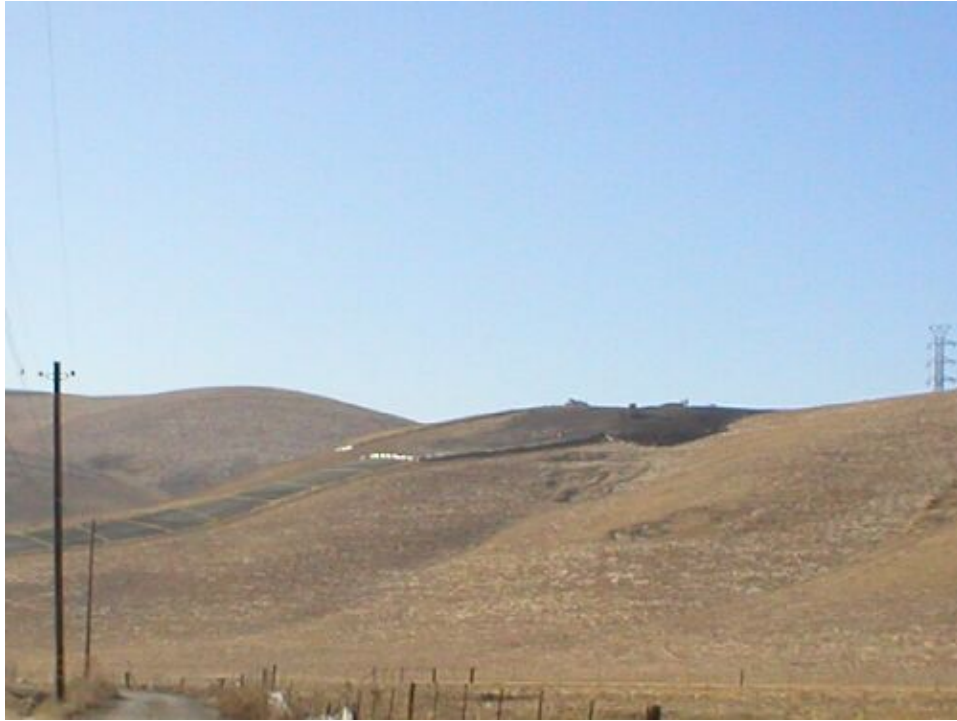
**Figure 1** – Transition Station and downslope area, November 22, 2005.

Underground construction included backfilling and erosion control installation. Crews continued work at the Transition Station. A large mound of spoils had been removed and wattles were placed directly below the Transition Station (see Figure 1). Previously, the CPUC EM noted that the trench line which extends along Road 7 needed additional water flow dissipation controls such as straw wattles or water bars, and additional erosion controls including mulching and seeding. A call was put into PG&E and the independent SWPPP contractor North Valley Construction installed jute wattles and hydro-seeded the area on Saturday, November 19. Per Opus, the cows in the area investigated the wattles, but it appeared that they were not eating them as has been a continual problem along portions of the project. During the site tour on November 22, the CPUC EM noted that although erosion controls had been installed along Road 7, the installation was sparse (see Figures 2 and 3).

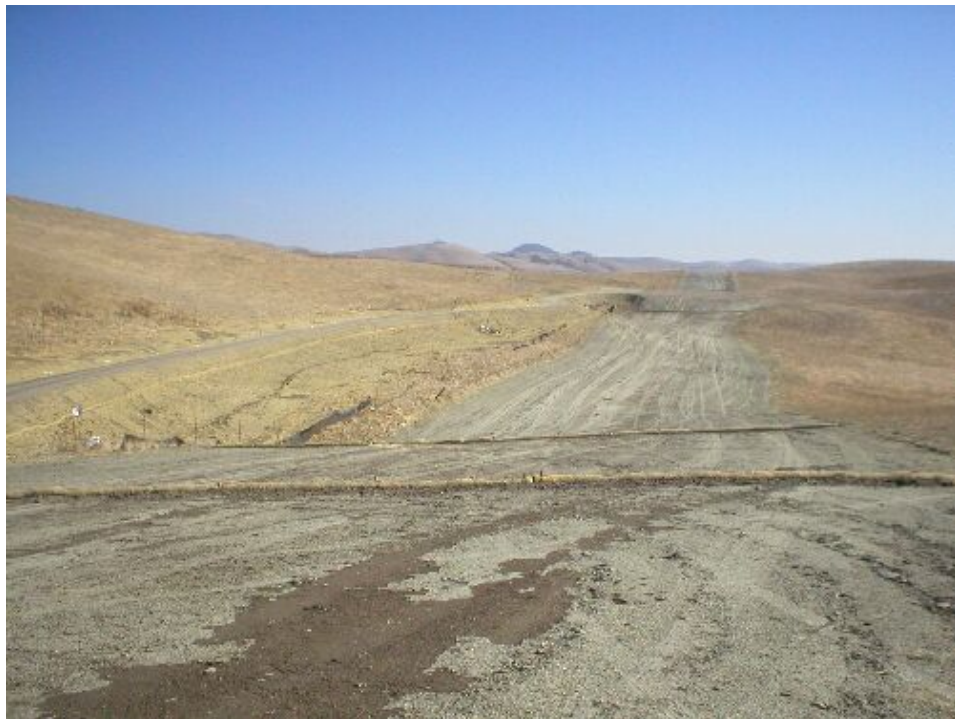
**Figure 2** – Road 7 and trench line, November 22, 2005.  
Note the sparse erosion controls over the trench line.

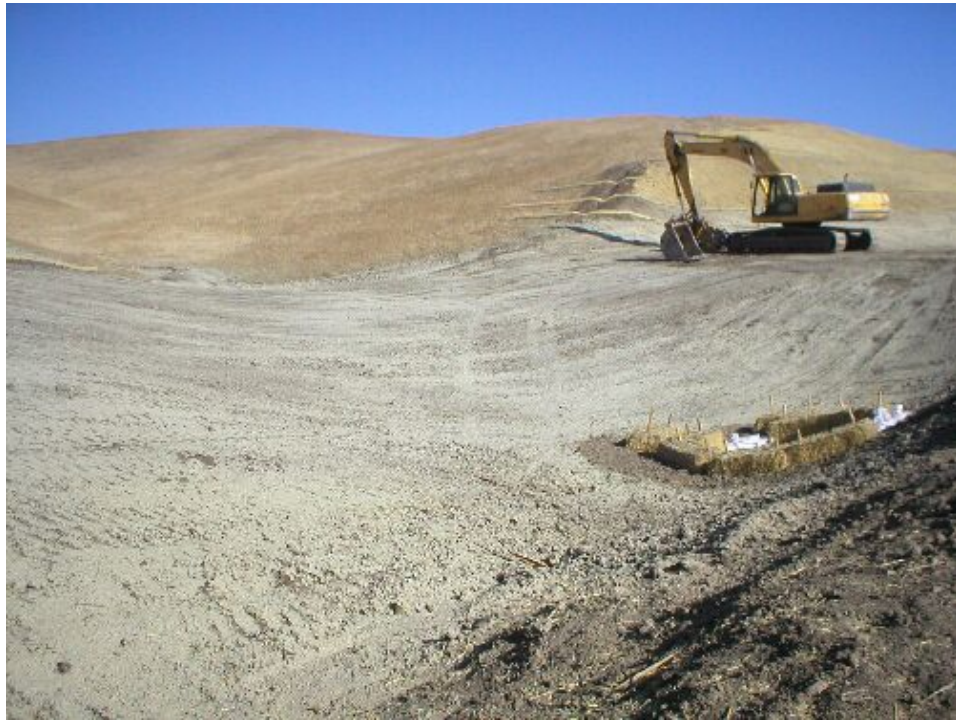
**Figure 3** – Road 7, trench line and culvert area, November 22, 2005.  
Note the sparse erosion controls.

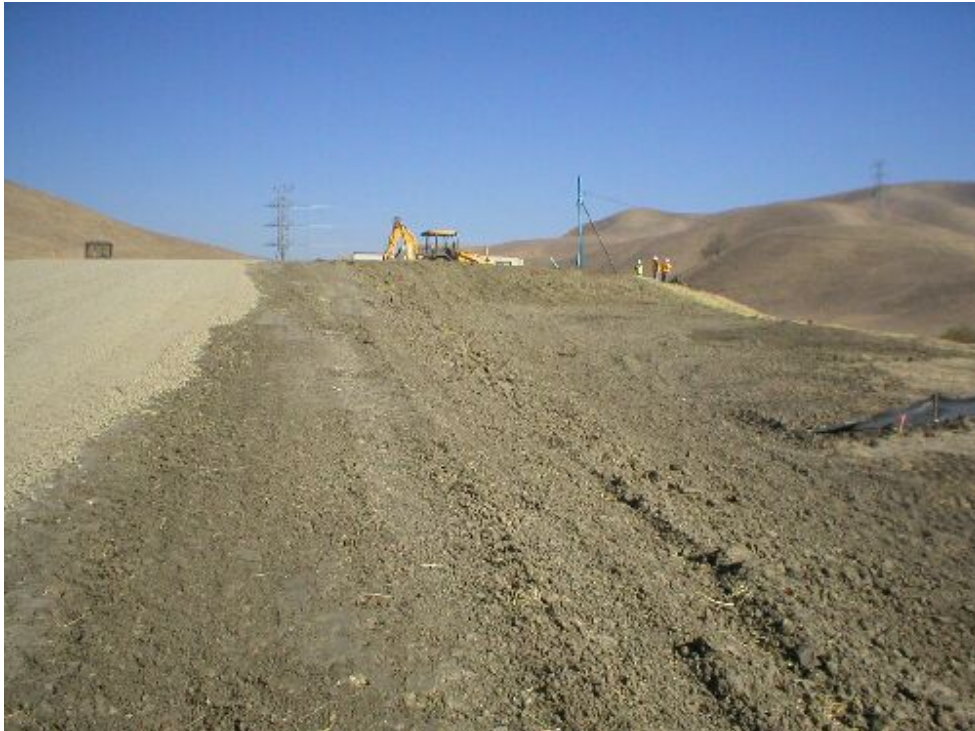
During the subject week, Black and Veatch extended the North Dublin Substation pad to meet the project specifications. Fence post holes were augured. During the tour on November 22, the CPUC EM noted that down slope of the substation, the installed sediment fencing which protects a culvert leading to Tassajara Creek had been buried by construction spoils resulting from the substation pad work (see Figures 4 and 5). The PG&E EI was notified and the sediment fencing was repaired.

**Figure 4**– Work to extend the Substation pad, November 22, 2005.  
Note the buried sediment fence to the right.

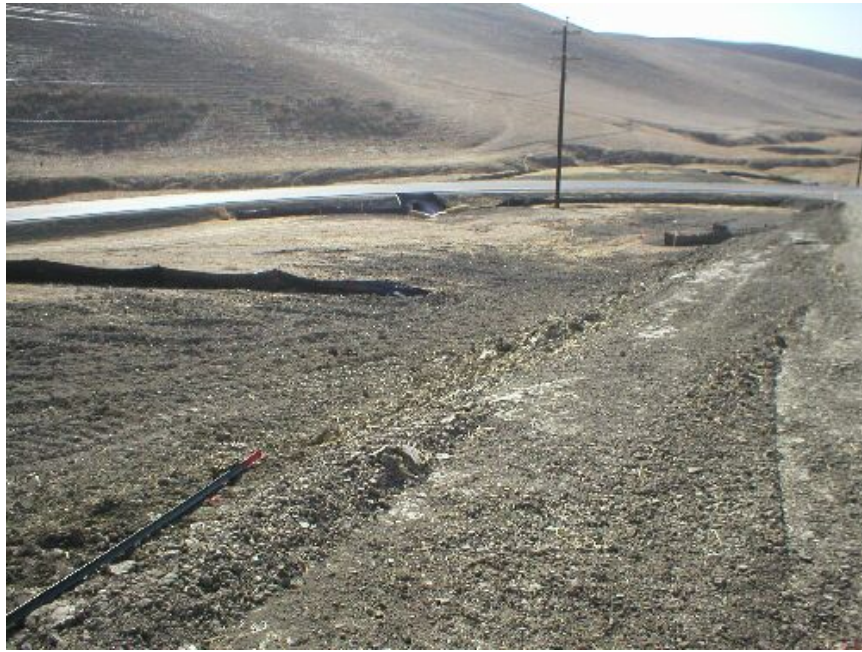
**Figure 5** – Work to extend the Substation pad, November 22, 2005.  
Note the buried sediment fence to the left and the culvert.
