PROJECT MEMORANDUM PG&E – TRI-VALLEY 2002 CAPACITY INCREASE PROJECT

To: Jensen Uchida, CPUC
From: Vida Strong, Aspen Project Manager
Date: December 14, 2005
Subject: Weekly Report #88: December 4, 2005 – December 10, 2005
CPUC Environmental Monitor (EM): Anne Sweet

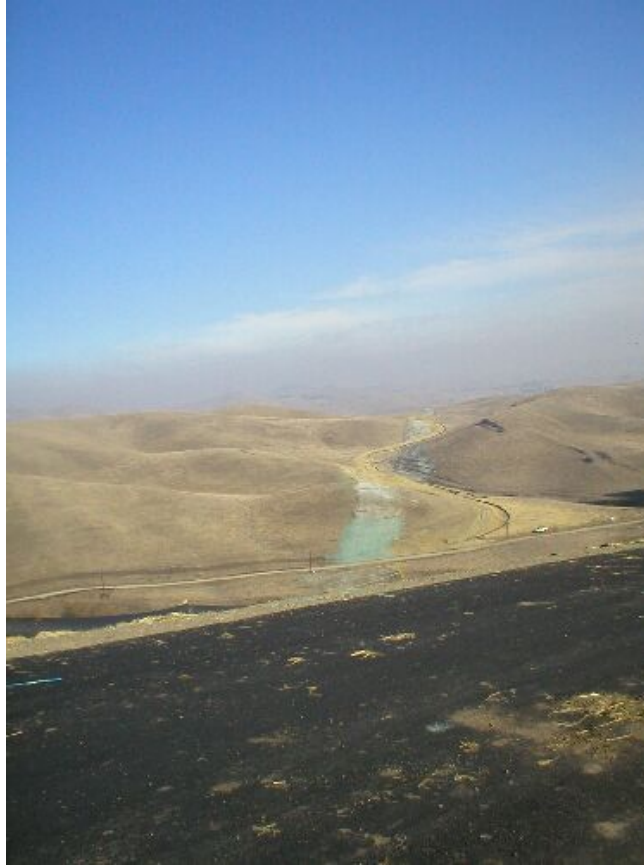
Underground construction included continued work at the Transition Station where crews continued installation of the ground grid within trenches which were then backfilled. Erosion control installation and maintenance continued. Along Roads 6 and 7, hay was broadcasted and areas were hydro-seeded (see Figure 1). The CPUC EM noted that along Road 7 where previously minor erosion had occurred near a drainage area, the area was covered with hay and hydro-seeded (see Figure 2).

Figure 1 – Trench line extending from the Transition Station and Road 7, December 8. Note the new, green hydro-seed.

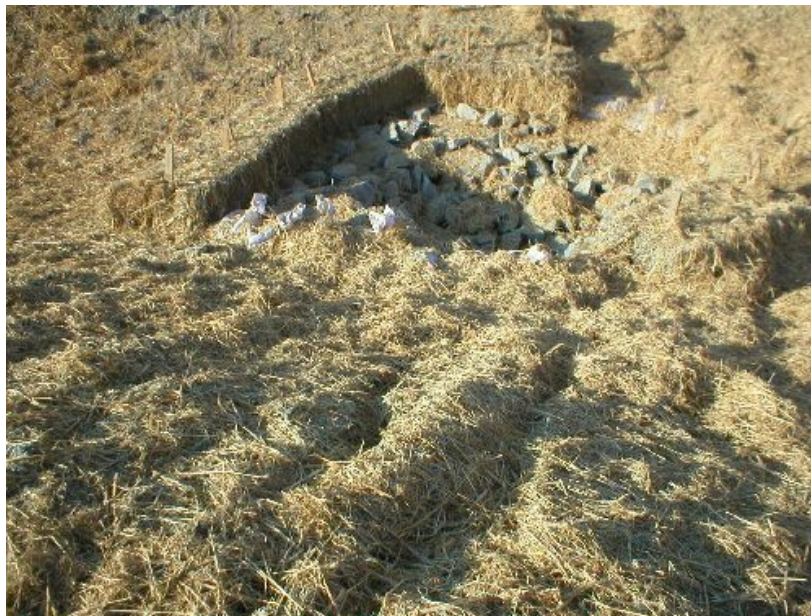
Figure 2 – Area of erosion near a culvert along Road 7, December 8, 2005. Hay was broadcast and the area hydro-seeded during the subject week.

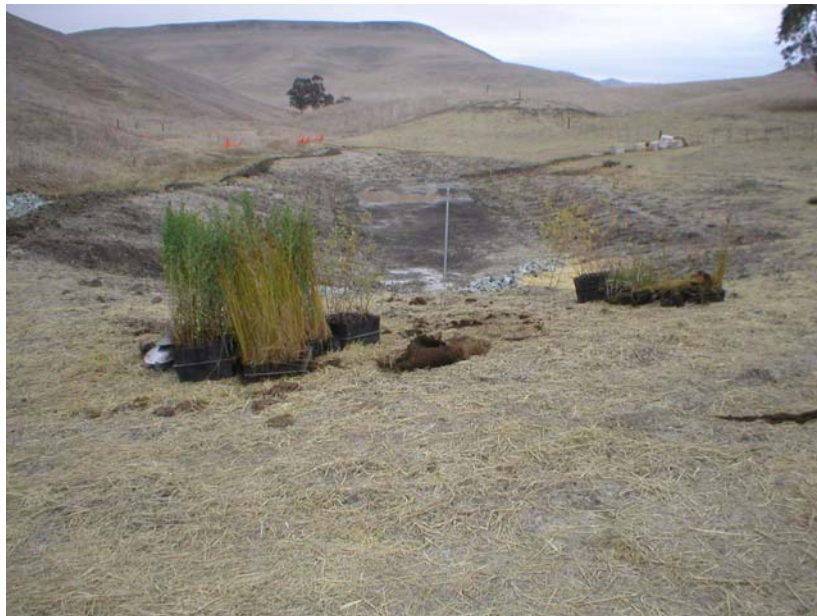
The CPUC EM inspected the Mitigation Site. During the subject week, Jones and Stokes planted vegetation in the wetland site (see Figure 3).

Figure 3 – Jones and Stokes installed wetland species plantings in the Mitigation Area, December 8, 2005.

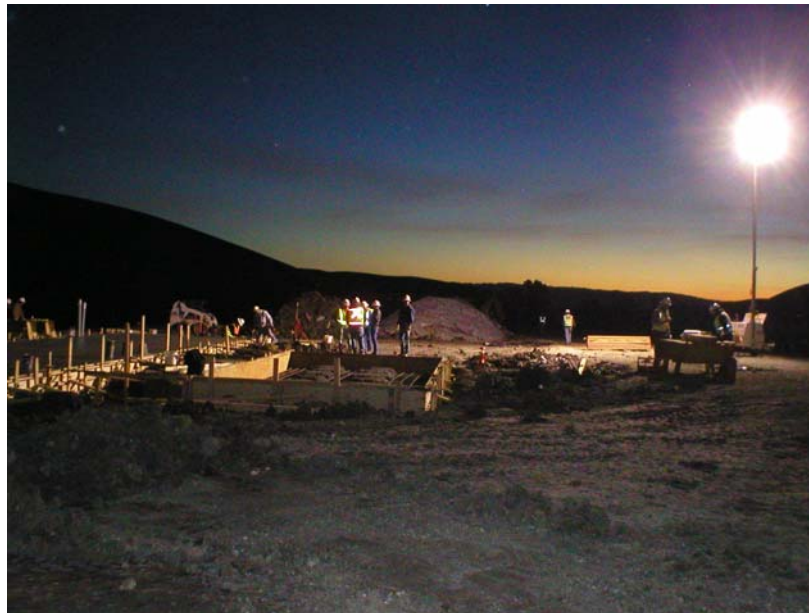
During the subject week, fence continued to be installed around the Substation. Concrete was poured for transmission pads requiring work after sunset on December 7 (see Figure 4). Lighting was brought to the site. PG&E conducted the required resource agency notifications. Per agreements with USFWS, the Opus biologist walked the project vehicles out of the site on foot.

Figure 4 – Night work at the North Dublin Substation, December 7, 2005.
