PROJECT MEMORANDUM PG&E – TRI-VALLEY 2002 CAPACITY INCREASE PROJECT

To: Jensen Uchida, CPUC
From: Vida Strong, Aspen Project Manager
Date: January 4, 2006
Subject: Weekly Report #90: December 18, 2005 – December 24, 2005
CPUC Environmental Monitor (EM): Anne Sweet

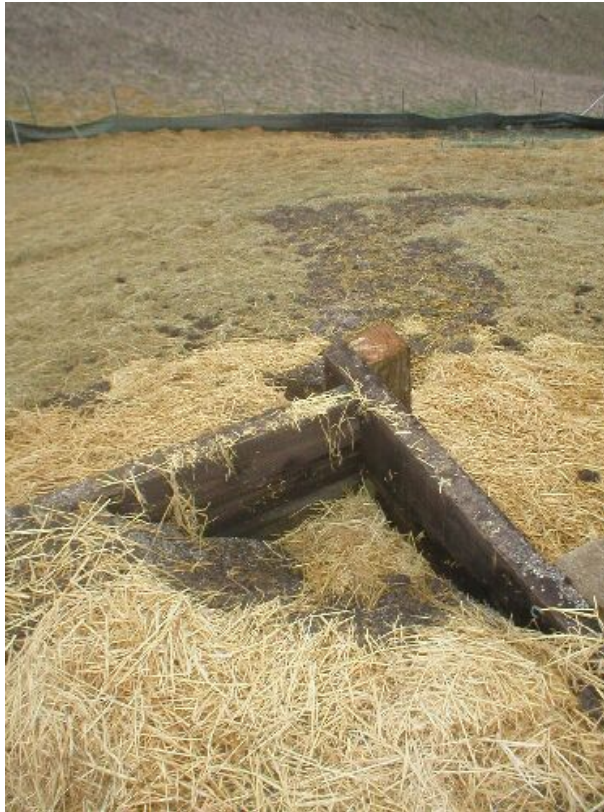
At the Transition Station the recently erected frame structure has shown signs of instability. Welded bolts have snapped and popped off of the structure. PG&E decided to take the structure down and after the installation of base rock, the top cross beam removal commenced on December 22 (see Figure 1). The Transition Station pad should show signs of erosion at the north east corner of the bulkhead (see Figure 2). Granite filled the corner with concrete and installed sediment fence below the area on December 22.

Figure 2 – Erosion at the Transition Station bulkhead, December 20, 2005.

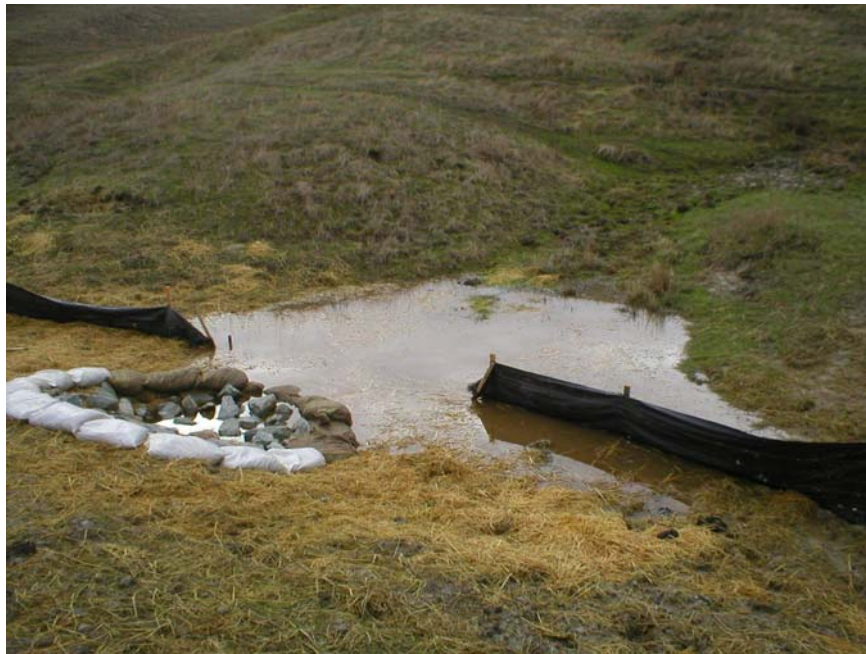
An extensive on-foot tour was conducted by the CPUC EM and PG&E EI on December 19 and 20 to review the site after the large storm event which had occurred over the weekend. Erosion control effectiveness, as well as maintenance needs were assessed. Along Moller Road and the mitigation site access road, the new roadbed areas including some culvert inlet areas showed signs of ponding (see Figure 3). In most areas the controls worked well; however, several areas had sediment build up and other areas were in need of repair. An extensive punchlist of these maintenance and repair needs was compiled. Opus issued a project-wide concern regarding these areas. An Informational Project Memorandum was issued by the CPUC EM on December 20 to document the findings of the project wide walkthrough. In response, Granite sent a single contractor to work on the punchlist and he was unable to complete work on the issue areas prior to another rain event that evening. Additional Granite crewmen were sent the following day and North Valley Construction, the independent SWPPP contractor, was called to complete work. As detailed in the punch-

Figure 3 – Flooded culvert inlet located along the MSA Access Road, December 19, 2005.

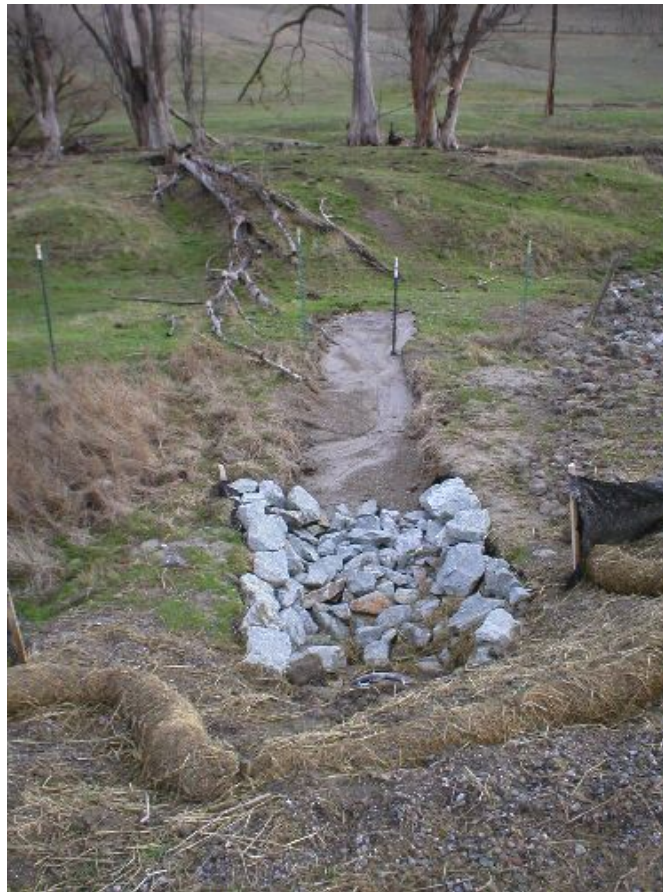
list, along Moller Road, sediment build-up has occurred at culvert areas, each flow directly to Tassajara Creek (see Figure 4). Controls protecting the creek were either in need of repair or lacking. The areas were repaired and maintained by the end of the week (see Figure 5). Along Road 7, a side slope had showed signs of erosion and the installed wattles were full of sediment, just down slope lays a tributary to Cayetano Creek. Crews removed the built-up sediment. Along Cayetano Creek, in an area known to be CTS and CRLF breeding habitat, pasturing cows have entirely eaten the installed erosion controls protecting the creek. This area was left unprotected during the weekend storm event (see Figure 6). By the end of the subject week, North Valley Construction installed straw wattles along the resource and installed a fence to keep the cows from eating the installation (see Figure 7). By the end of the subject week, Granite and North Valley Construction repaired and maintained the erosion controls outlined in the Information Project Memorandum.

Figure 4 – Sediment past a culvert along Moller Road upstream of Tassajara Creek, December 19, 2005.

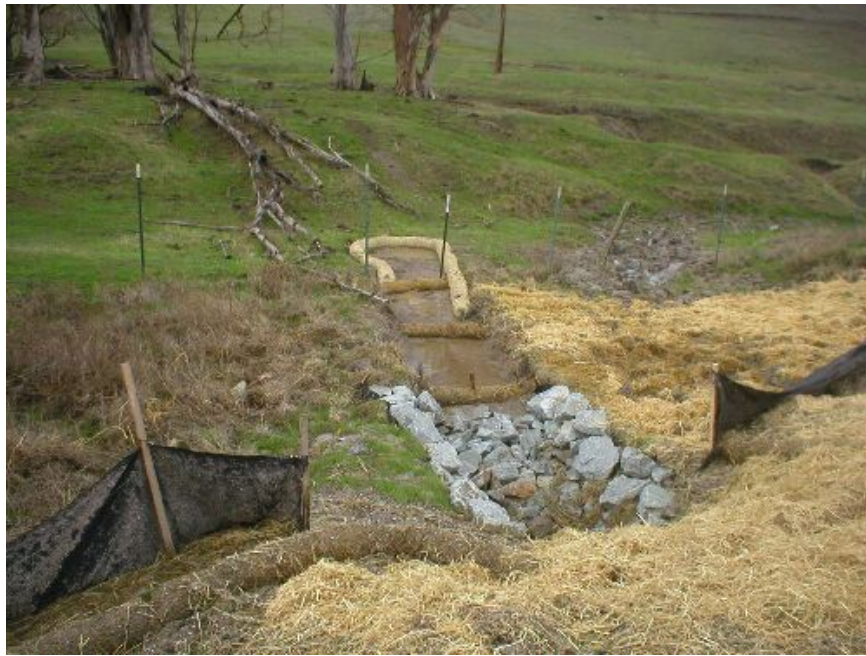
Figure 5 – Sediment cleaned and contained past a culvert along Moller Road upstream of Tassajara Creek , December 22, 2005.

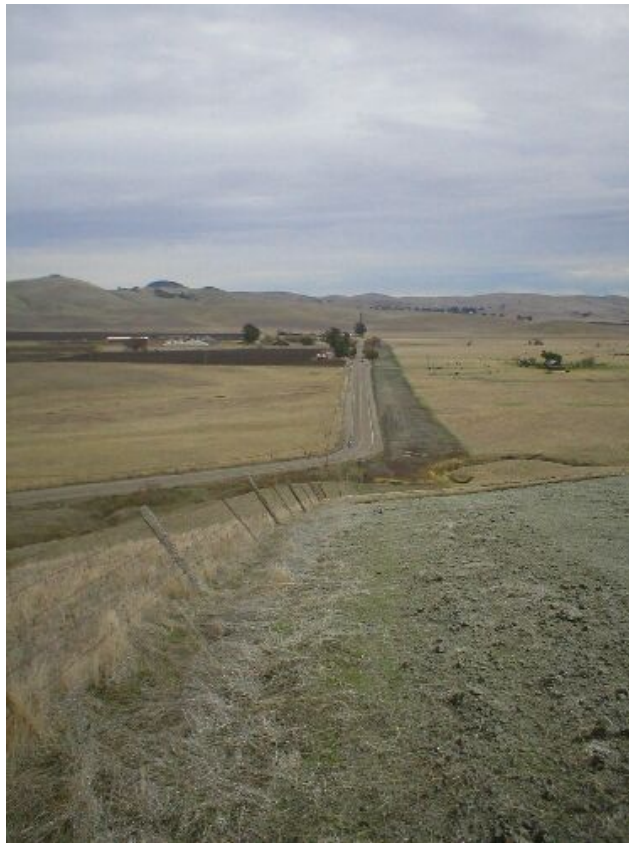
Figure 6 – Cayetano Creek where the pasturing cows have eaten the installed erosion controls, December 19, 2005.

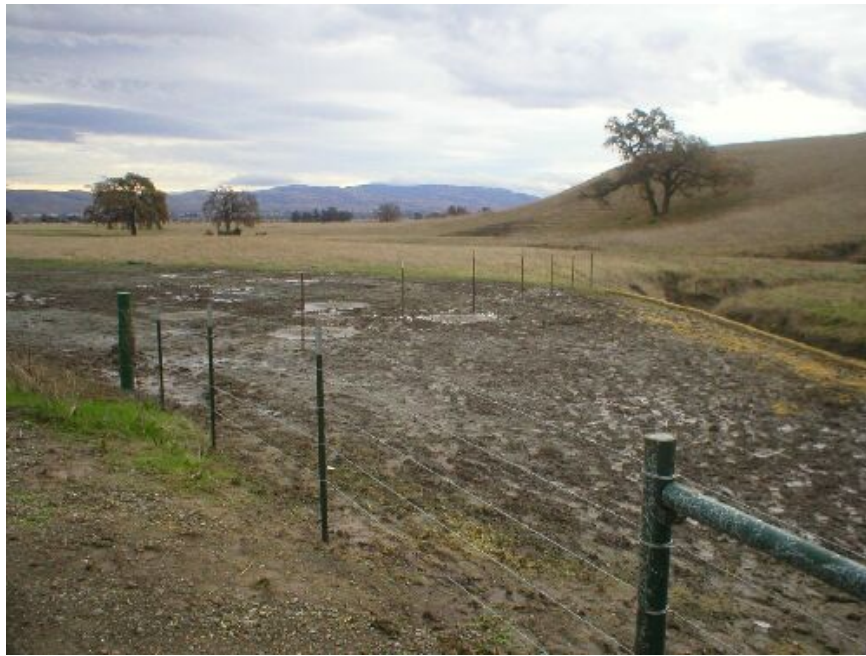
Figure 7 – Cayetano Creek, fenced area around newly installed wattles, December 22, 2005.
