PROJECT MEMORANDUM PG&E – TRI-VALLEY 2002 CAPACITY INCREASE PROJECT

To: Jensen Uchida, CPUC
From: Vida Strong, Aspen Project Manager
Date: January 19, 2005
Subject: Weekly Report #93: January 8, 2006 – January 14, 2006
CPUC Environmental Monitor (EM): Anne Sweet

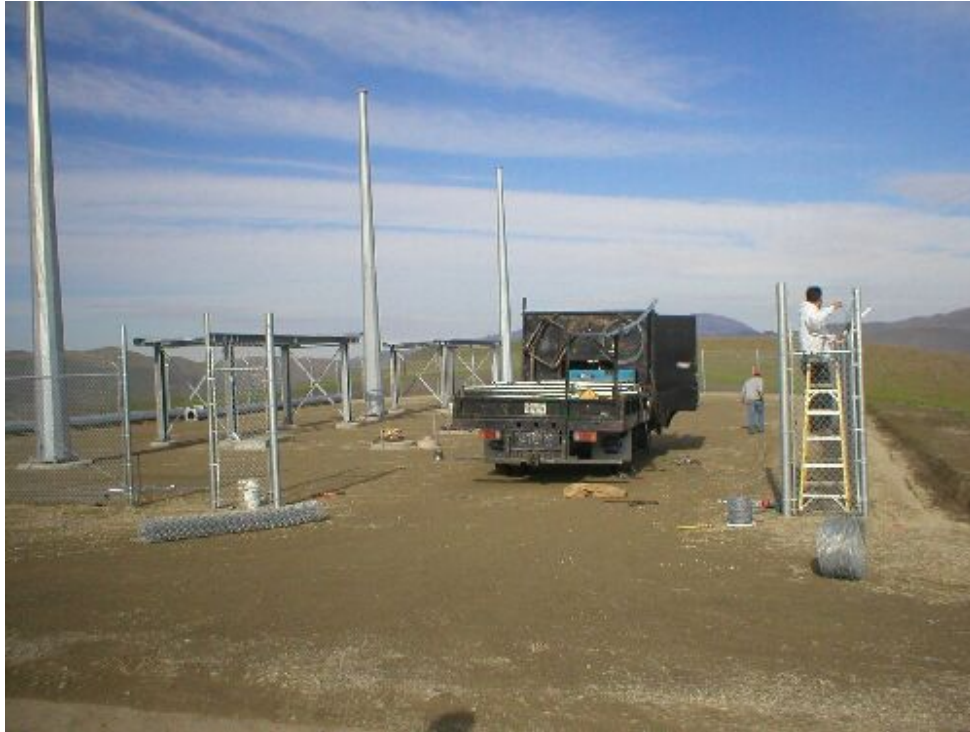
At the Transition Station, crews installed a fence with barb wire around the area during the subject week (see Figure 1). Work at the station is finished for the time being. Per the PG&E inspector, Wilson Construction will most likely return March 15th.

Figure 1– Fence installation at the Transition Station, January 11, 2006.

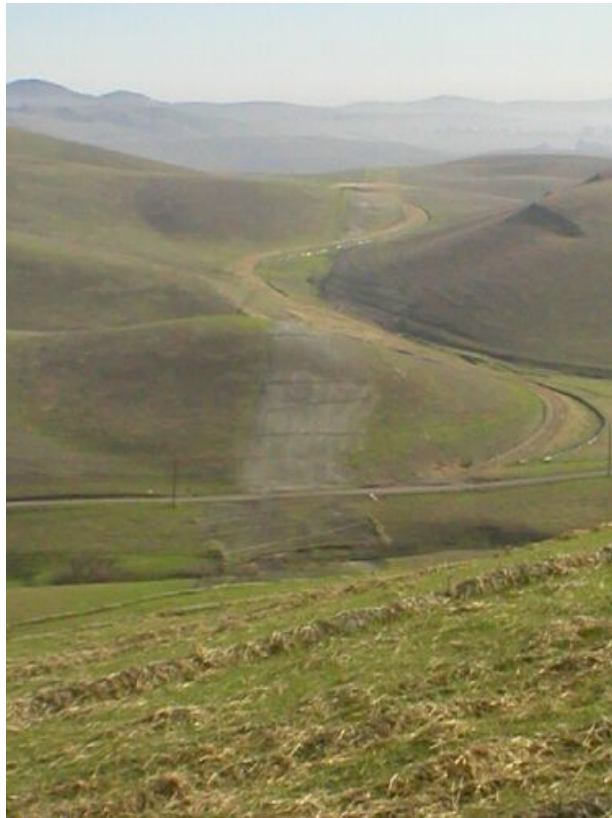
Previously, along Road 6, the earthen v-ditches showed erosion and sediment had buildup in the sandbag checks. The sediment has been cleaned out from the area and additional sandbags have been installed. On Friday, January 13, a burrowing owl was observed approximately 80 feet northeast of Road 6 at approximately Station 29+00. Opus notified the CPUC EM and CDFG. No work other than erosion control maintenance is planned to occur in the area. Previously along Road 7, some landslides had occurred which uprooted the staked in wattles. The area has been repaired and erosion controls have been reinstalled (see Figure 2).

Figure 2 – Road 7 previous landslide area where erosion controls have been fixed, January 11, 2006.

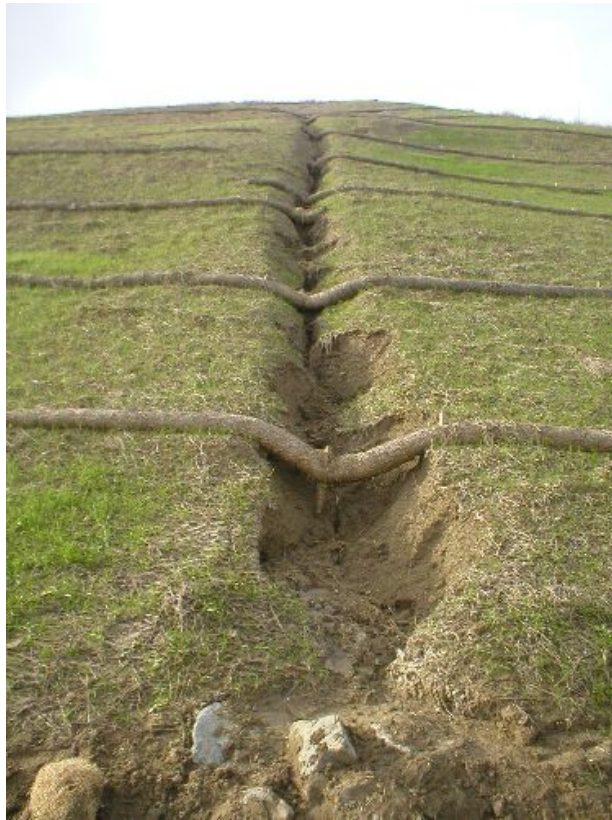
Along Moller Road and the mitigation site access road, several areas along the new roadbed including some culvert inlet areas continue to show signs of ponding. Great erosion has occurred in v-ditches along the side of Moller Road (see Figure 3). Although the large amount of erosion debris/accumulated sediment run off has been removed, some dispute remains over whether the erosion was caused by a design flaw and

whether Granite or PG&E will be responsible for repairs/maintenance. The earthen v-ditch remains at risk for further erosion. Previously a landslide had occurred at a new culvert outlet also upstream of Tassajara Creek, a plastic tarp has been installed over the area (see Figure 4).

Figure 3– Erosion along the earthen v-ditch
along Moller Road,
January 4, 2006.

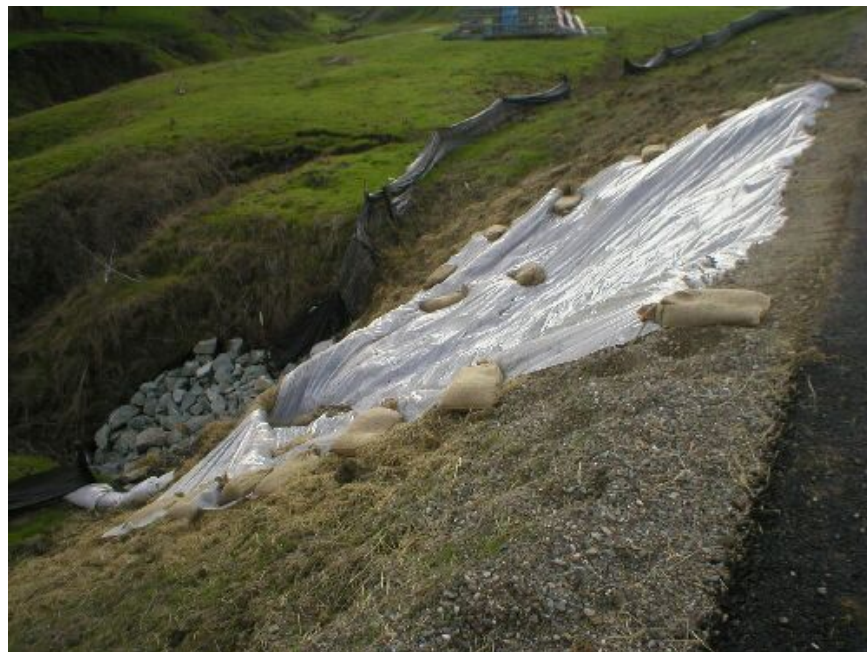
Figure 4 – Plastic placed over a small landslide at a culvert outlet
along Moller Road,
January 13, 2006.

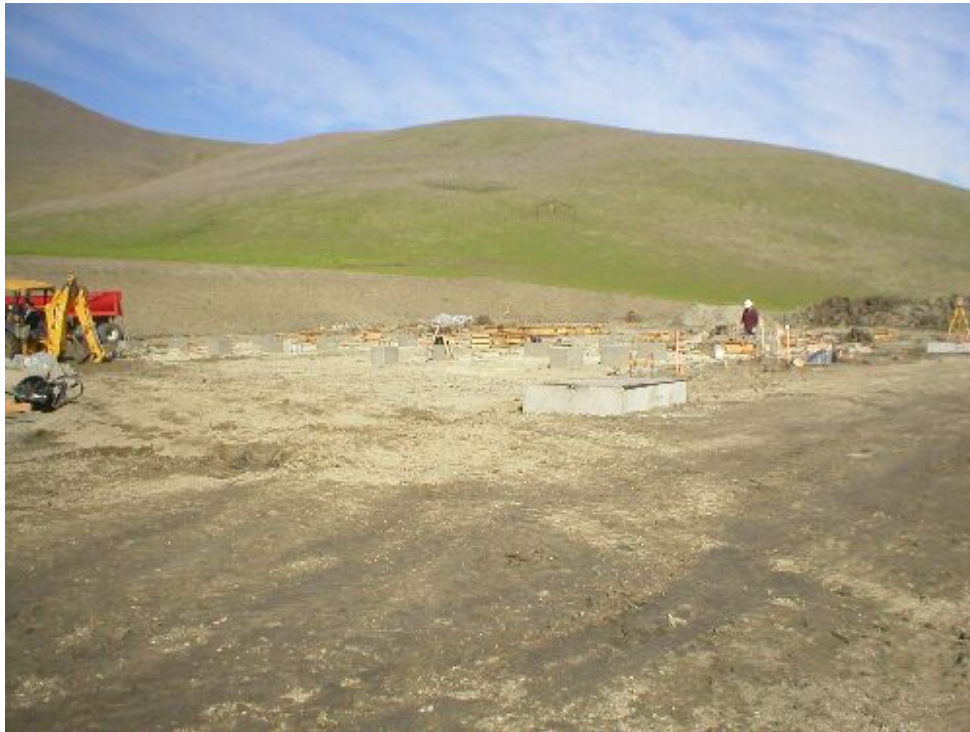
At the North Dublin Substation, during the previous week, the concrete forms from the SPCC pond were removed. During the subject week, Black and Veatch excavated foundation holes and installed construction forms, which were set in concrete (see Figure 5). Crews installed fiber optic pull boxes. Extra spoils were removed from the site on January 13th.

Figure 5 – Foundation structure installation at the North Dublin Substation, January 11, 2006.
