PROJECT MEMORANDUM PG&E – TRI-VALLEY 2002 CAPACITY INCREASE PROJECT

To: Jensen Uchida, CPUC
From: Vida Strong, Aspen Project Manager
Date: January 26, 2005
Subject: Weekly Report #94: January 15, 2006 – January 21, 2006
CPUC Environmental Monitor (EM): Anne Sweet

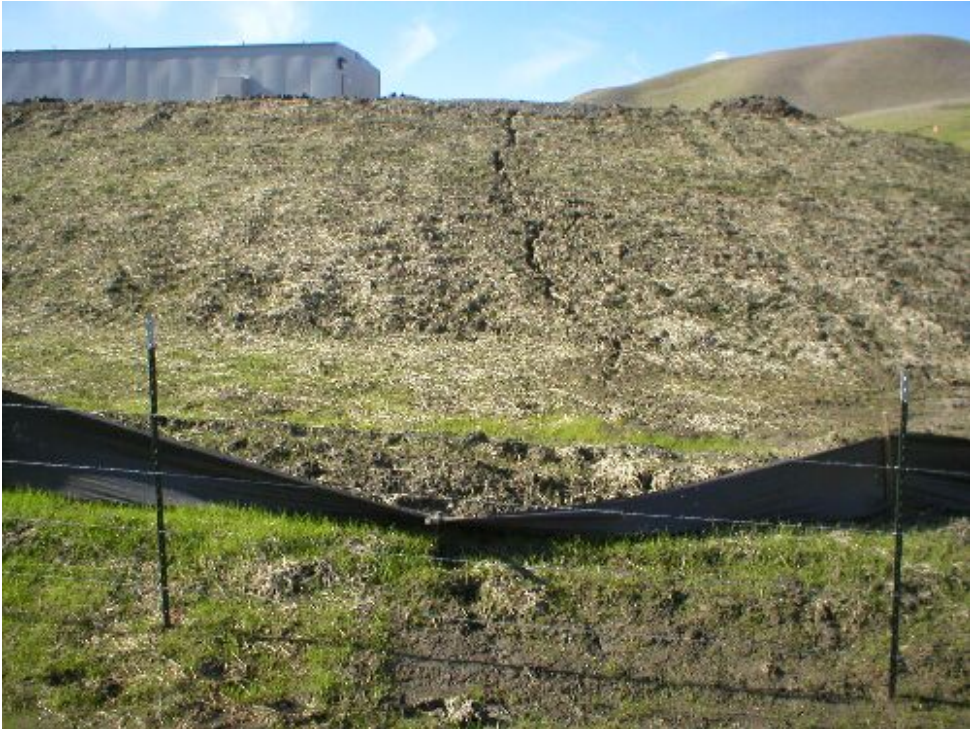
Figure 1 – Erosion extending down the side of the North Dublin Substation pad, January 20, 2006.

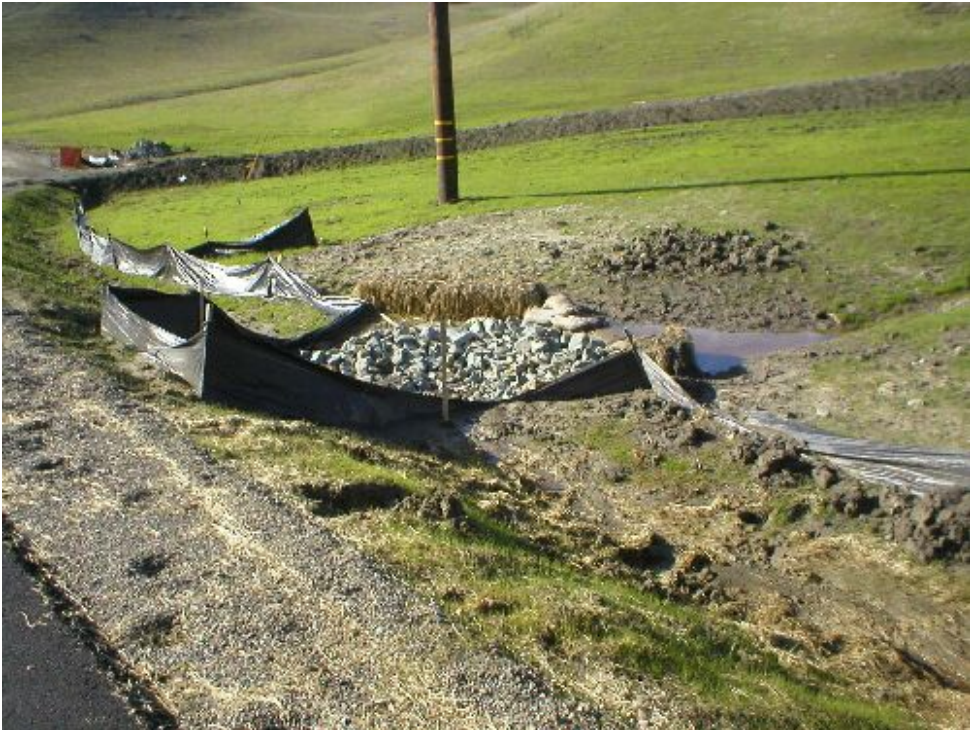
Along Moller Road and the mitigation site access road, several areas along the new roadbed including some culvert inlet areas continue to show signs of ponding and erosion. Great erosion has occurred in v-ditches along the side of Moller Road. The earthen v-ditch areas remain at risk for further erosion. The substation pad shows signs of erosion some of which has breached the sediment fence installed below the area (see Figure 1). Near this area sediment fencing installed around a culvert outlet to Tassajara Creek is in danger of being overrun by accumulated sediment (see Figure 2). The earthen v-ditch which surrounds the north-eastside of the substation has been lined in concrete (see Figure 3).

Figure 2 – Culver along Moller Road down slope of the substation in danger of being overrun by built-up sediment, January 20, 2006.

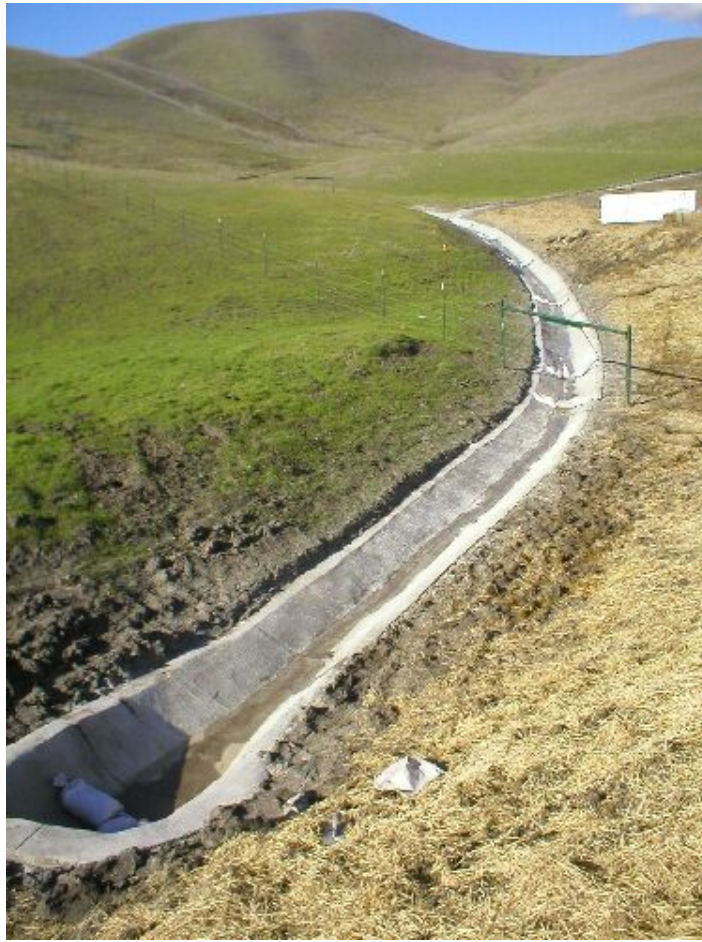
Figure 3 – Concrete lined v-ditch along the side of the North Dublin Substation, January 20, 2006.

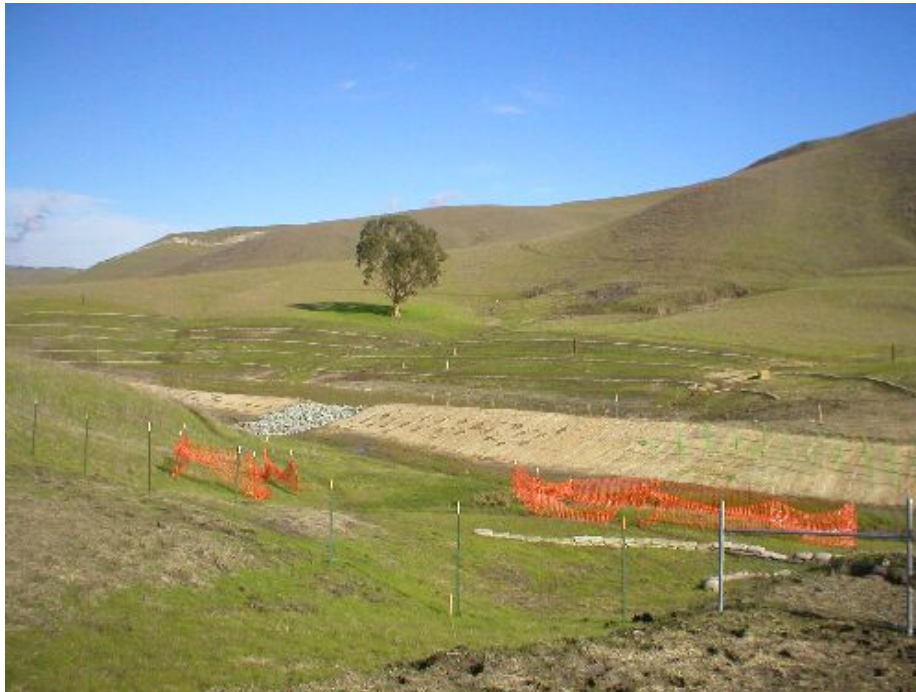
The valves for the engineered pond at the mitigation site have been closed and the area is now holding water (see Figure 4).

Figure 4 – Mitigation Site and pond holding water, January 20, 2006
