## **PROJECT MEMORANDUM PG&E – TRI-VALLEY 2002 CAPACITY INCREASE PROJECT**

**To:** Jensen Uchida, CPUC  
**From:** Vida Strong, Aspen Project Manager  
**Date:** February 14, 2006  
**Subject:** Weekly Report #97: February 5, 2006 – February 11, 2006  
**CPUC Environmental Monitor (EM):** Anne Sweet Coronado

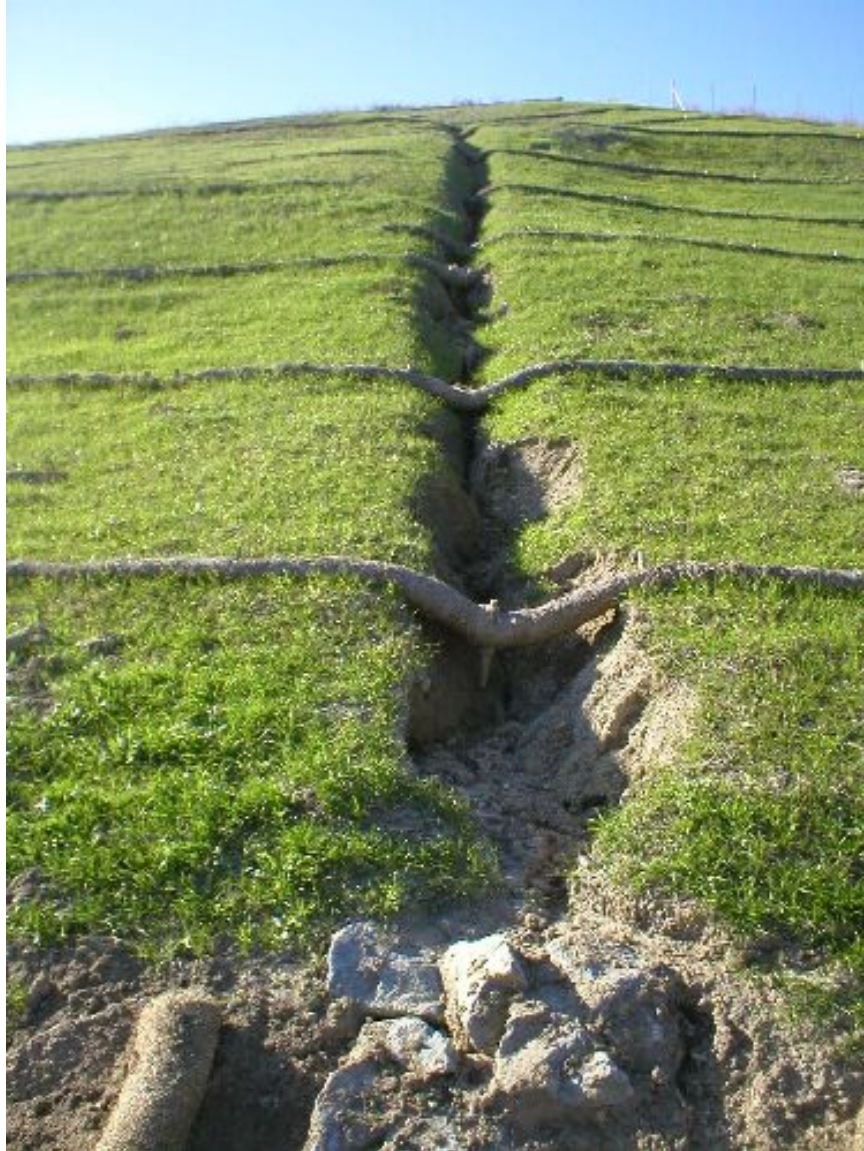
Significant erosion has occurred in v-ditches along the side of Moller Road, as well as slumping and some sinkage upslope and down slope of the road bed. Certain earthen v-ditch areas remain at risk for further erosion (see Figure 1). Opus and North Valley have been and will continue to take steps to ensure that down-slope sedimentation into resource areas does not occur. Per the PG&E EI, the repairs and restoration of the side slopes and certain v-ditch areas will need to be conducted by CH2MHill and Granite. On February 5<sup>th</sup>, PG&E supplied information that the slopes are currently too wet for heavy equipment use. In addition, PG&E stated that for the eroded v-ditch at Station 15+50: “Temporary additional measures to contain further erosion have been under discussion . . . and are to be installed next Tuesday (February 14<sup>th</sup>) . . . . The final repair is scheduled for the week of March 6th, should this dry weather continue”.

**Figure 1** – Eroded v-ditch along Moller Road - February 9, 2006.

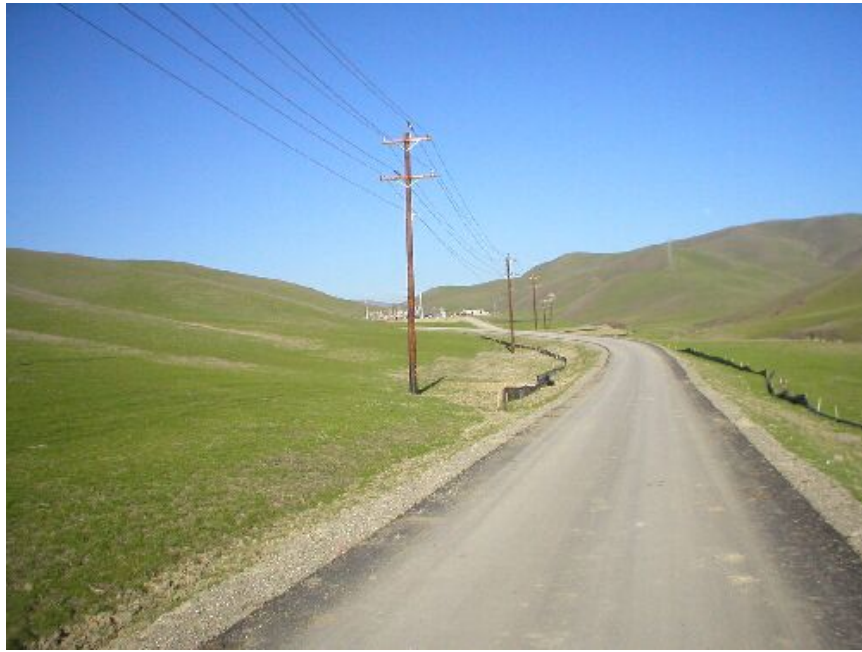
During the tour, the CPUC EM noted that in some areas along the Moller Road construction corridor some grass cover growth is good, but in other areas growth is very poor, particularly in areas where grazing cattle have trampled the seeded soil (see Figure 2). The area upslope from the Tassajara Creek bank stabilization area shows poor growth as well (see Figure 3). The CPUC EM discussed this issue with the PG&E EI and was informed that he is currently proposing to PG&E that sparsely vegetated areas be re-seeded.

**Figure 2** – Moller Road - February 9, 2006.  
Note the brown areas where grass growth is poor.

During the subject week, concerns were discussed with the PG&E EI regarding poor vegetation growth and the potential need for seeding. Opus and North Valley Construction continued work and SWPPP maintenance on-site.

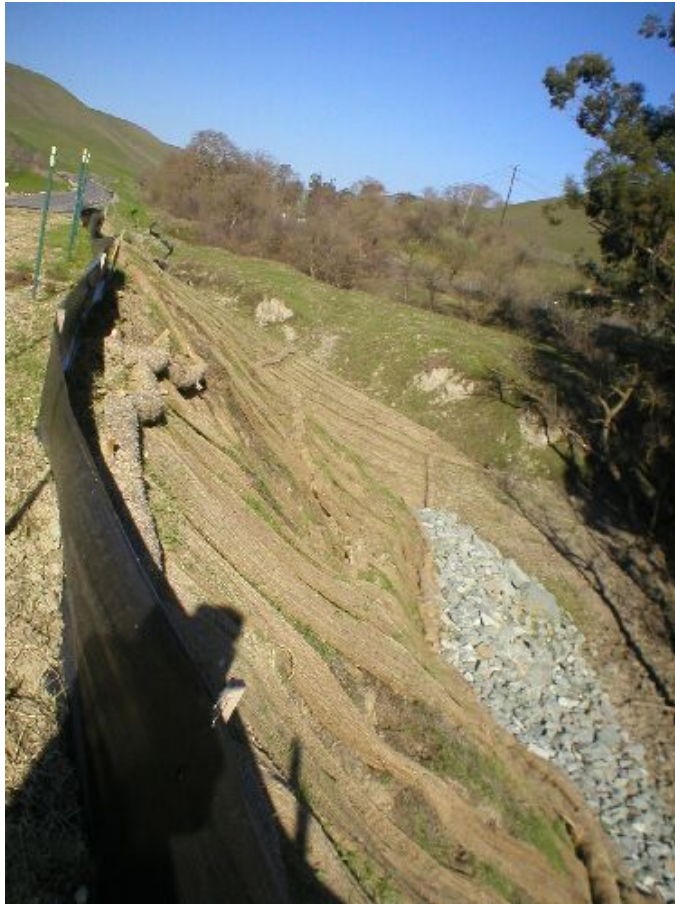
**Figure 3** – Tassajara Creek bank stabilization area –  
February 9, 2006. Note the poor grass growth.

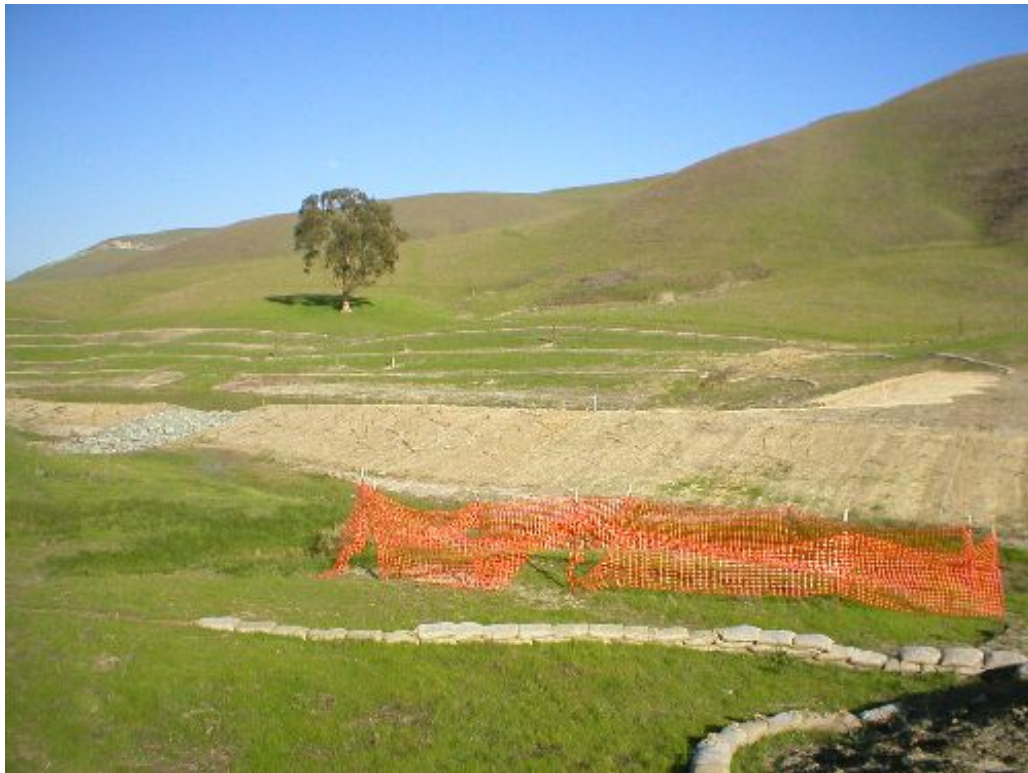
The engineered pond at the mitigation site continues to hold water (see Figure 4).

**Figure 4** – Mitigation area – February 9, 2006.  
The pond is now holding water, but is not visible in the photo.

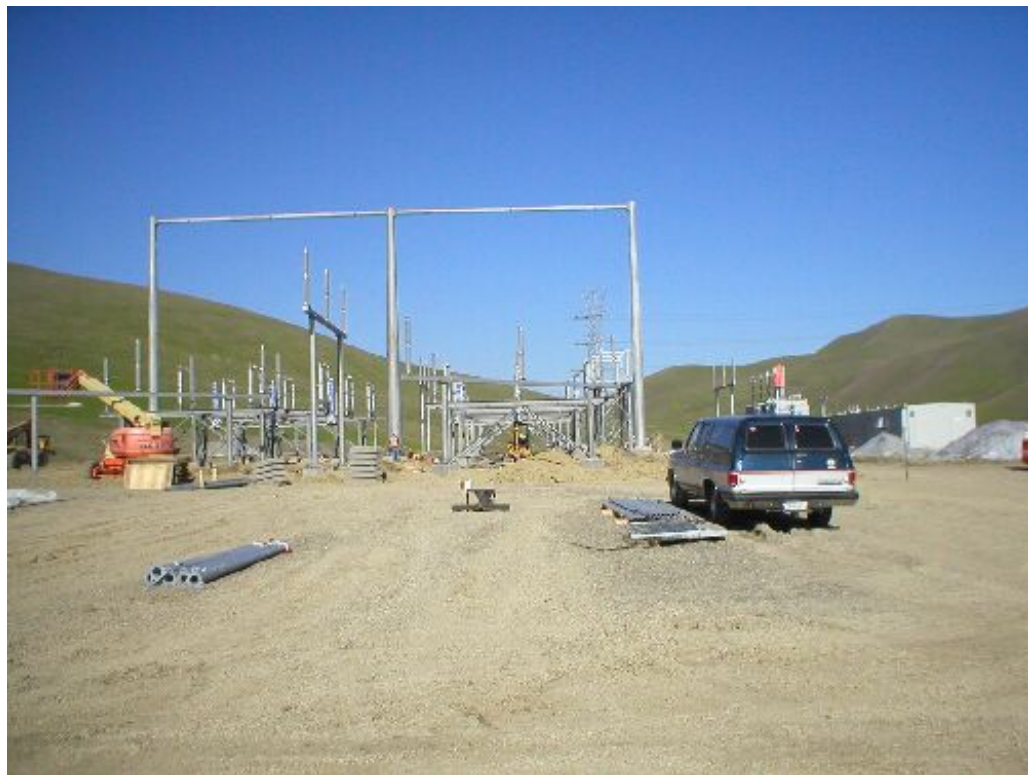
Black and Veatch worked on trenches for the grounding line at the North Dublin Substation during the subject week (see Figure 5). On January 25<sup>th</sup>, crews filled the transformer with mineral oil. The Spill Prevention Control Countermeasure (SPCC) pond and drainage network has not been completed. An earthen berm with a plastic cover was placed around the transformer in case an oil spill occurs prior to completion of the pond. The secondary containment will continue to be maintained until the constructed SPCC pond is functional.

**Figure 5** – North Dublin substation where trenching and grounding line installation is occurring - February 9, 2006.
