PROJECT MEMORANDUM PG&E – TRI-VALLEY 2002 CAPACITY INCREASE PROJECT

To: Jensen Uchida, CPUC
From: Vida Strong, Aspen Project Manager
Date: February 23, 2006
Subject: Weekly Report #98: February 12, 2006 – February 18, 2006
CPUC Environmental Monitor (EM): Anne Sweet Coronado

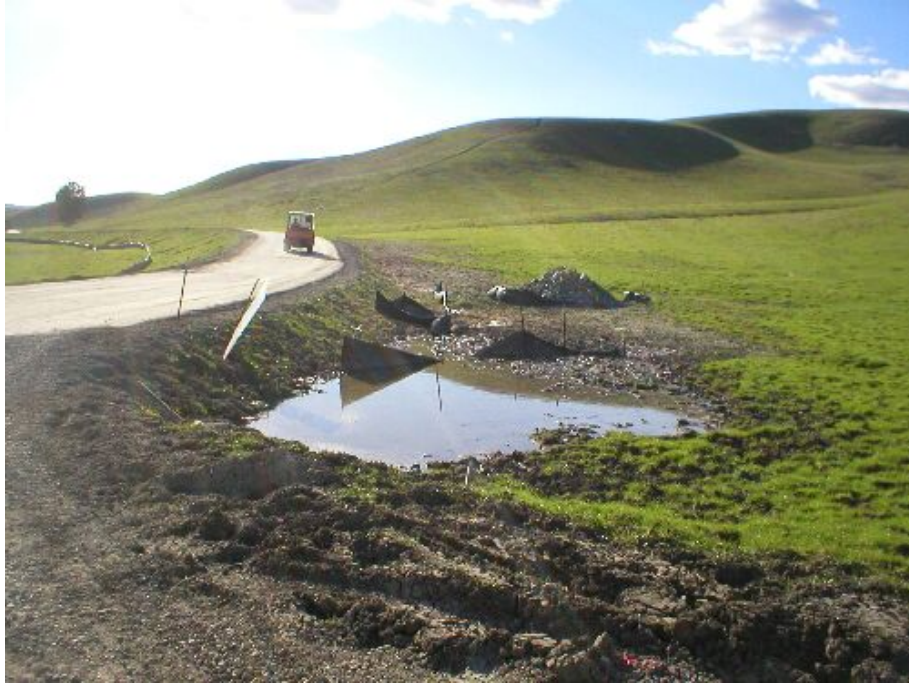
Along Moller Road and the mitigation site access road, several areas along the new roadbed including some culvert inlet areas continue to show signs of ponding. During the subject week, the ponded area adjacent to the west ramp to the substation (see Figure 1) was drained. Crews hand dug a small trench from the pond to the nearest culvert outlet. Prior to this work sand bags were installed in the culvert and an additional straw wattle was installed below the culvert to filter any accumulated sediment.

Figure 1 – Poned area adjacent to the Substation ramp prior to draining, February 15, 2006.

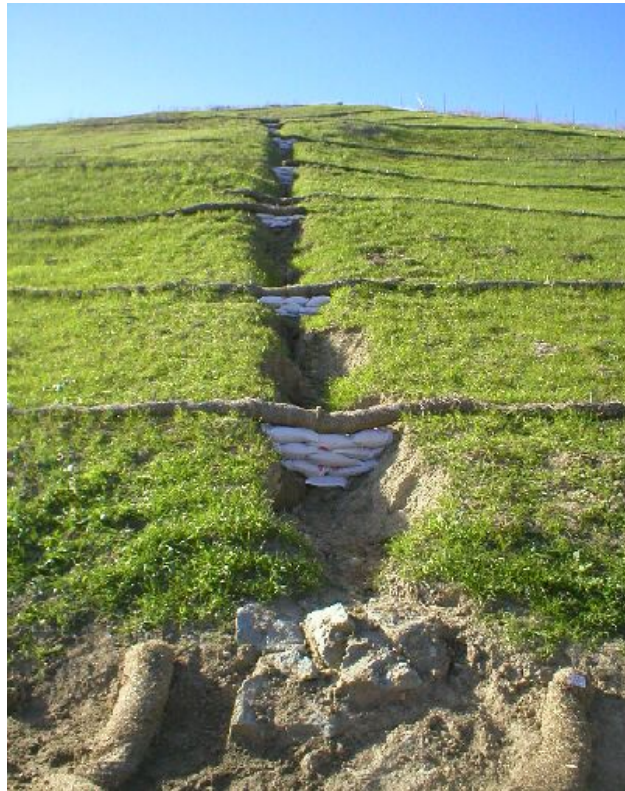
During the subject week, sand bags were placed within the v-ditch along the side of Moller Road which has shown significant erosion (see Figure 2). In addition crews later filled in the incised areas with compacted dirt. Along Moller Road two areas of slumping down slope of the road bed remain covered in plastic. Opus and North Valley have been and will continue to take steps to ensure that down slope sedimentation into resource areas does not occur. On February 10th, PG&E supplied information that the slopes are currently too wet for heavy equipment use.

Figure 2 – Eroded v-ditch along Moller Road showing the newly installed sandbag check dams February 9, 2006.

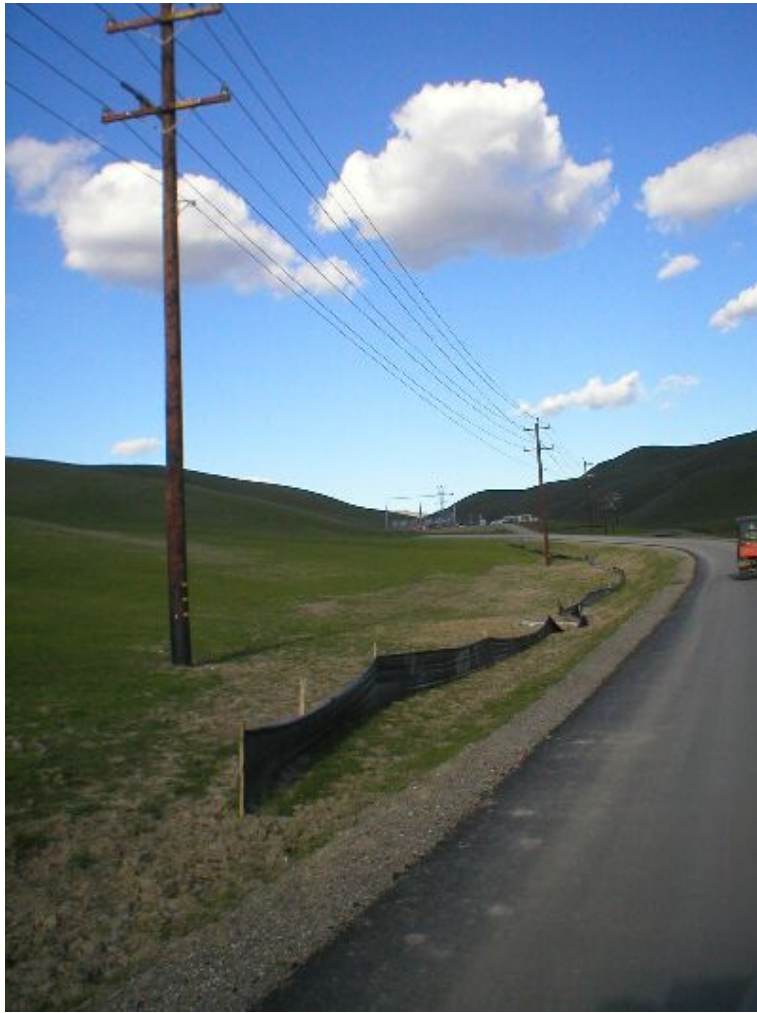
During the tour, the CPUC EM noted that in some areas along the Moller Road construction corridor some grass cover growth is good, but in other areas growth is very poor, particularly in areas where grazing cattle have trampled the seeded soil (see Figure 3). The area upslope from the Tassajara Creek bank stabilization area shows poor growth as well. PG&E has provided information that they are looking into the Tassajara Creek area and will provide a final plan to deal with the issue.

Figure 3 – Moller Road - February 15, 2006.
Note the brown areas where grass growth is poor.

Previously, concerns were discussed with the PG&E EI regarding poor vegetation growth and the potential need for seeding. PG&E has given information that additional seeding is planned to occur prior to the next significant rain event.
