## **PROJECT MEMORANDUM PG&E – TRI-VALLEY 2002 CAPACITY INCREASE PROJECT**

**To:** Jensen Uchida, CPUC  
**From:** Vida Strong, Aspen Project Manager  
**Date:** June 29, 2006  
**Subject:** Weekly Report #113: June 18, 2006 – June 24, 2006  
**CPUC Environmental Monitor (EM):** Anne Sweet Coronado

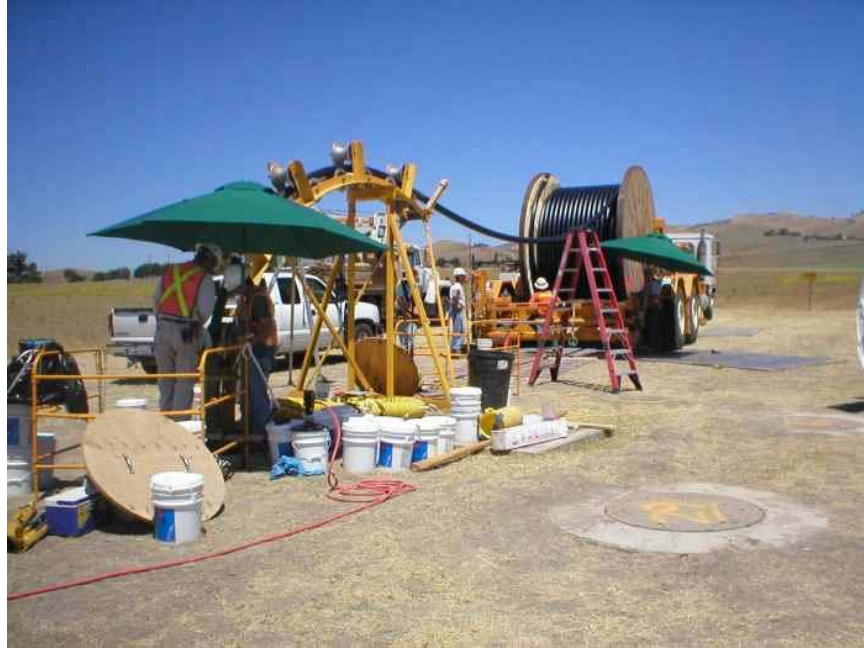
**Figure 1** – Cable pulling through installed conduit at Vault 3, June 22, 2006.

Jensen PreCast crews continued racking at Vaults 7 and 8. Wilson continued to pull transmission cable at Vaults 2, 3, and 4, through the installed conduit (see Figure 1 and 2). On Thursday, June 22, a fatal accident occurred. While transferring a cable reel (approximately 50,000 pounds), the crane tipped and rolled crushing the operator. The boom of the crane fell across North Livermore Boulevard and across existing energized power lines which follow the street. The lines were snapped creating an additional hazard. California Highway Patrol closed North Livermore Boulevard. Police and OSHA investigated the accident through the afternoon and into the evening. Underground line pulling work was suspended until Monday, June 26. A safety meeting will occur prior to the restart of work. Opus provided that they will submit a variance request asking for additional space at the vault area for safety reasons.

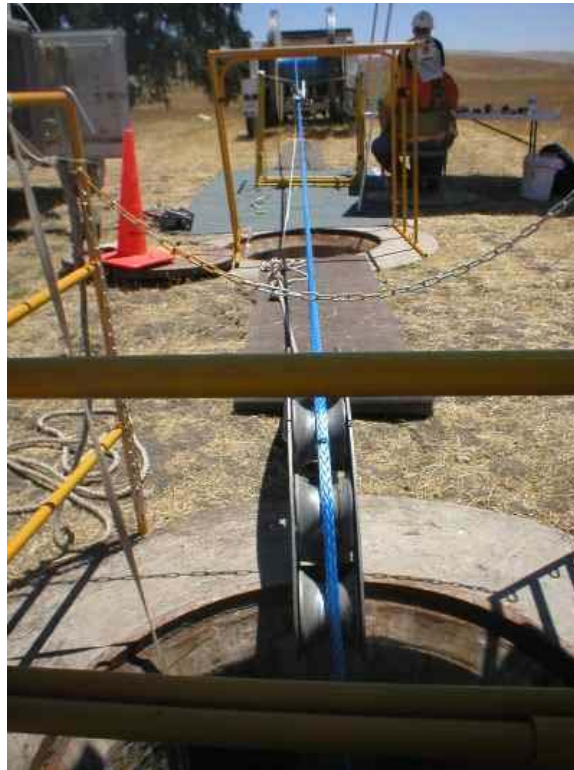
**Figure 2** – Line pulling the cable from Vault 3 to Vault 4, June 22, 2006.

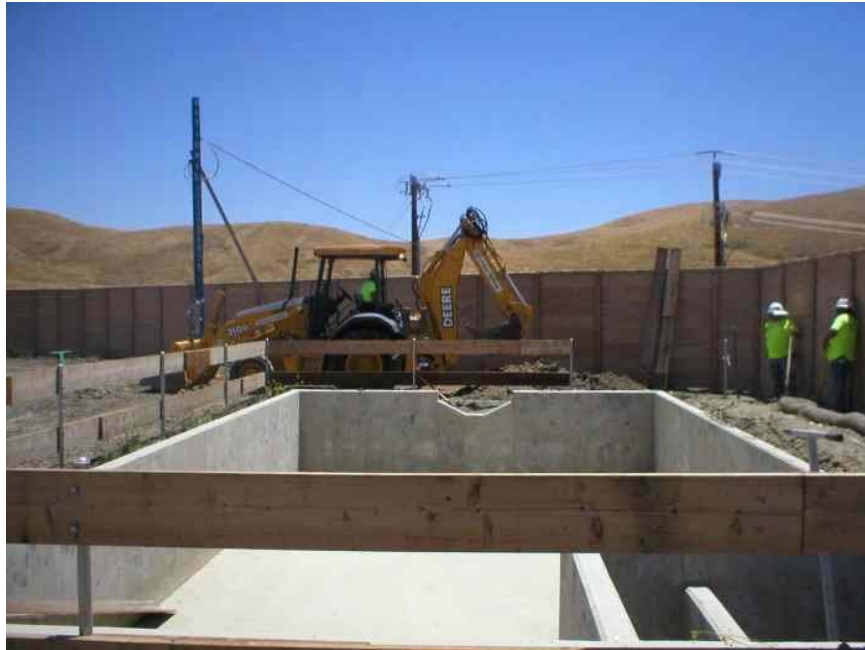
**Figure 3** – Granite crews trenching for plumbing hookups to the SPCC pond at the North Dublin Substation, June 22, 2006.

Black and Veatch have been overseeing work at the North Dublin Substation. Granite construction began grading and paving preparations at the substation site. Granite worked on trenching for plumbing hookups to the SPCC pond during the subject week (see Figure 3). Atlas wire crews conducted overhead wire testing and switch gear testing. On January 25<sup>th</sup>, crews filled the transformer with mineral oil. The Spill Prevention Control Countermeasure (SPCC) pond and drainage network has not been completed. An earthen berm with a plastic cover was placed around the transformer in case an oil spill occurs prior to completion of the pond. The secondary containment will continue to be maintained until the constructed SPCC pond is functional.
