PROJECT MEMORANDUM
PG&E – TRI-VALLEY 2002 CAPACITY INCREASE PROJECT

To: Jensen Uchida, CPUC
From: Vida Strong, Aspen Project Manager
Date: September 8, 2006
Subject: Weekly Report #123: August 27, 2006 – September 2, 2006
CPUC Environmental Monitor (EM): Anne Sweet Coronado

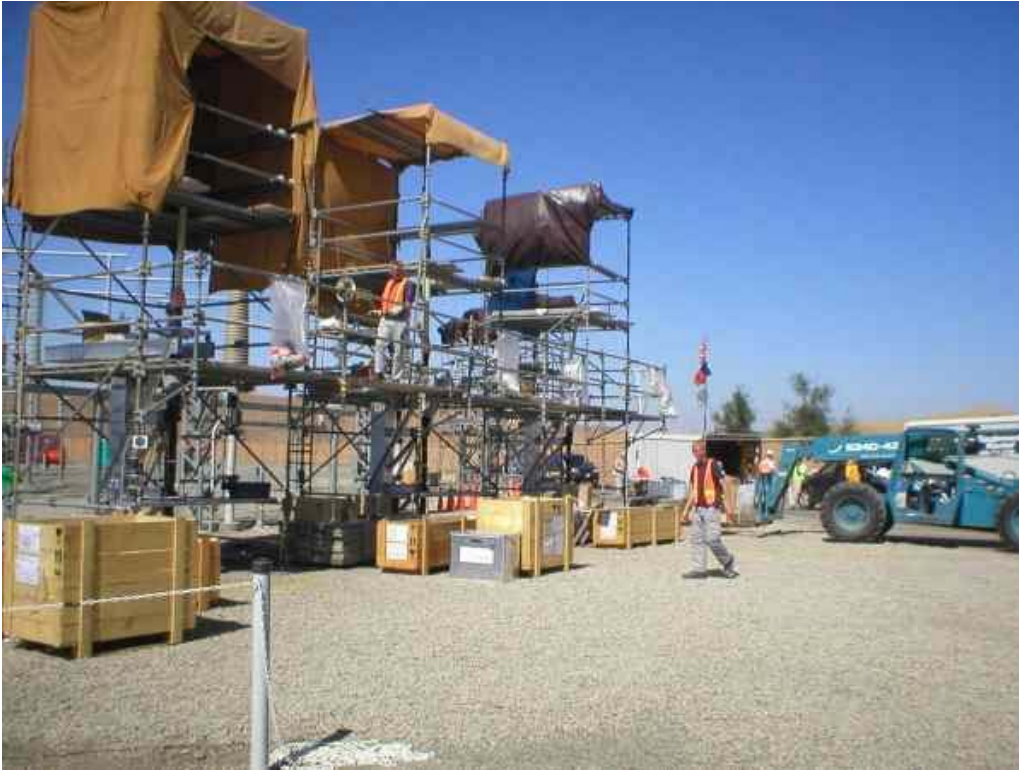
Figure 1 – Crews work on the termination structures at the Cayetano Substation, August 29, 2006.

All underground cable pulling work is now complete across the project. Cable splicing continued at vaults by Nexans crews. Nexans crews also worked on pothead installation. At the Cayetano Substation Wilson crews worked on the termination structures which will connect the underground line to the substation (see Figure 1). Wilson also conducted grounding work at the Cayetano Substation.

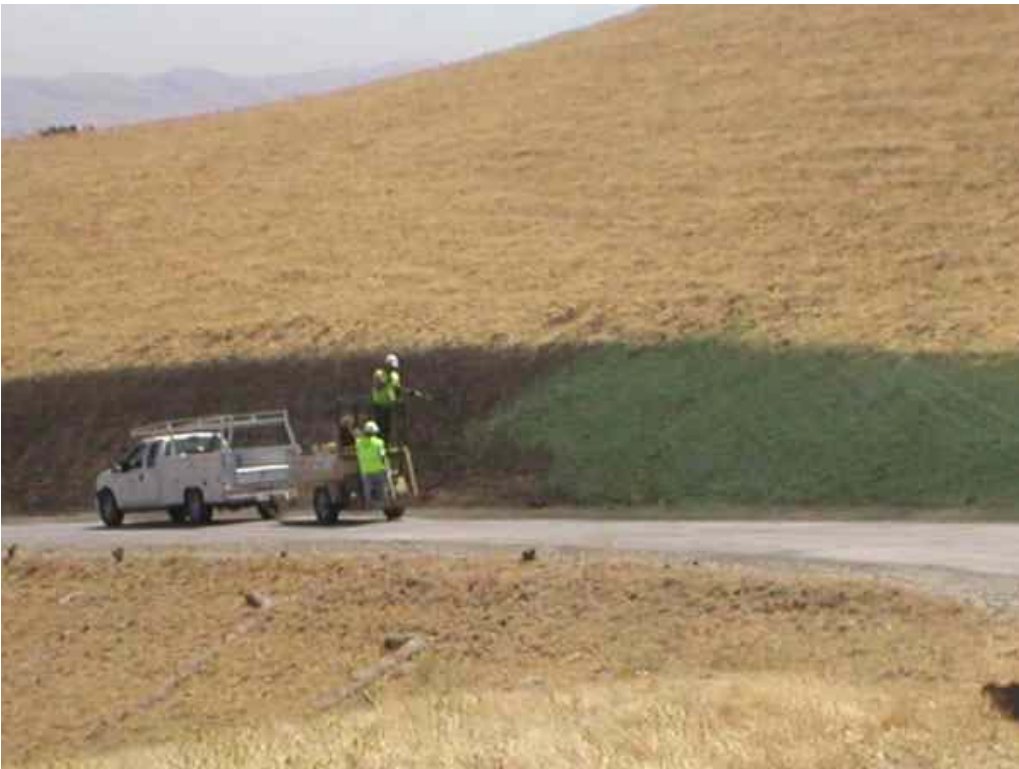
Figure 2 – With restoration work completed, NVC crews hydro-seeded upslope of Road 6, August 29, 2006.

NVC crews completed restoration of the cut slope areas above Road 6 and hydro-seeded the area during the subject week (see Figure 2). In addition they placed geotextile netting over the seeded areas. In another area along Road 6, project related erosion had occurred down slope of the road. The area occurs outside of the project limit of disturbance. However, during repair work which occurred during the previous week, no grading or earth disturbance occurred. Crews filled and compacted eroded areas to prevent further erosion and hydro-seeded the area during the subject week. In addition, NVC crews paved v-ditches along Road 6 (see Figure 3), and removed erosion controls such as sandbags and straw wattles that were no longer necessary.

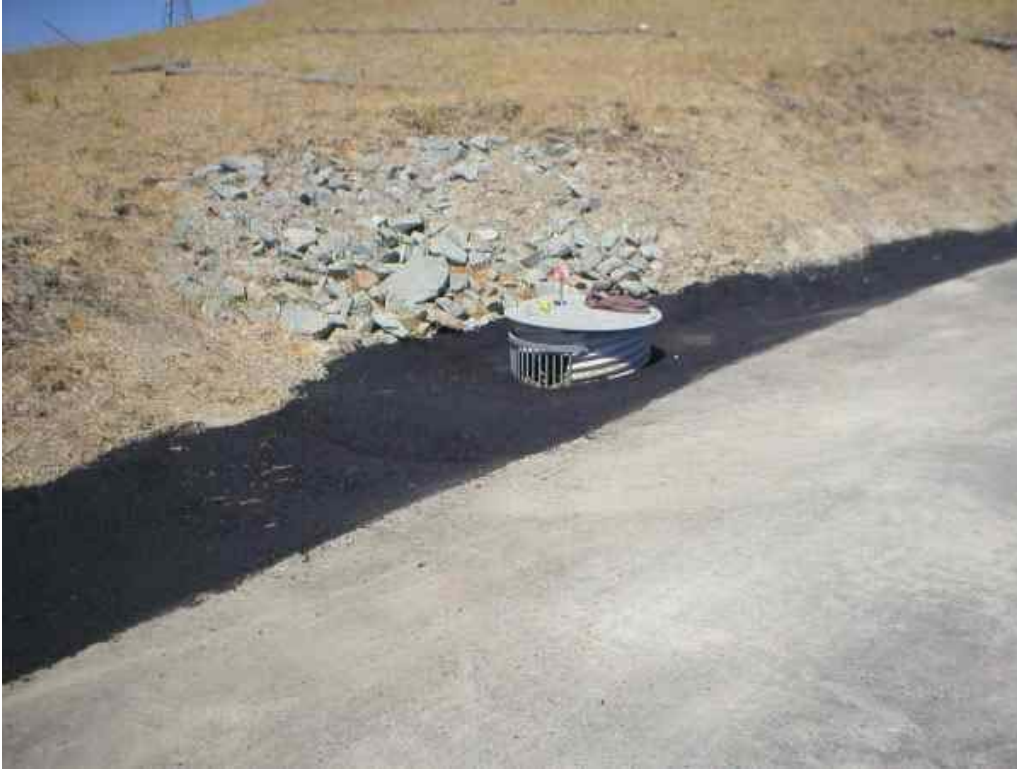
Figure 3 – NVC crews paved v-ditches along Road 6, August 29, 2006.

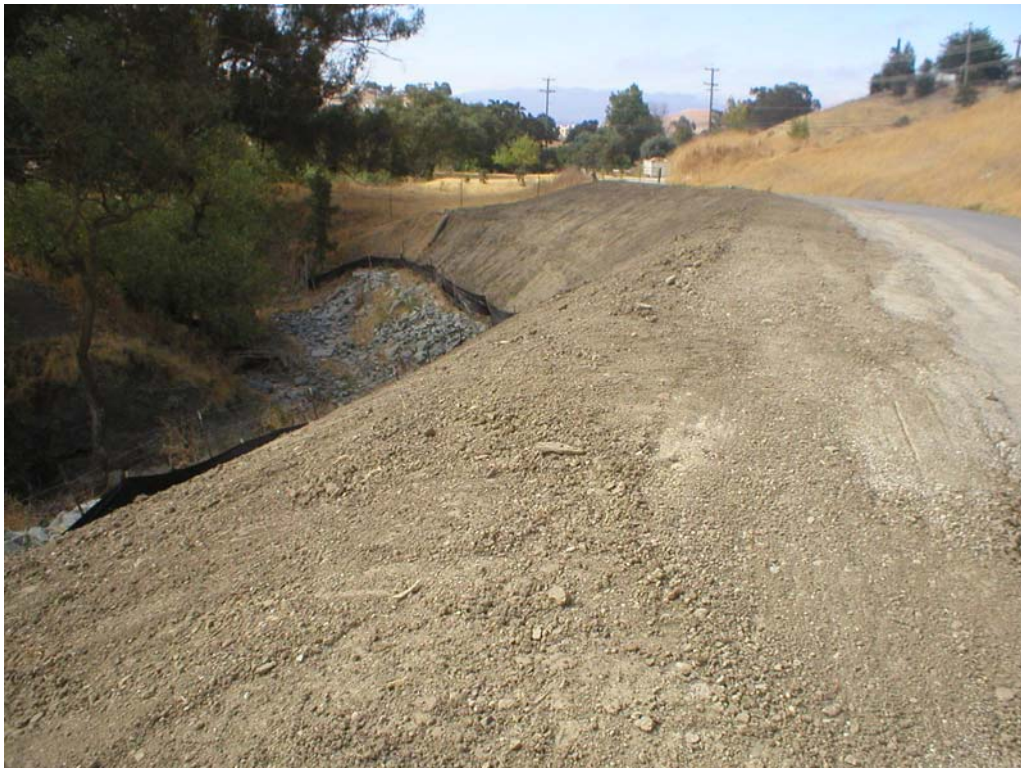
Figure 4 – NVC crews completed earthwork at the Tassajara Creek bank stabilization area, August 29, 2006.

Along Moller Road, NVC completed the earthwork on the Tassajara Creek bank stabilization area (see Figure 4). During the subject week, crews hydro-seeded and placed geotextile netting over the area. NVC finished repair work on culverts located along Moller Road and replaced rocks in the inlets and outlets (see Figure 5). NVC crews removed damaged asphalt and repaved impacted areas along Moller Road. In addition, NVC crews removed previously installed erosion controls which are no longer necessary, including sand bags and straw wattles.

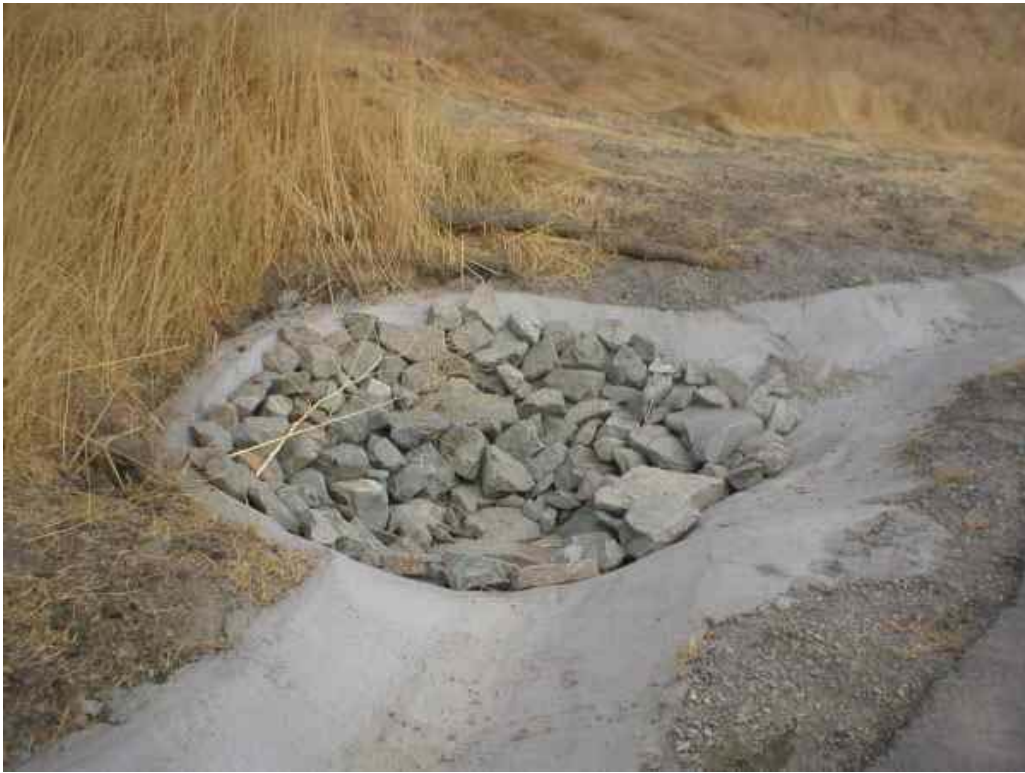
Figure 5 – Rocks have been replaced in the restored culverts along Moller Road, August 29, 2006.
