PROJECT MEMORANDUM PG&E – TRI-VALLEY 2002 CAPACITY INCREASE PROJECT

Subject: Weekly Report #127: September 24, 2006 – September 30, 2006

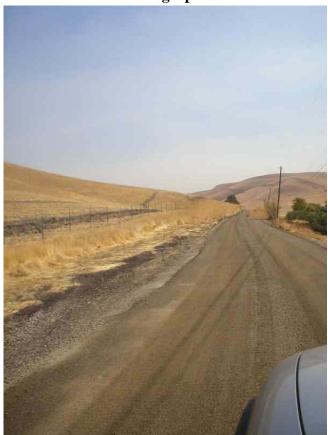
Figure 1 – The spoils created by Road 5 widening have been removed, September 27, 2006.

During the subject week, NVC crews graded and compacted base rock along Road 5 (see Figure 1).

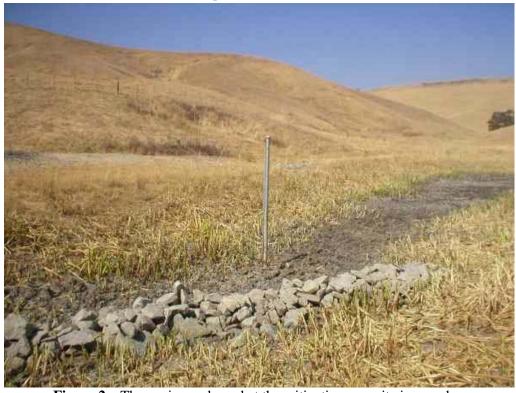
Figure 2 – The engineered pond at the mitigation area site is now dry, September 27, 2006.

The engineered pond at the mitigation site is now dry (see Figure 2). Opus has been in communication with Mary Hammer of the U.S. fish and Wildlife Service (USFWS) to gain clarifications on larval California tiger salamander (CTS) and CRLF monitoring, as well as bull frog eradication protocols covered in the project Biological Opinion (BO).
