PROJECT MEMORANDUM PG&E – TRI-VALLEY 2002 CAPACITY INCREASE PROJECT

To: Jensen Uchida, CPUC
From: Vida Strong, Aspen Project Manager
Date: August 1, 2005
Subject: Weekly Report #68: July 17, 2005 – July 23, 2005
CPUC Environmental Monitor (EM): Anne Sweet

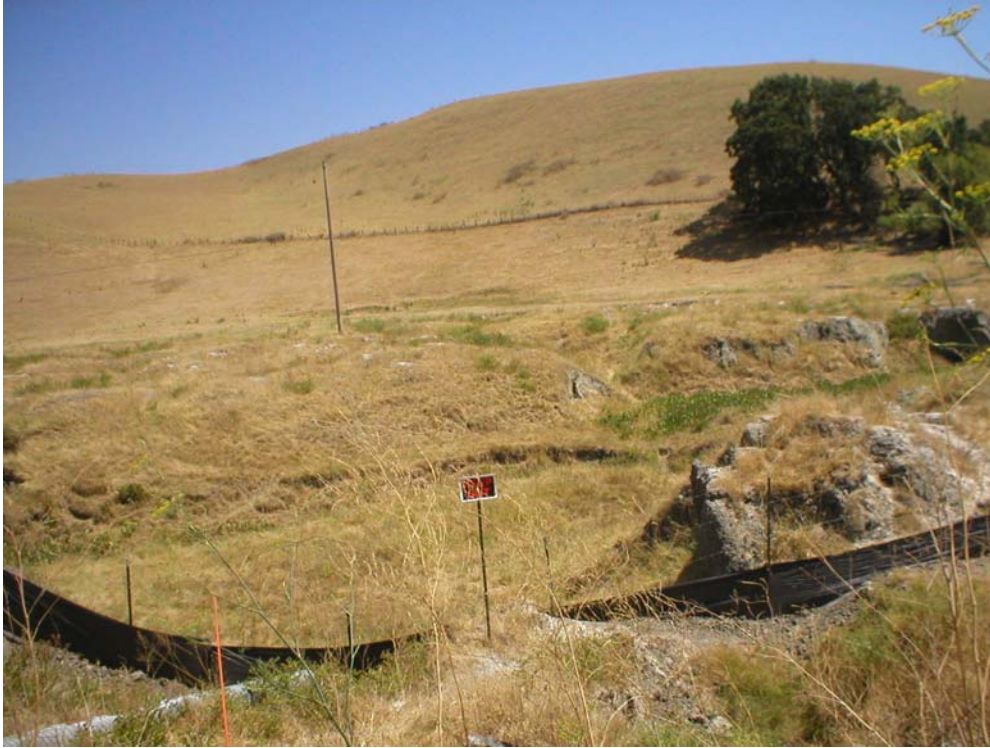
On July 18th the CPUC EM noted that “No Project Access” or exclusion signs had not yet been installed in the fence gaps and had not been placed at the CTS exclusion boundary. On July 20th, a Project Memorandum was issued to document the lack of adequate project boundary marking, as well as the grading which occurred within the CTS exclusion zone. On July 20th crews installed signage along the Moller Ranch Road (see Figure 1); however, no signage had been placed at the CTS exclusion zone boundary.

Figure 1 –Project boundary marking, Phase 3, July 20, 2005.

Crews have installed exclusion fencing as well as sediment fencing in areas with potential for spoils to slide in to sensitive areas. Numerous gaps were left in the fencing to allow moving cows. However, no exclusion signs have been installed in the gaps. In addition, the CTS exclusion zone was toured and no sensitive resource or exclusion signs to notify crews of the resource have been installed. Notifications had been made to the PG&E EI. On July 14th, an operator was not aware of the 500 foot CTS exclusion zone and a 400-foot by 20-foot area was scraped within the zone coming within 100 feet of the CTS burrow. A Project Memorandum was issued on July 20th documenting these issues.

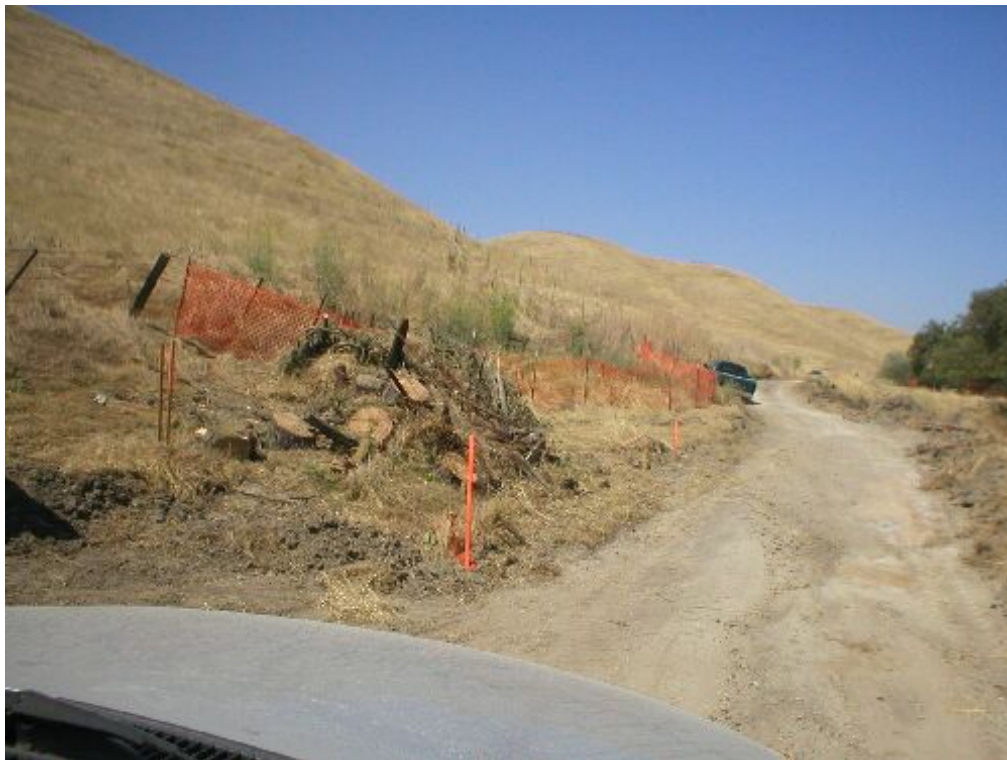
While driving along the Moller Ranch Road on July 20th, the CPUC EM noticed that tree removal debris was left along the roadside (see Figure 2). The CPUC EM asked the PG&E EI about the tree removal and he said that he didn't know about the removal and that it must have occurred when he was not on-site.

Figure 2 – Tree removal remains along the Moller Ranch Road, Phase Three, July 20, 2005.

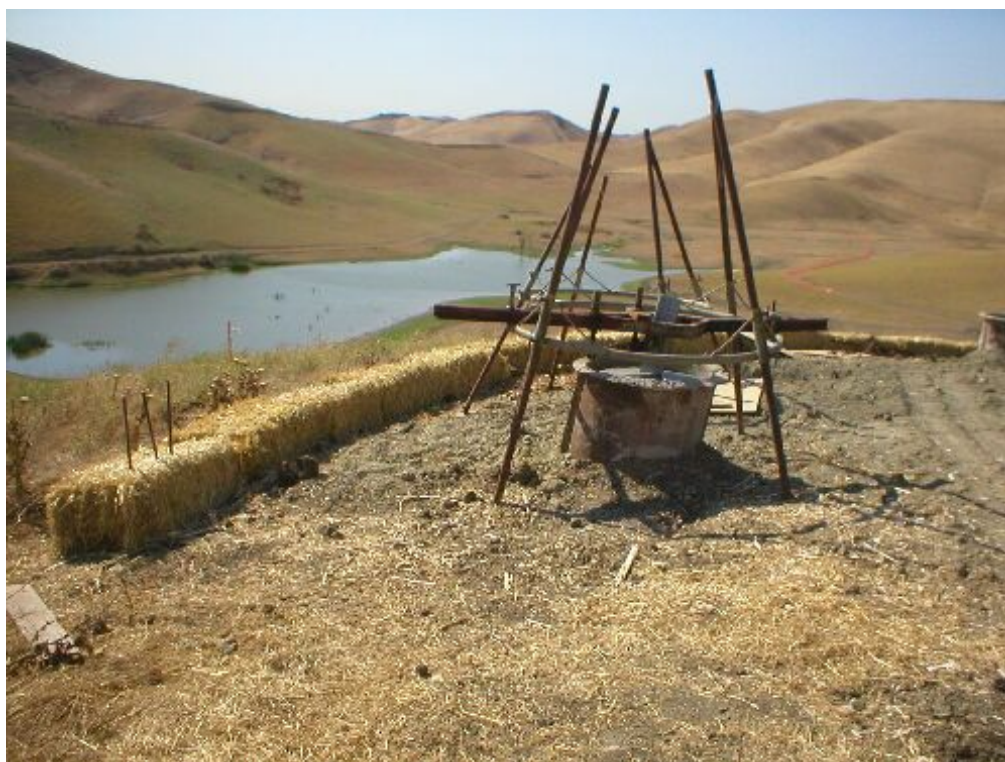
Continuing from Doolan Road, the overland access to Tower #38 was toured. A PG&E flat bed trailer had been left by the tower crews off of the approved access road. The CPUC EM notified the PG&E EI that the trailer placement is out of compliance and that due to its proximity to CRLF and CTS breeding and aestivation habitat areas, as well as San Joaquin kit fox range, a biologist needs to inspect the flat bed trailer prior to removal. The CPUC EM called and informed the Opus Environmental Supervisor of the trailer. The Opus Environmental Supervisor called the CPUC EM on Friday July 22nd, and said that the trailer had been inspected by the biologist/EI and removed from the location. Crews have completed foundation work and have poured concrete for the tower footings at Tower #38 (see Figure 3).

Figure 3 – Foundation construction at Tower #38, Phase Three, July 20, 2005.
