# **Aspen** *Environmental Group*

## **PROJECT MEMORANDUM PG&E – TRI-VALLEY 2002 CAPACITY INCREASE PROJECT**

**To:** Jensen Uchida, CPUC  
**From:** Vida Strong, Aspen Project Manager  
**Date:** August 26, 2005  
**Subject:** Weekly Report #72: August 14, 2005 – August 20, 2005  
**CPUC Environmental Monitors (EMs):** Anne Sweet and Jenny Slaughter

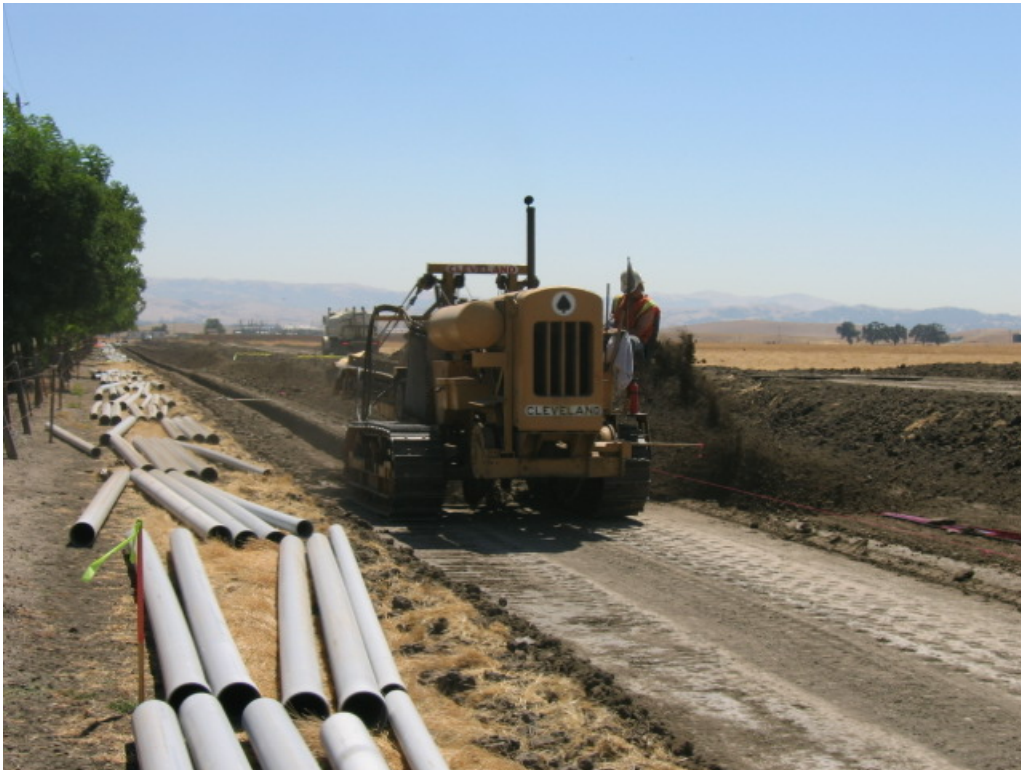
Construction of the underground portion began just north of the Cayetano Substation on North Livermore Avenue (see Figure 2). Crews initially used a disk to break up the soil and then were able to strip the top soil and stockpile it along the side of the right-of-way. Excavation is being conducted using a trencher. Two trenches are being installed 15-feet apart as part of the double circuit project. Underground construction is currently limited to the area between the Cayetano Substation and the area where Manning Road leaves the right-of-way. Crews requested that the CPUC EM field verify right-of-way flagging in the Road 7 area of the underground alignment in order for them to begin construction. On August 18<sup>th</sup>, the

**Figure 2** – Trenching continues along North Livermore Ave., August 17<sup>th</sup>, 2005.

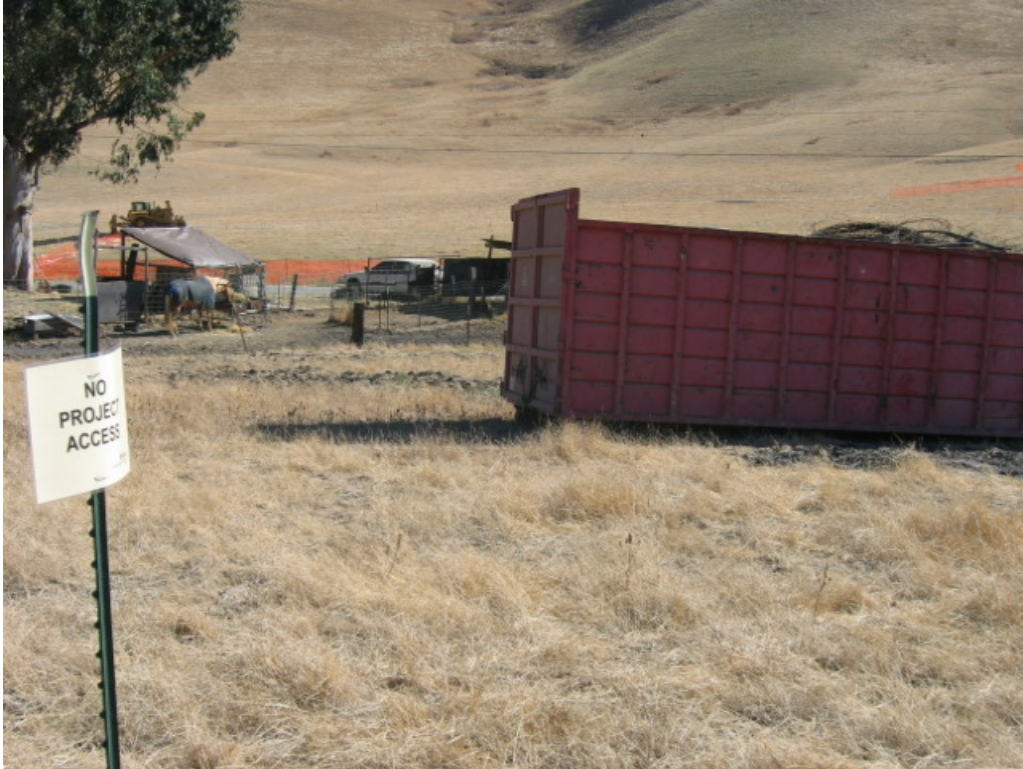
On August 17<sup>th</sup>, a dumpster used for fence materials was placed outside of the approved right-of-way along Access Road 7 (see Figure 3). The CPUC EM informed PG&E of the incident and they planned to remove the dumpster the next day. The dumpster was not removed until late August 19<sup>th</sup>. A Project Memorandum was issued for the dumpster on August 21<sup>st</sup>.

**Figure 3** – A Project Memorandum was issued for this dumpster placed outside of the project area, August 16, 2005.
