PROJECT MEMORANDUM SCE – VIEJO SYSTEM PROJECT

To: Michael Rosauer, CPUC
From: Vida Strong, Aspen Project Manager
Date: September 21, 2004
Subject: Weekly Report #7: September 12, 2004 – September 18, 2004
CPUC Environmental Monitor (EM): Christopher Meyer

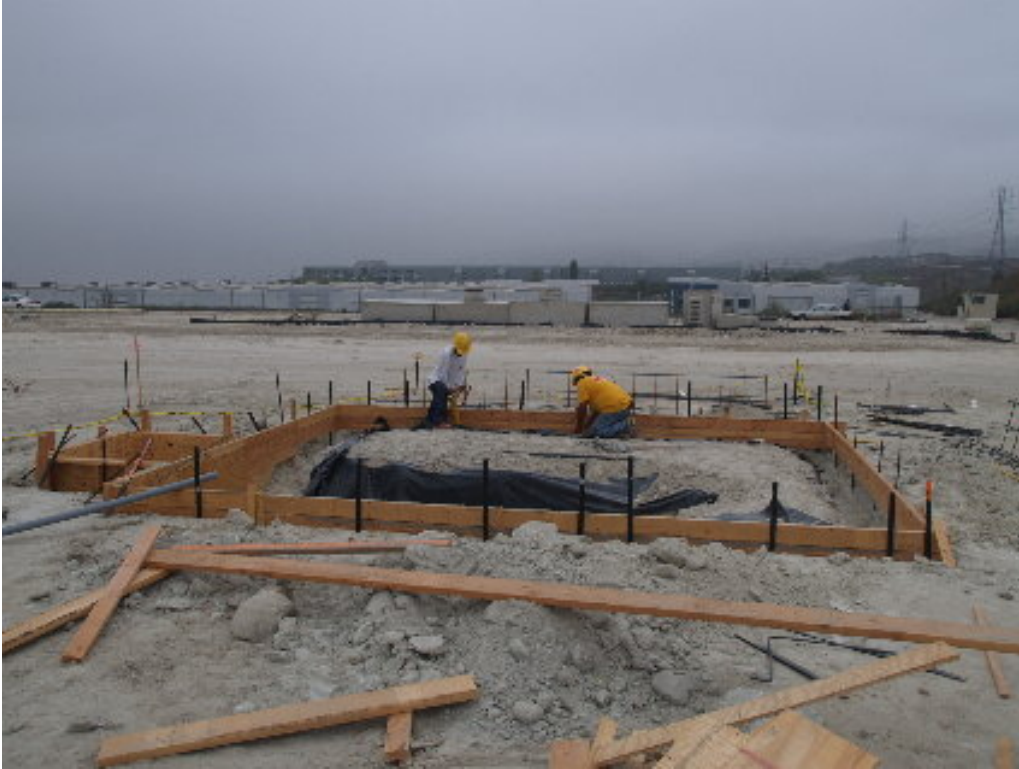
Crews continued working on building forms for the foundation of buildings on the substation site (see Figure 1). The pad for the mechanical/electrical equipment room (MEER) has completed and is ready for the stub wall pour (see Figure 2). The building will be constructed with a raised floor to facilitate the running of electrical conduit.

Figure 1 – Crews working on the form work for the foundations at the substation site.

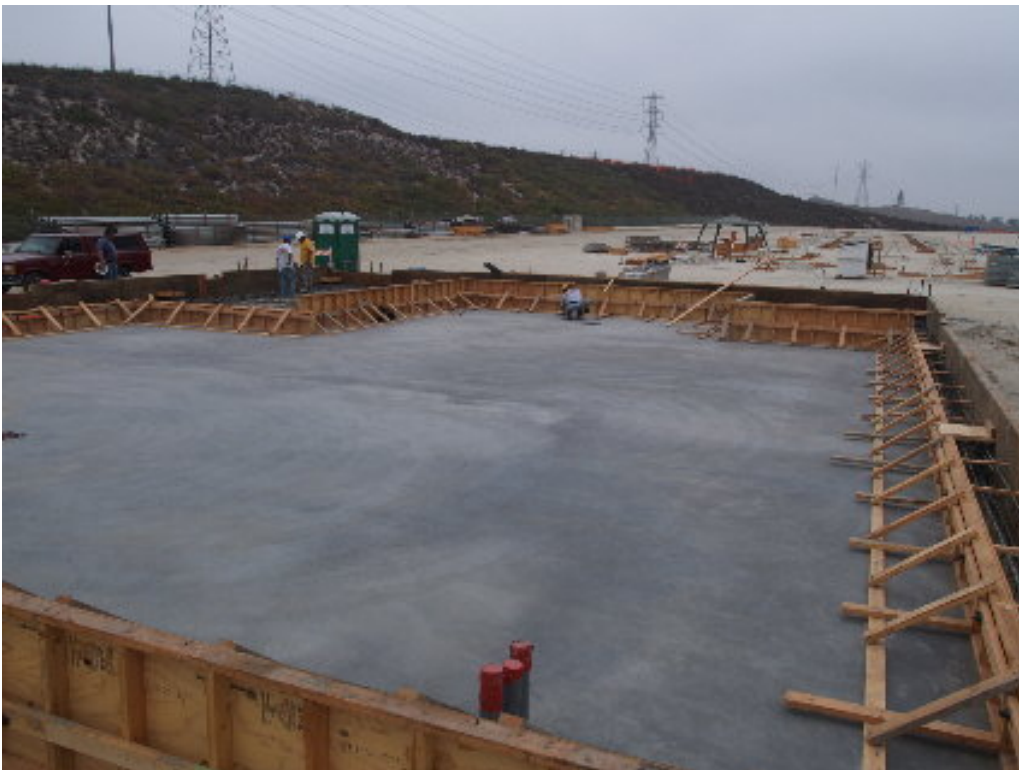
Figure 2 – Completed floor and formwork for the stub walls on the MEER.

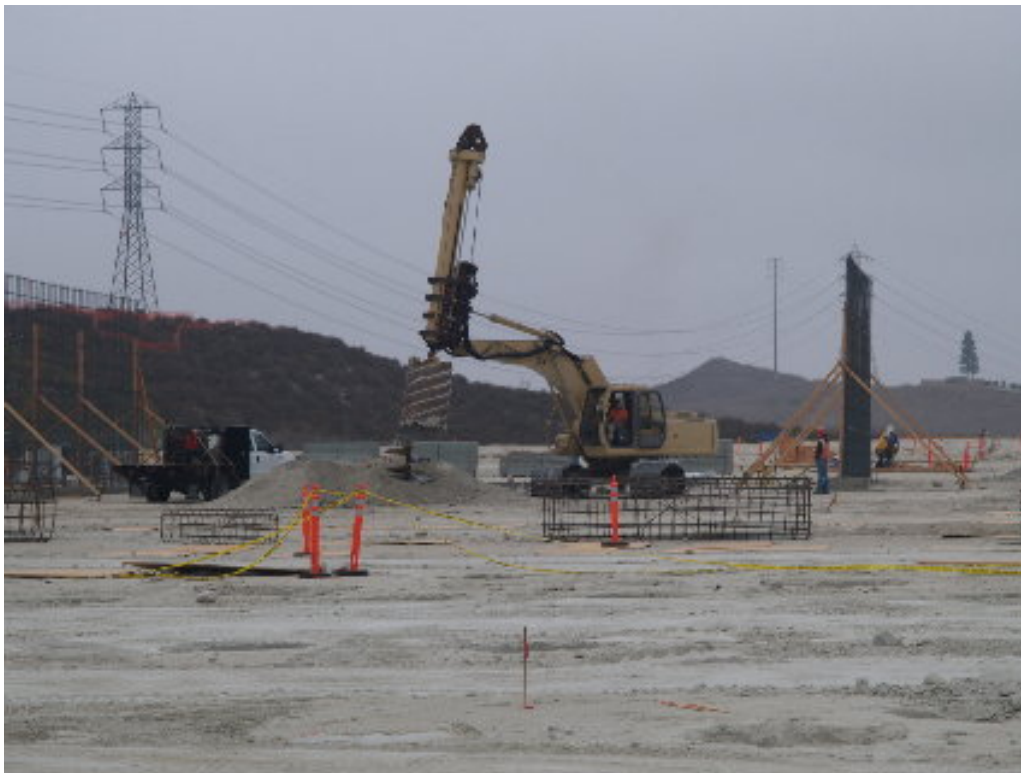
A drilling machine continued working between the two vertical forms for the firewalls that will separate the two A transformers (see Figure 3). The drilling crew worked with a coring bit and an auger bit for boring the holes to depth and a side-cut bit to make the shelf at the top of the foundation hole. Several teeth on the drill head broke on the dense material. Numerous bore holes throughout the substation site have been completed and are covered by plywood and marked with orange warning flagging. SCE will place caution tape around the drilling area after work hours. No hazard to the public is anticipated with the open holes due to the security fence around the perimeter of the site.

Figure 3 – Drilling continues between the vertical forms for the firewalls that will separate the two A transformers (230 kV).

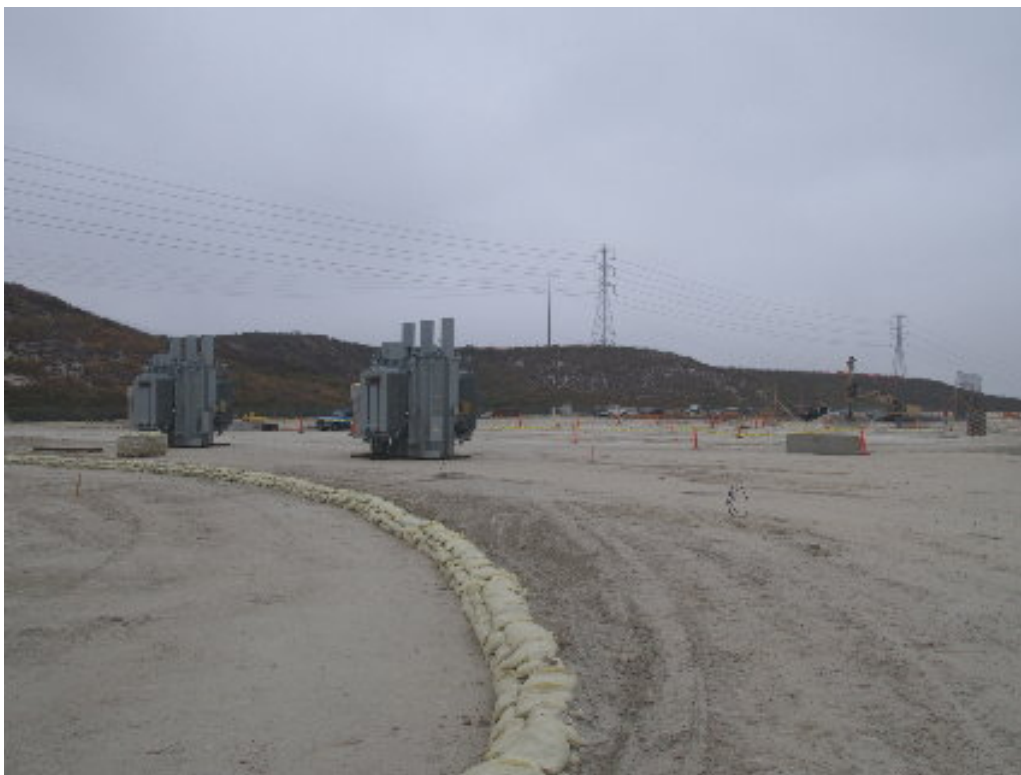
The grounding grid on the substation site has been covered in rock and the area is being used for storage of materials that have been delivered to the site. The two B transformers (66 kV) have been delivered to the site (see Figure 4). Several duct banks have been delivered to the site and have been staged near the B transformers.

Figure 4 – The two B transformers (66 kV) have been delivered to the substation site.

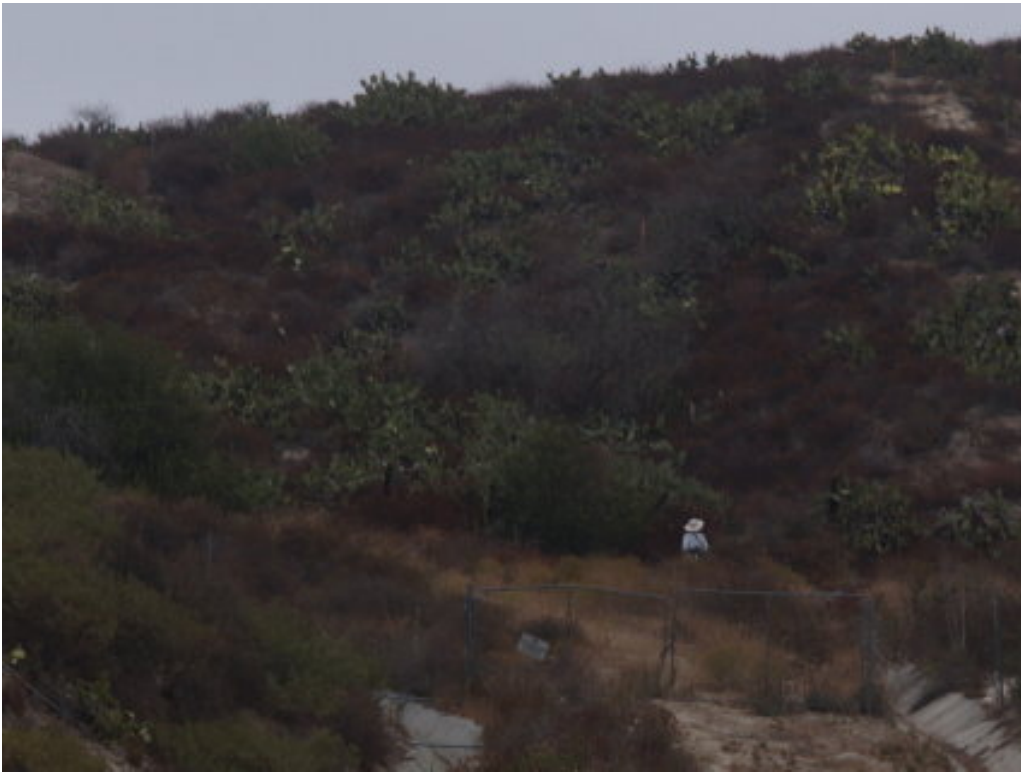
The site vegetation has been removed from the substation site and a LSA Environmental Inspector (EI) will not be on-site full-time. The LSA was on-site during the site visit, surveying the hillside adjacent to the 230 kV line for sensitive species (see Figure 5). The LSA EI is also checking the excavations and

Figure 5 – A LSA biologist surveys for sensitive species along the 230 kV transmission line corridor in preparation for the upcoming NTP.
