PROJECT MEMORANDUM SCE – VIEJO SYSTEM PROJECT

To: Jensen Uchida, CPUC
From: Vida Strong, Aspen Project Manager
Date: February 8, 2005
Subject: Weekly Report #27: January 30, 2004 – February 5, 2005
CPUC Environmental Monitor (EM): Christopher Meyer

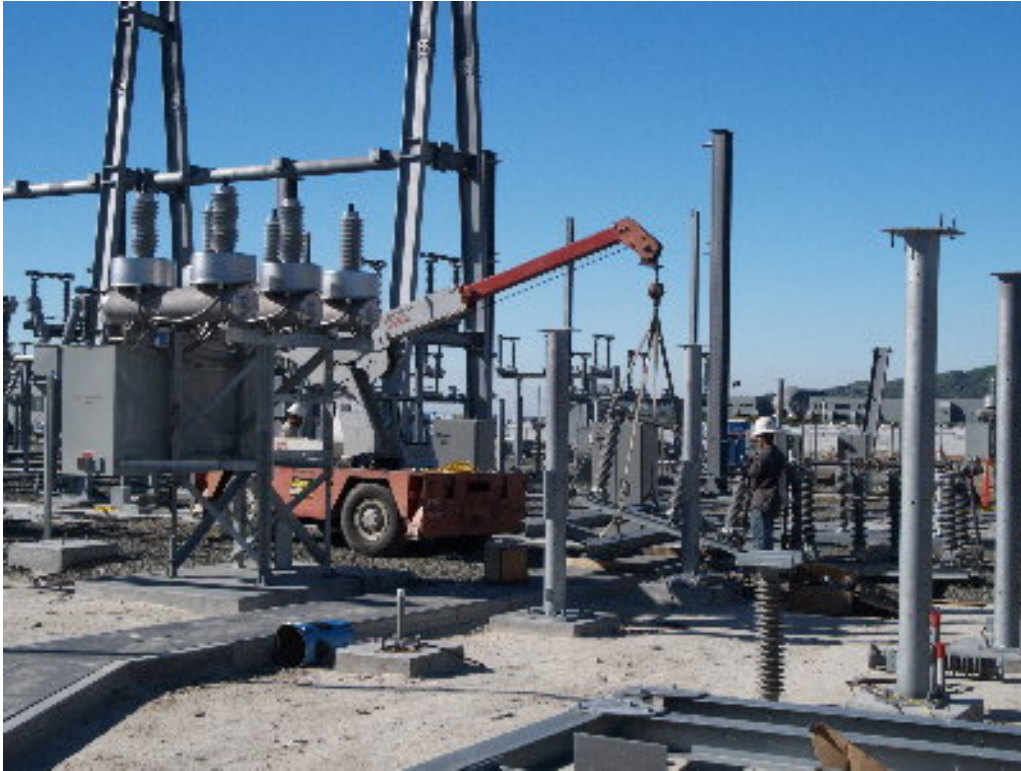
Figure 1 – A small NRG crew worked with lifts to prepare the 220 kV circuits.

NRG crews worked on the 66 kV cable and disconnect switches, as well as circuit breakers during the subject week (see Figure 1). Crews with NRG also worked on conductoring at the disconnect switch and circuit breaker on the 220 kV section of the substation.

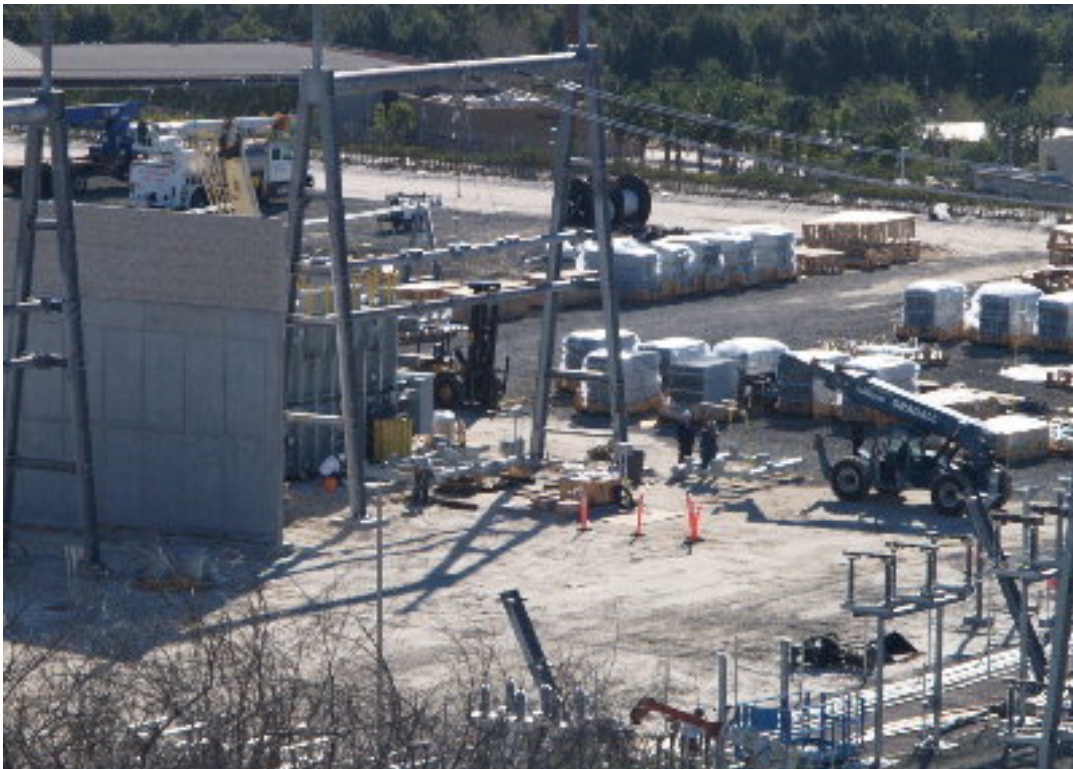
Figure 2 – SCE crews worked to dress the two A-bank transformers.

A crew from SCE was working to dress the A-bank transformers during the site visit (see Figure 2). Dressing the transformers includes making all the external connections and preparing the transformer for the oil fill.

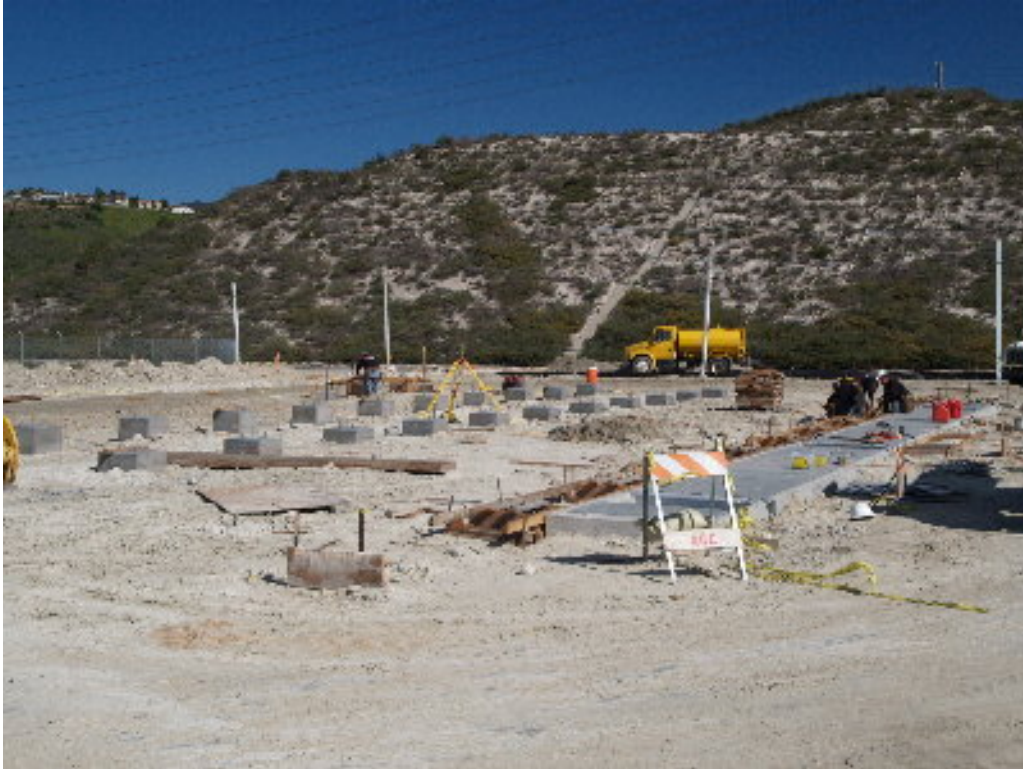
Figure 3 – Kindness worked on the 12 kV foundations on the northern section of the substation site.

A small crew with Kindness continued work on the foundations for the 12 kV section of the substation site (see Figure 3). The foundations have been poured and the crew was preparing the foundations for the support structures.

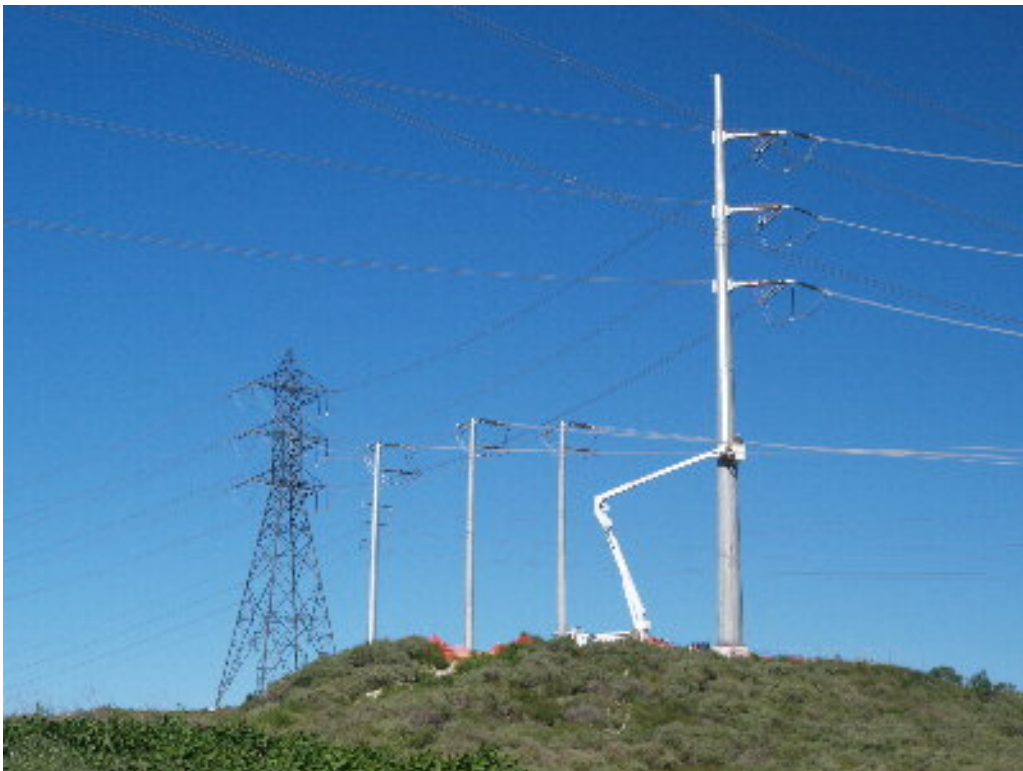
Figure 4 – The transmission line crew worked in a man-lift to on the large turning pole.

A small crew was working on the 220 kV transmission line right-of-way during the CPUC EM site visit. The crew worked on the large turning-pole in a man-lift, well below the transmission cables (see Figure 4). No other work was observed on the 220 kV transmission line segment during the site visit.
