## **PROJECT MEMORANDUM SCE – VIEJO SYSTEM PROJECT**

**To:** Jensen Uchida, CPUC  
**From:** Vida Strong, Aspen Project Manager  
**Date:** May 11, 2005  
**Subject:** Weekly Report #40, May 1 – May 7, 2005.

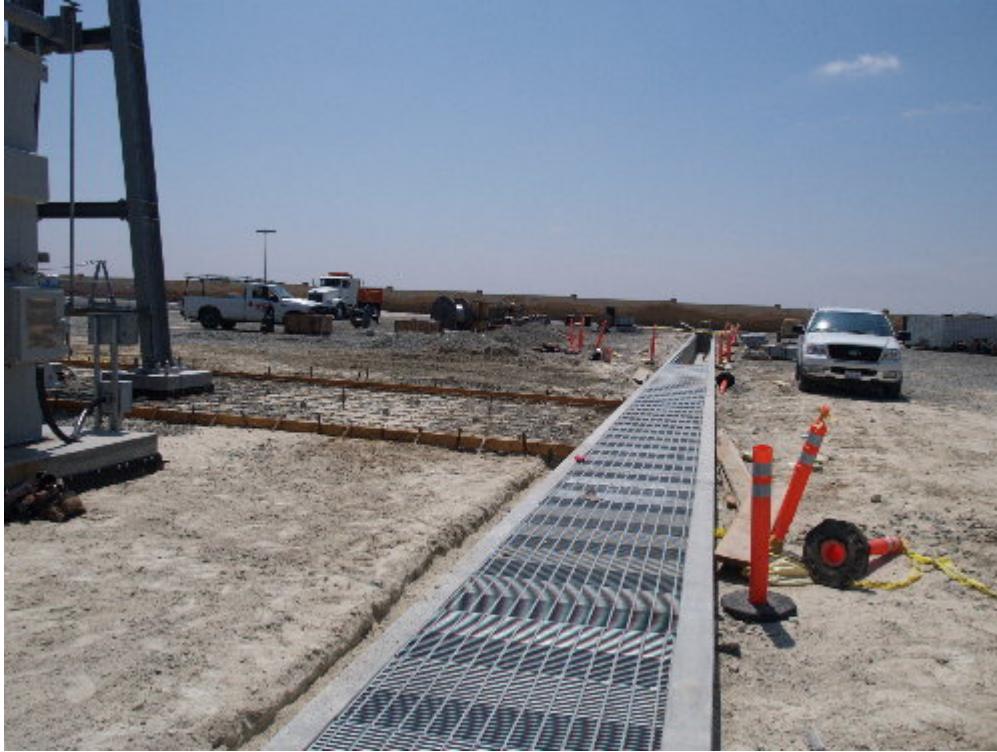
**Figure 1** – Crews have installed the steel grate trench covers.

1. Work has been completed on the main trench running east-west, dividing the 220 kV and 66 kV sections of the substation site. Crews have installed the steel grating over the concrete trench (see Figure 1).

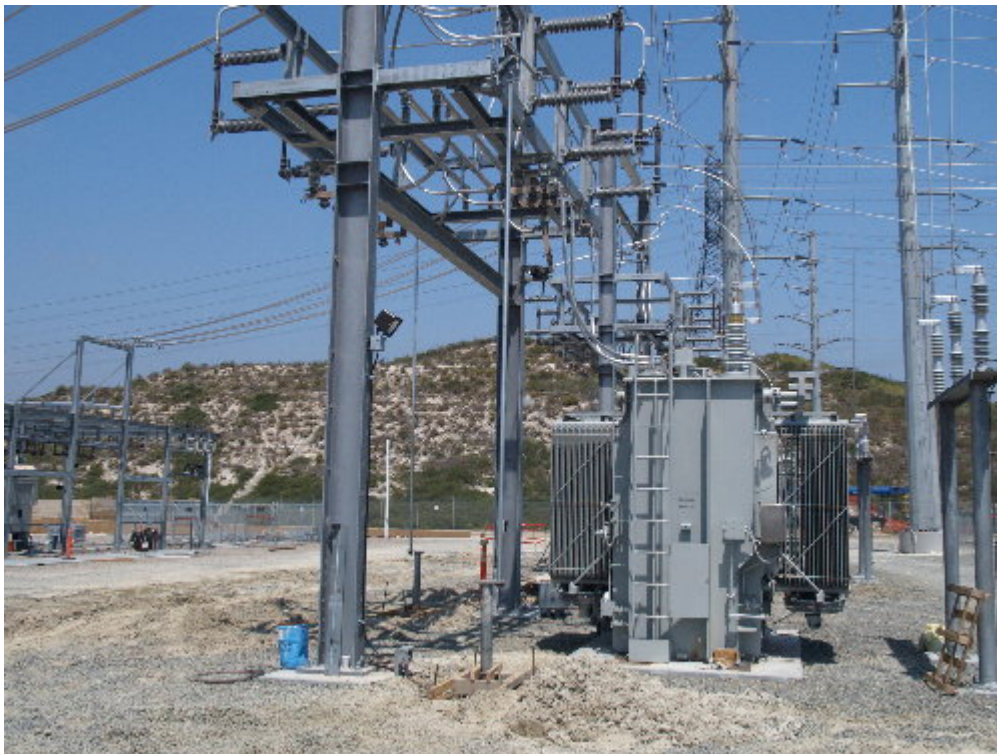
**Figure 2** – The manual disconnect switches have been set and the forms for the foundation are ready for concrete.

4. Light standards have been set on the 12 kV section of the substation site. Manual disconnect switches have been connected on the north end of the 66 kV portion of the site (connecting to the 12 kV portion) and have been formed for pouring the foundation (see Figure 2).

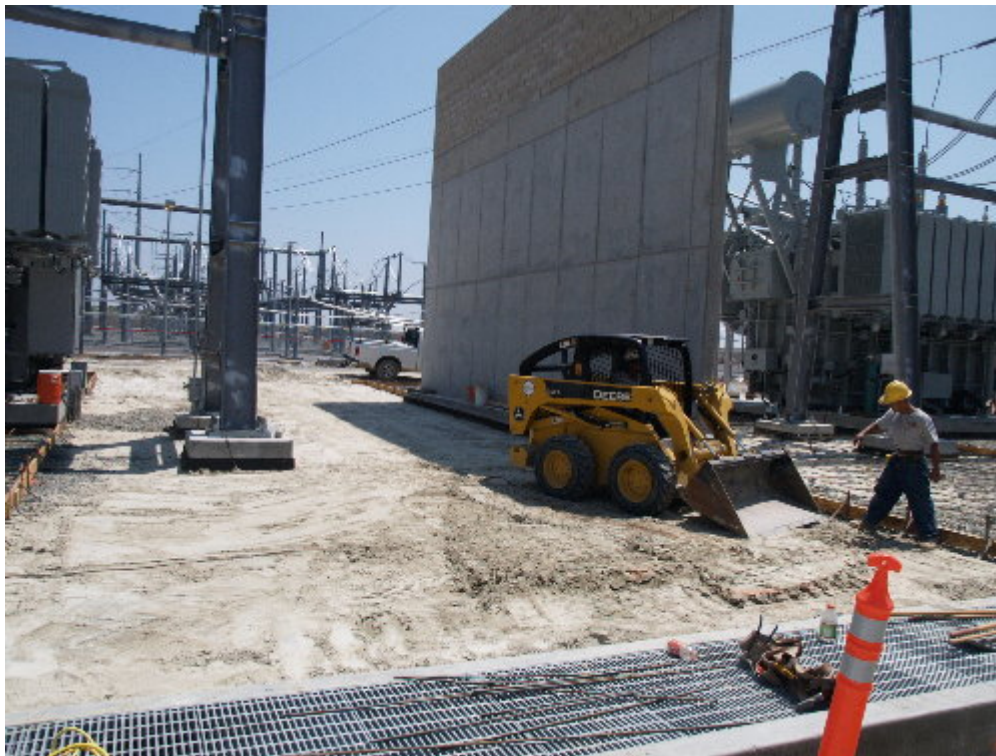
**Figure 3** – A crew graded for the concrete pads that will be poured between the various foundations.

5. A small crew worked to test the 66 kV transformers and associated equipment in preparation for energizing that section of the substation site.
6. The forms around the A-bank transformers have been prepared for concrete and the pour was scheduled for later in the week. A crew worked to grade the section between the forms in preparation for future form work (see Figure 3). An asphalt berm will be placed around the perimeter of the pad to contain the oil from the transformers in case of an accident.

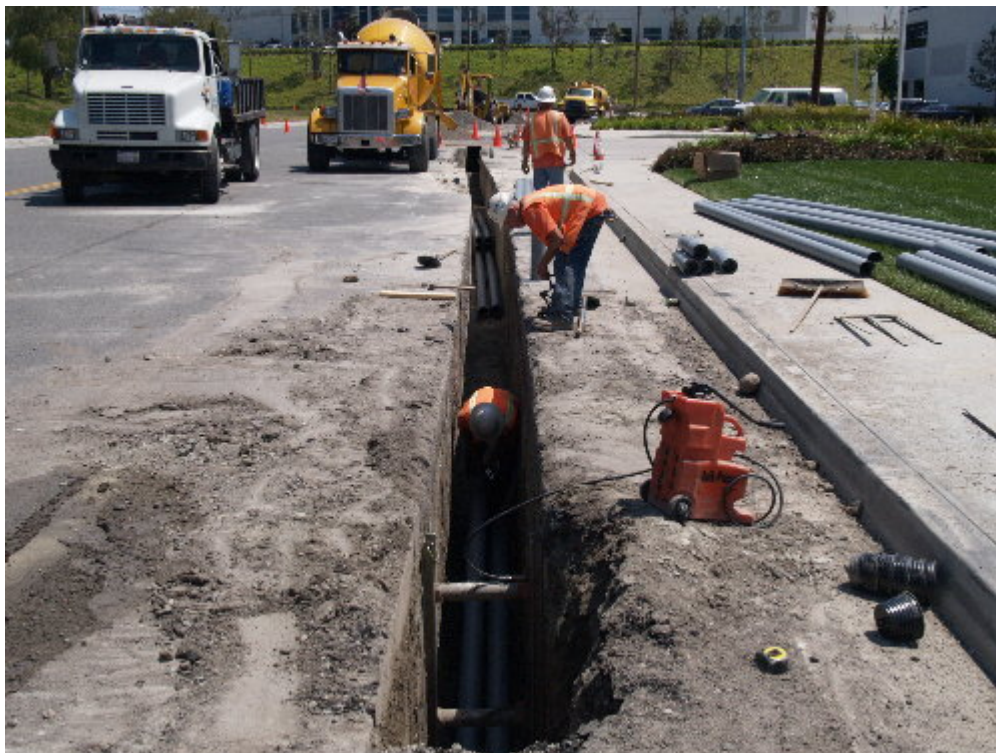
**Figure 4** – Arizona Pipeline worked on Ellipse Road, trenching, laying conduit for the 12 kV distribution conductor, and backfilling with slurry.

7. A crew with Arizona Pipeline worked on Ellipse Road outside the substation site on the 12 kV buried cables connecting the substation to the distribution network (see Figure 4). The crews have been trenching, placing conduit and backfilling with a slurry mix. The CPUC EM noted that traffic controls have been improved within the work area. The crews were working with local businesses to allow access across the work area for employees. A second crew worked to unload vaults on the corner of Portola Parkway and Glenn Ranch Road (see Figure 5).

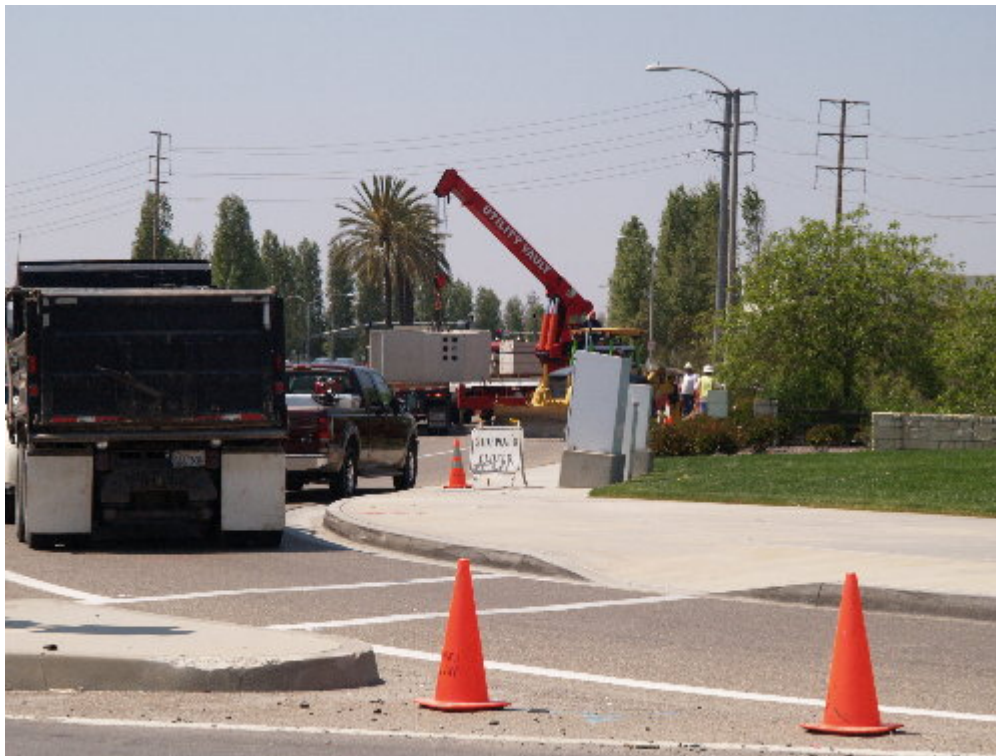
**Figure 5** – Arizona Pipeline worked to unload trench vaults on Portola Parkway during the site visit.

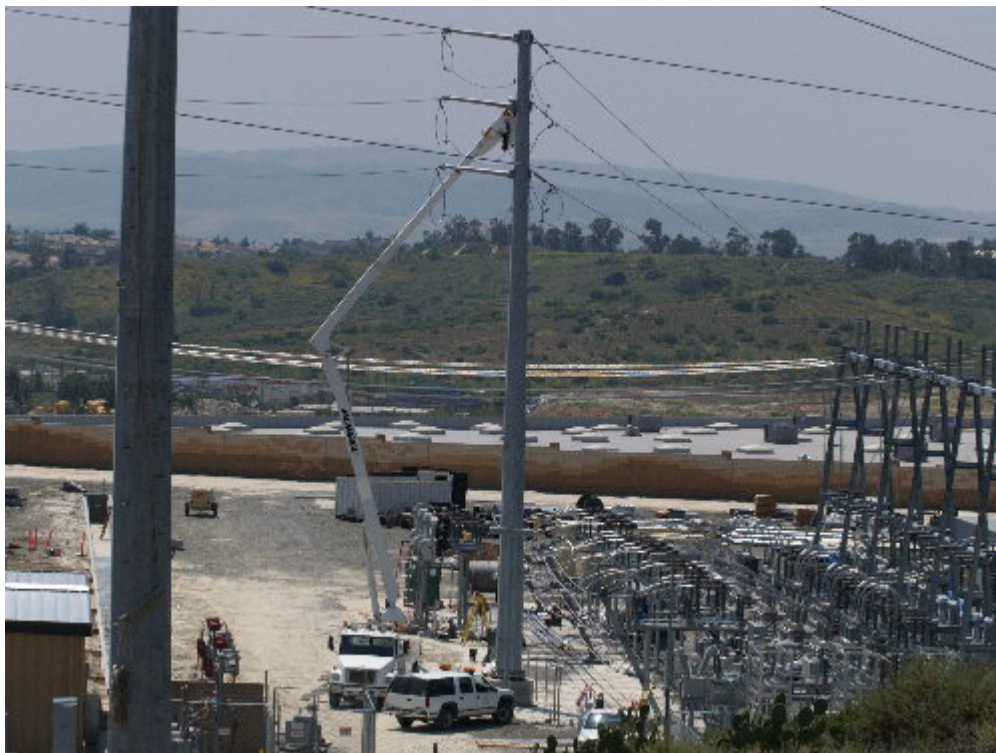
**Figure 6** – Crews worked on clipping in conductor between the 66 kV line and the substation during the site visit.

NTP #3, for the 66 kV work within the City of Lake Forest was issued on February 1, 2005 and NTP #4 was issued on April 19, 2005 for the remaining 66 kV H-structures. The transmission line crew worked on clipping in conductor on the 66 kV structures within the substation site (see Figure 6). The conductor temporarily bypassing the substation is still in place and will be removed after the 66 kV section is ready for energization.
