PROJECT MEMORANDUM SCE – VIEJO SYSTEM PROJECT

To: Jensen Uchida, CPUC
From: Vida Strong, Aspen Project Manager
Date: May 24, 2005
Subject: Weekly Report #42, May 15 – May 21, 2005.
CPUC Environmental Monitor (EM): Christopher Meyer

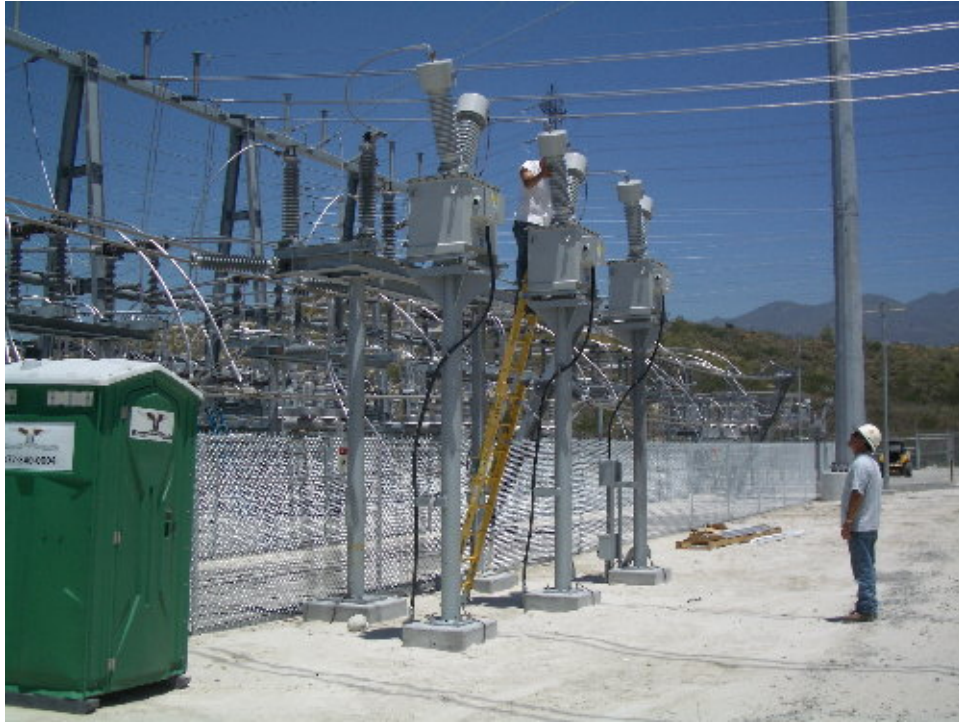
1. Several small NRG crews continued making connections within the 66 kV section of the substation site. The crew worked on many of the short connections between various pieces of equipment and insulators (see Figure 1).

Figure 1 – NRG crews worked on adjusting the insulators and other equipment during the site visit.

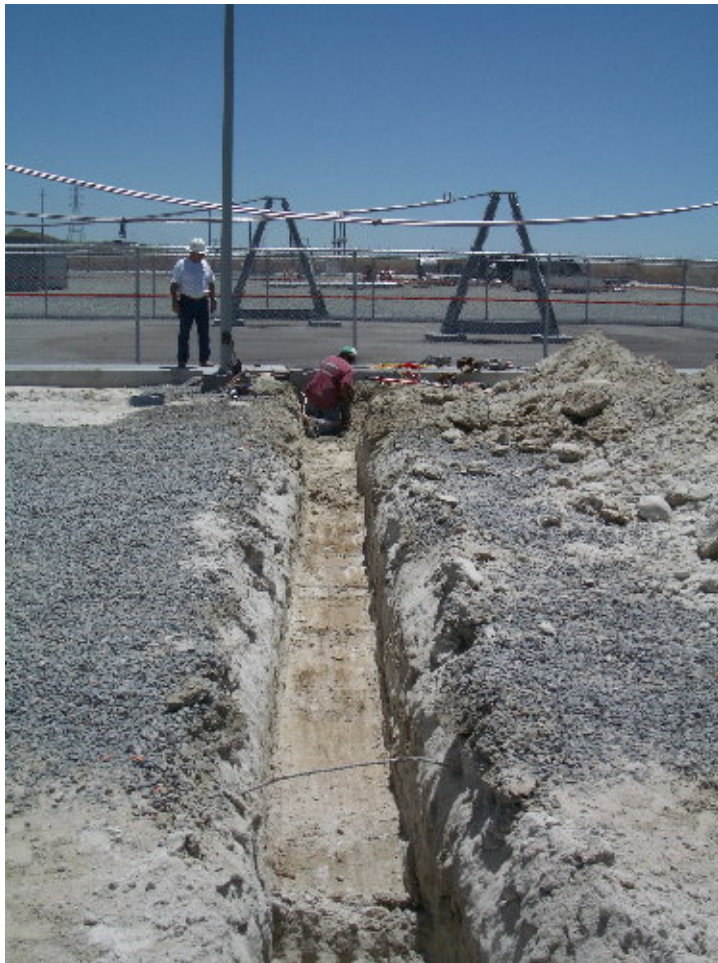
2. A small crew with KGC worked on excavating a trench and connecting it to the pre-formed concrete trench adjacent to the 220 kV fence (see Figure 2). Empty conduit will be placed in the trench that can be used for later expansion of the facility without removing the paving that will cover the area. KGC crews also worked to excavate foundation for additional light standards within the substation site. These foundations have been formed for concrete pours that will occur the following week.

Figure 2 – KGC excavated a trench for future expansion and tie it into the existing pre-formed concrete trench adjacent to the 220 kV fence.

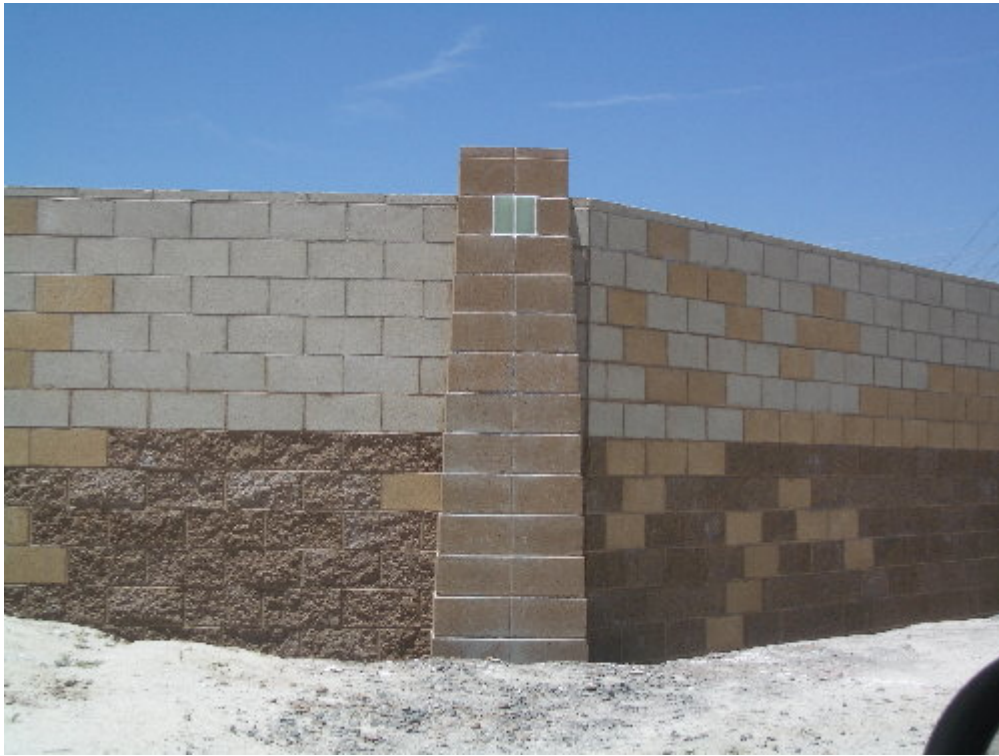
4. The block wall contractor, Reycon, returned to the substation site to start the installation of the glass blocks in the pilasters used to break up the block wall (see Figure 3). A special type of glass block was used that absorbs light energy during the day and is luminous at night without the need for electricity. The pilasters are decorative and do not serve a structural purpose.

Figure 3 – Reycon started installing the glass blocks in the pilasters on the block wall.

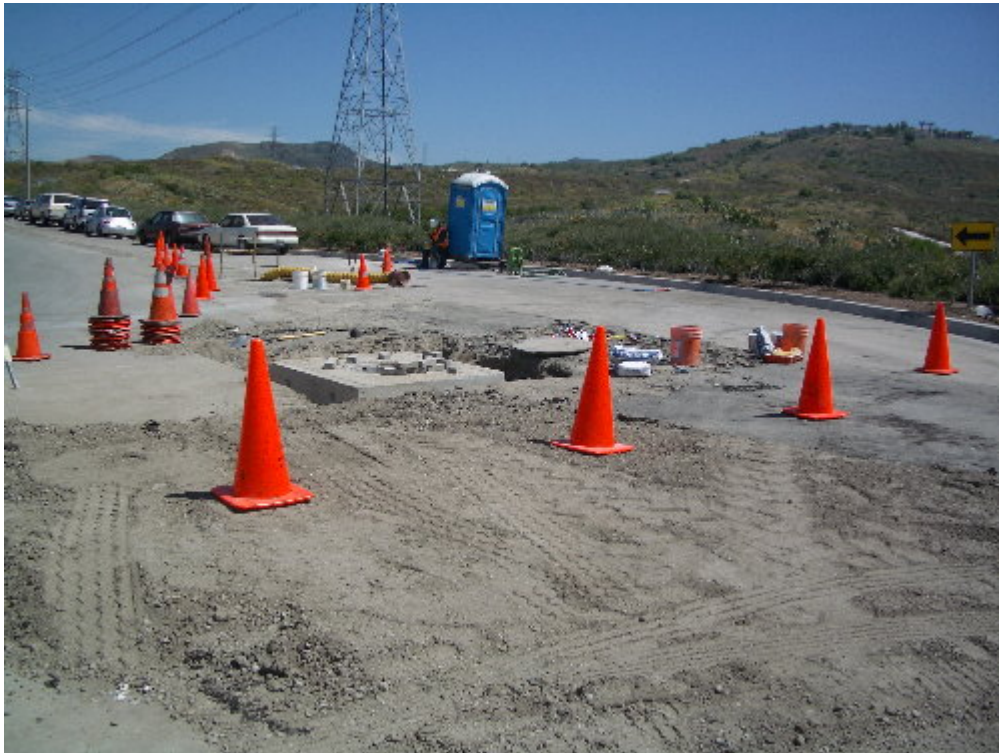
5. A crew with Arizona Pipeline worked on Ellipse Road excavating trench for the 12 kV buried cables connecting the substation to the distribution network. The crews have set a vault for the 12 kV conduit outside the access road gate on Definition Road (see Figure 4). A crew also worked on Portola Parkway pouring and finishing the concrete sidewalk at the site of the underground vault.

Figure 4 – Arizona Pipeline set a vault for the 12 kV conduit on Definition Road at the substation site.

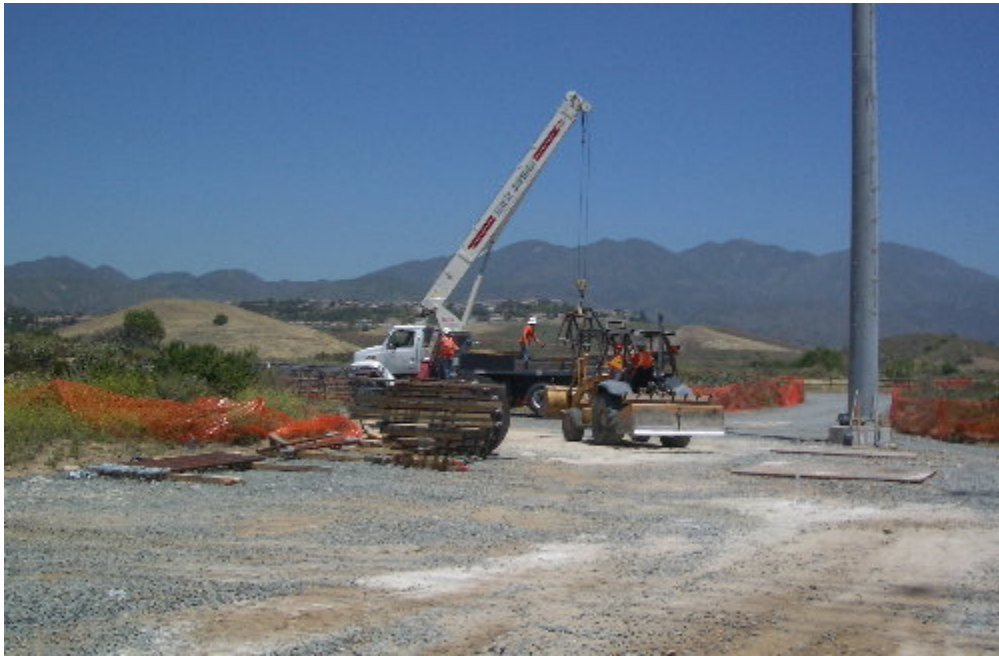
1. A crew worked with a drilling machine to complete excavations for one of the 66 kV H-structures that will run from the Viejo Substation into the City of Mission Viejo. The operator used a backhoe to load the spoils from the excavation into dump trucks for hauling back to the substation work area for stockpiling.
2. A crew worked on the center pad overlooking the substation site, unloading equipment for setting the anchor bolts and rebar cage into the H-structure foundations on the top of the hill (see Figure 5).
3. The excavations for the H-structure nearest the substation site has been completed and appears to have been filled with slurry (see Figure 6). This may be in order to hold the hole in the loose, sandy material. The rebar cage and anchor bolts are staged on-site, but have not been set in the excavations.

Figure 5 – Arizona Pipeline crews unloaded equipment for setting the rebar cages and anchor bolts for the 66 kV H-structure above the substation site.

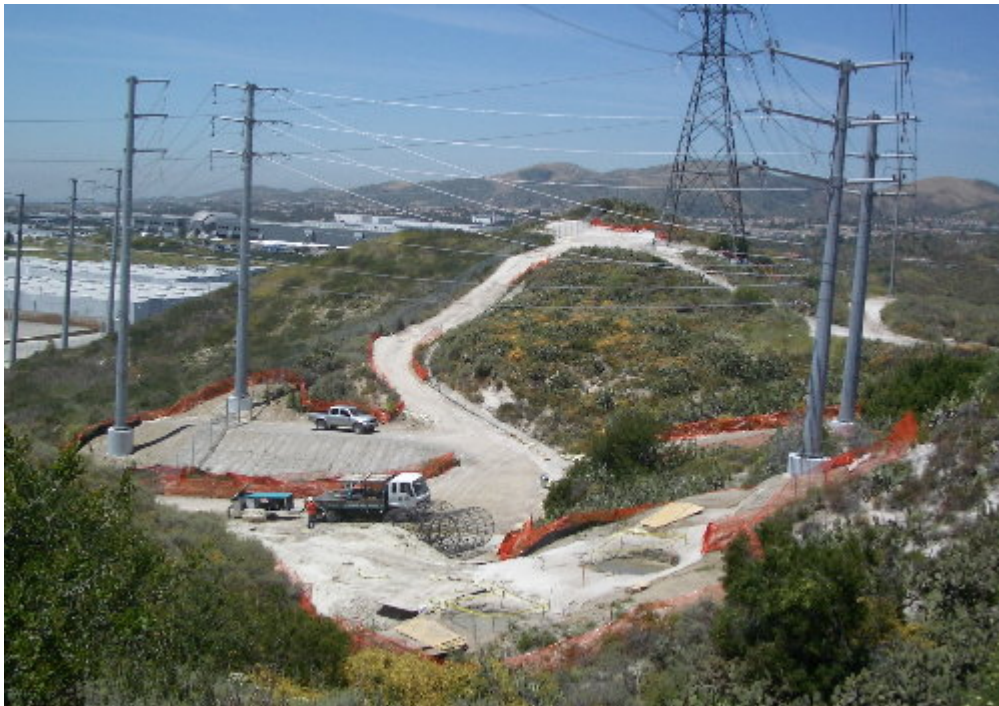
Figure 6 – Crews prepared the rebar cages for the 66 kV H-structure foundations during the site visit.
