## **PROJECT MEMORANDUM SCE – VIEJO SYSTEM PROJECT**

**To:** Jensen Uchida, CPUC  
**From:** Vida Strong, Aspen Project Manager  
**Date:** August 3, 2005  
**Subject:** Weekly Report #52, July 24 – July 30, 2005.  
**CPUC Environmental Monitor (EM):** Christopher Meyer

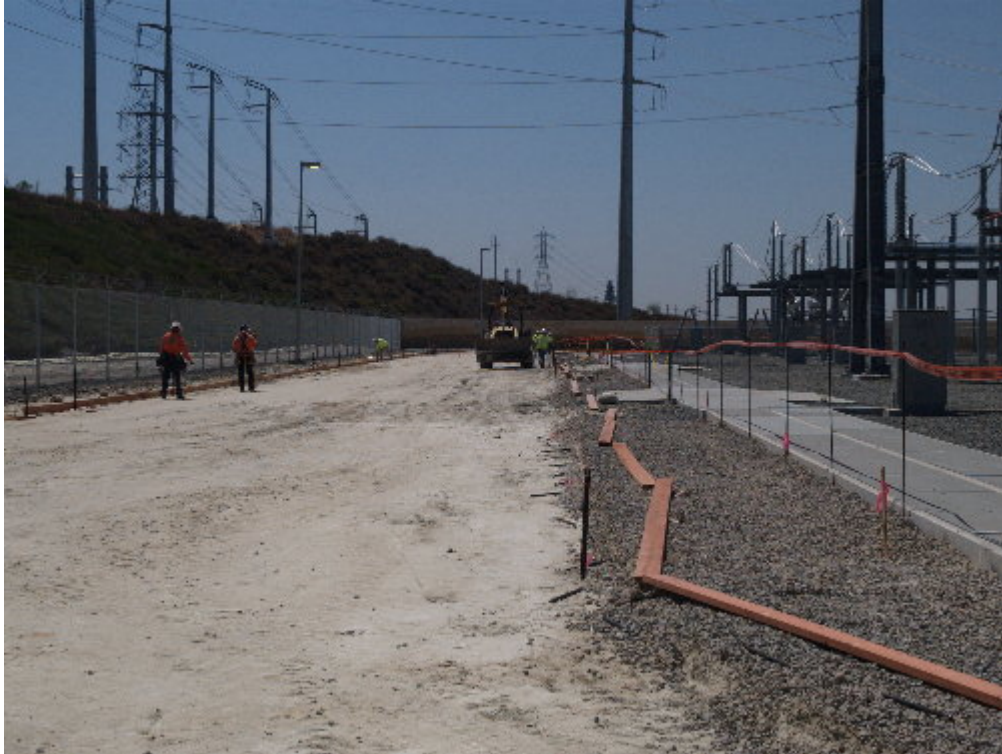
**Figure 1** – The paving contractor crew worked on installing the borders for the substation roadway prior to paving.

2. The road contractor had crews working on setting up the boundaries of the roads within the substation site in preparation for paving (see Figure 1). No work was occurring on paving during the site visit.

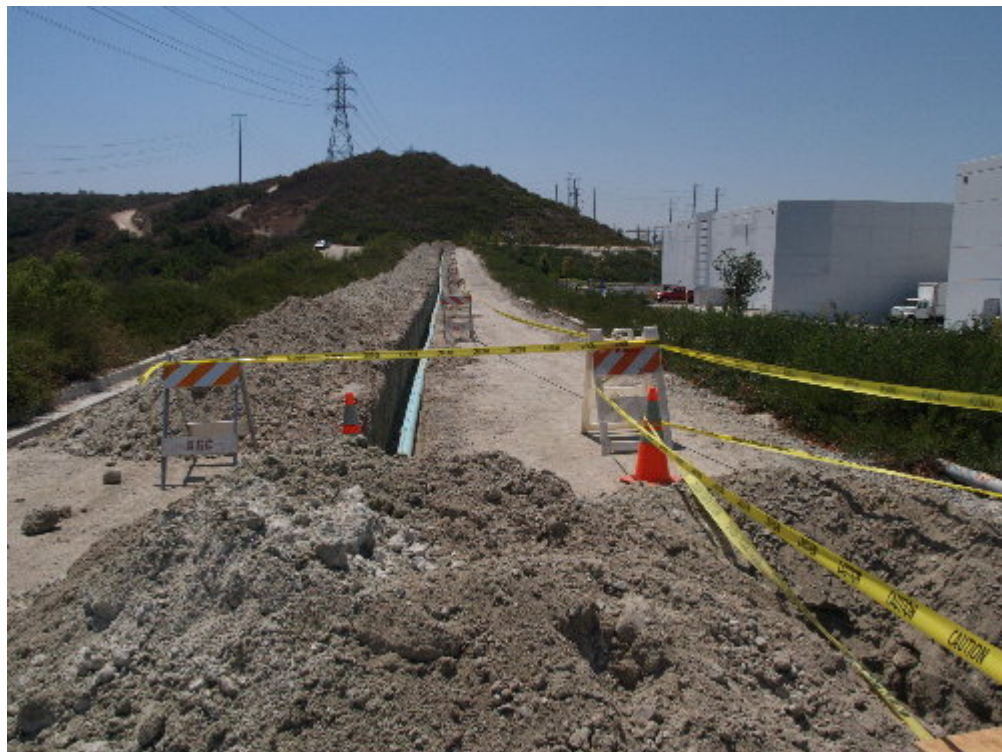
**Figure 2** – A subcontractor trenched along the access road to lay the water supply line for the fire control system.

3. Trenching for the water line leading into the substation site is near completion and much of the PVC pipe has been laid into the trench (see Figure 2). Sections of the open trench on the south end of the access road have been covered with steel plates for safety and to provide access.

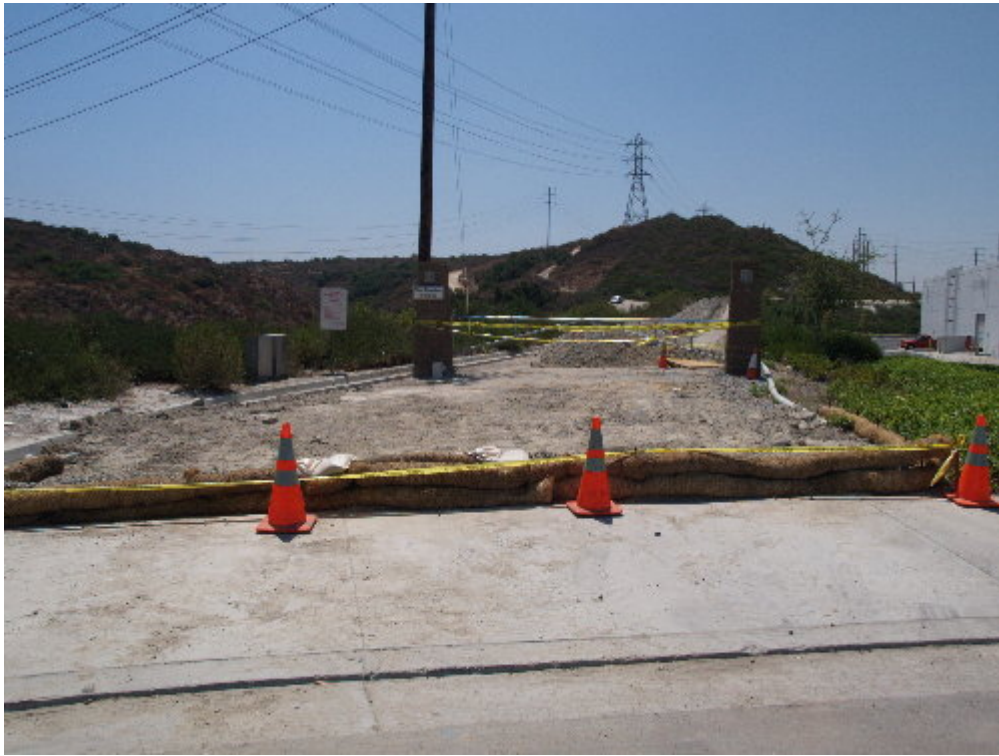
**Figure 3** – BMPs were installed to prevent sediment from entering the public roadway and adjacent storm drains.

1. For all operations, the CPUC EM observed that construction was in compliance with mitigation measures adopted in the MND and other permitting requirements.
2. Straw waddles have been placed at the end of the driveway to prevent sediment from entering the public right-of-way and keep it away from storm drains during trenching for the water line (see Figure 3).
3. A rabbit was observed within a section of the water pipe staged on the access road. The pipe in the trench has been capped and care will have to be taken to be sure no animals are trapped in the line.

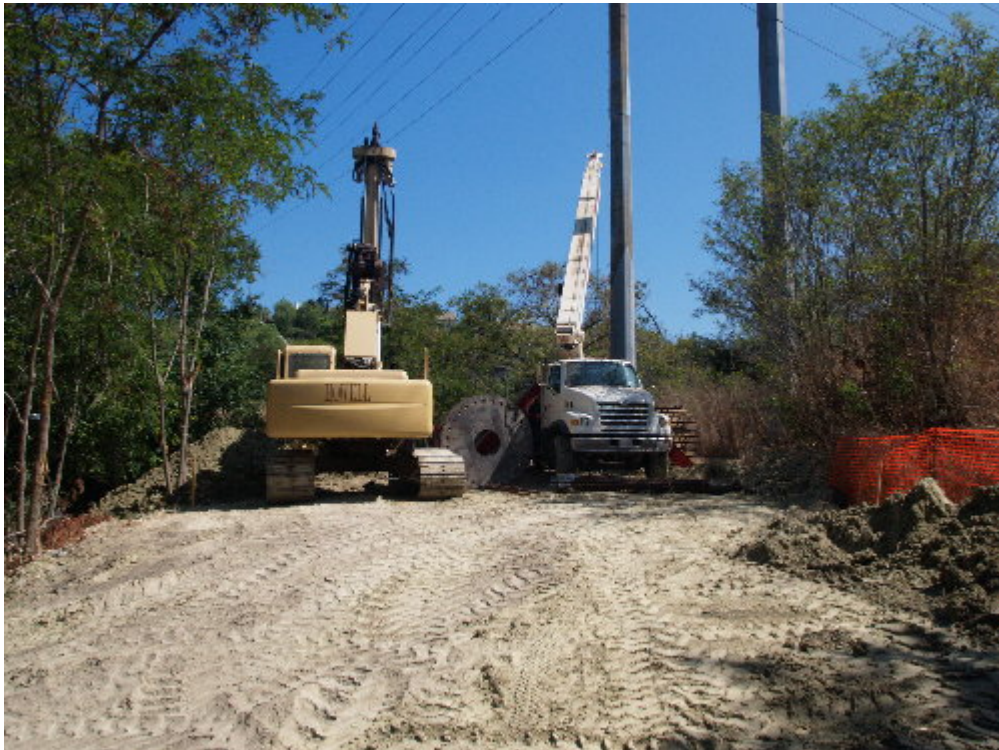
**Figure 4** – The drilling crew worked to prepare H-Structure 1 (at Chiquita Substation) for the concrete pour.

1. A mobile crane has been set up at Structure 7; however, work was shutdown while the crew waited for longer ISO outages. Work cannot safely proceed without taking the adjacent lines out of service. Those lines were needed to address the power demands during the extended heat spell. Arizona Pipeline may take some time off until work can proceed without interruption.
2. The drilling crew worked at Structure 1, preparing the foundations for the concrete pour (see Figure 4). The two foundations have been excavated and the concrete pumping crew worked to set of the pumper and hoses leading down to the excavation. Operators worked with two backhoes to move the re-bar cage down to the excavation (see Figure 5). An SCE inspector was on-site to check the foundations and concrete pour.

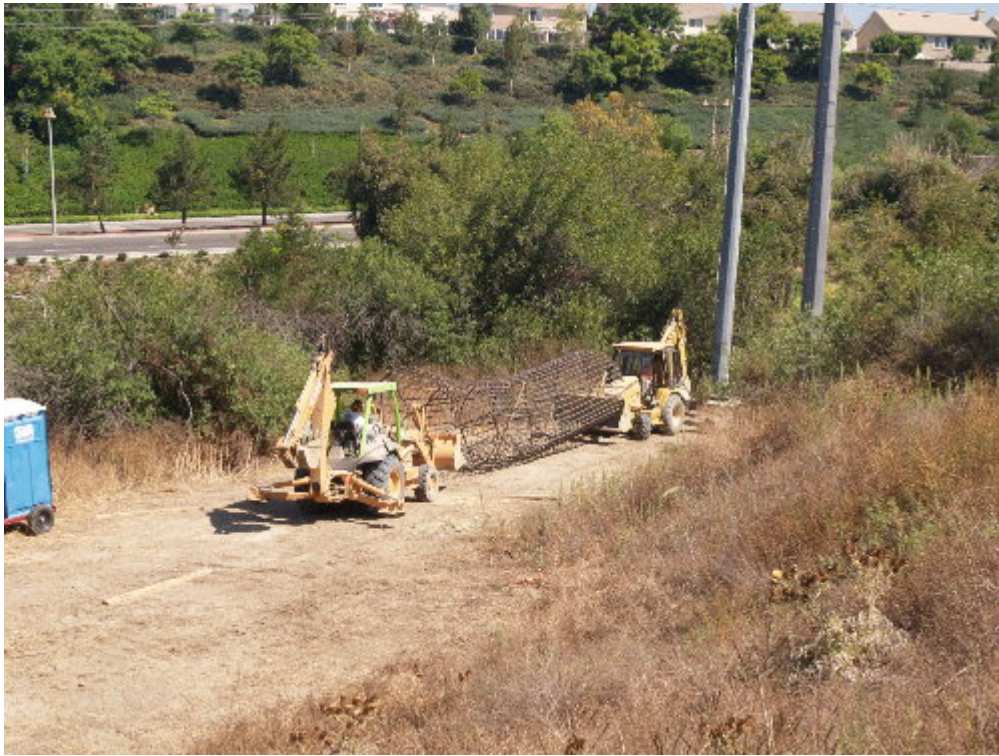
**Figure 5** – The re-bar cage was moved to the excavation at H-Structure 1 (at Chiquita Substation).
