PROJECT MEMORANDUM SCE – VIEJO SYSTEM PROJECT

To: Jensen Uchida, CPUC
From: Vida Strong, Aspen Project Manager
Date: November 9, 2005
Subject: Weekly Report #65, October 30 – November 5, 2005.
CPUC Environmental Monitor (EM): Christopher Meyer

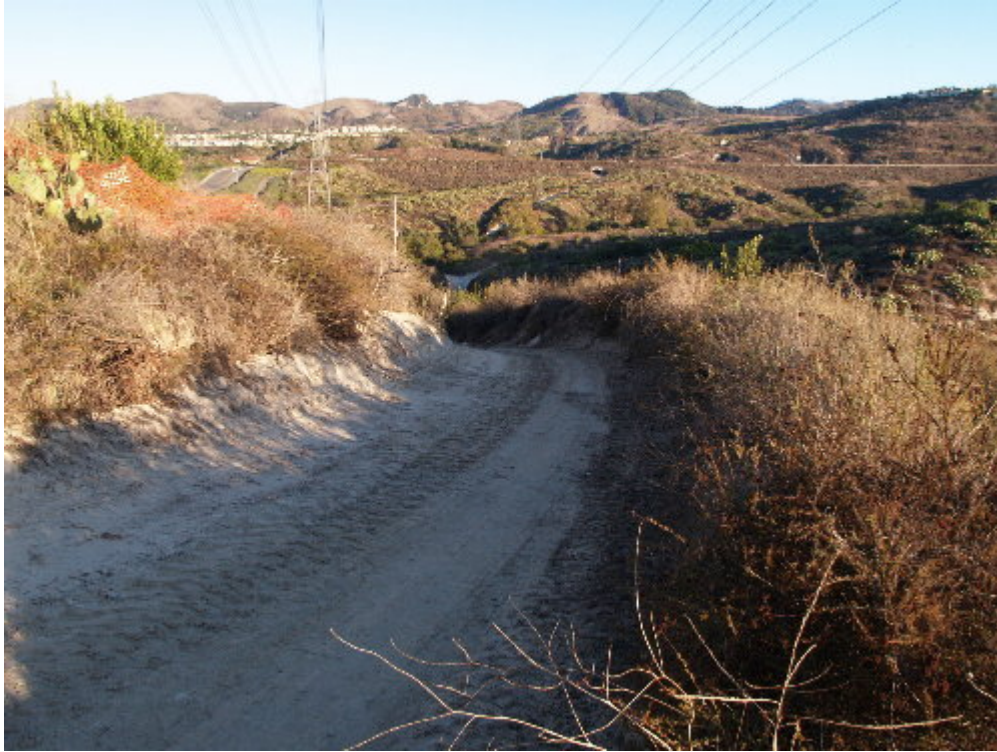
1. The invasive plant species in the recontoured area of the 220 kV right-of-way, adjacent to the native plant communities, have been removed by SCE without disturbing the native species. However, some of this area was disturbed during the site visit by a crew placing communication conduit along the SCE right-of-way. The disturbance to the steep road leading from the main access road for the substation to the lattice towers has been disturbed by the communication trench and will be rocked to address erosion (see Figure 1). This crew is not part of the Viejo System Project. The area adjacent to the project is dominated by native species and is part of a habitat conservation area. The parts of the 220 kV right-of-way that have not recently been disturbed are showing natural revegetation by native species.

Figure 1 – A crew unrelated to the Viejo System Project installed communication conduit in the SCE right-of-way above the Viejo Substation. This disturbance will require stabilization prior to rainfall.

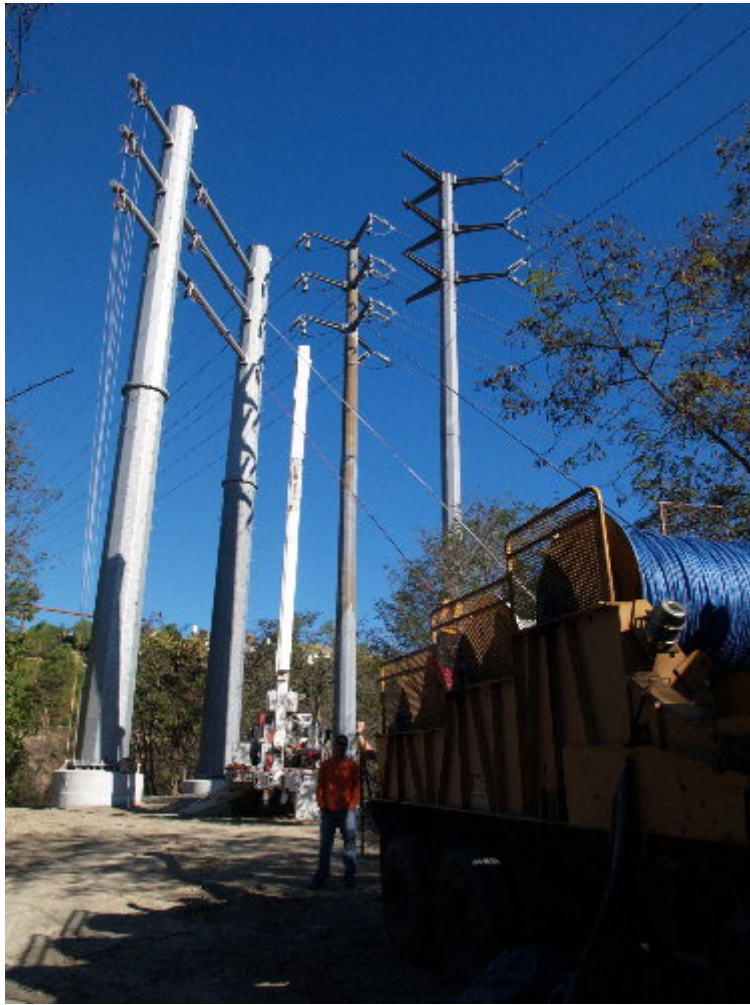
1. SCE transmission line crews were set up adjacent to Structure 1 to pull conductor from Structure 5 to Structure 1 (see Figure 2). Crews were working at both Structure 1 and Structure 5 during the site visit, with additional workers checking the right-of-way between the pulling stations. Nets have been strung between the guard structures at Aliso Parkway to protect the trees in the median from the conductor (see Figure 3). No other work was noted during the site visit.

Figure 2 – The SCE transmission line crew worked to pull conductor between Structures 5 and 1. Structure 1 is adjacent to the Chiquita Substation.

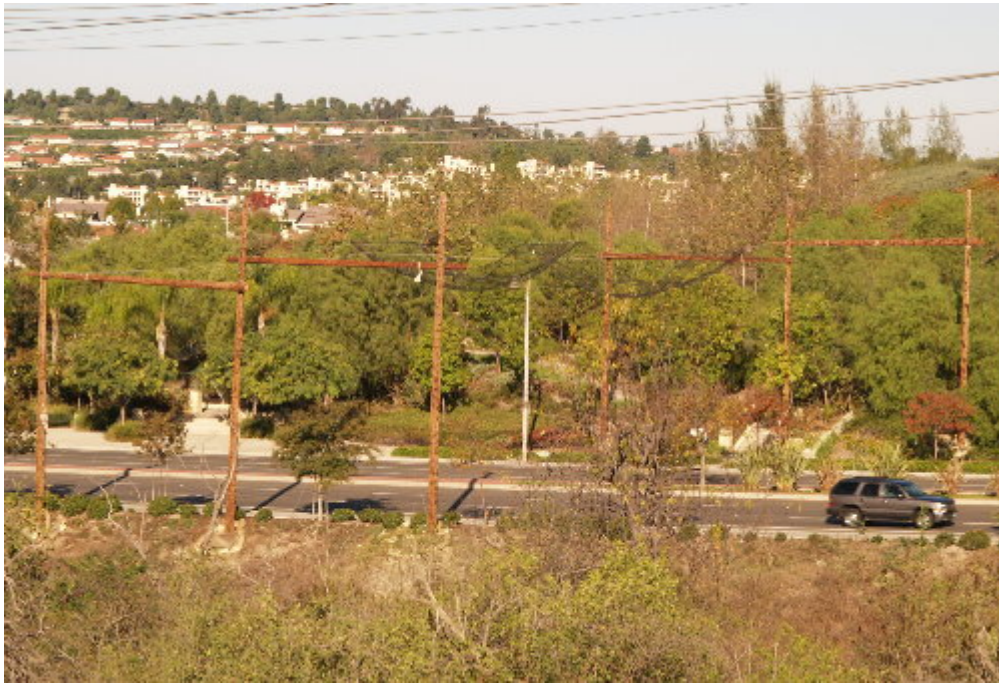
Figure 3 – Netting has been placed between the guard structures at Aliso Parkway to protect the trees in the median.

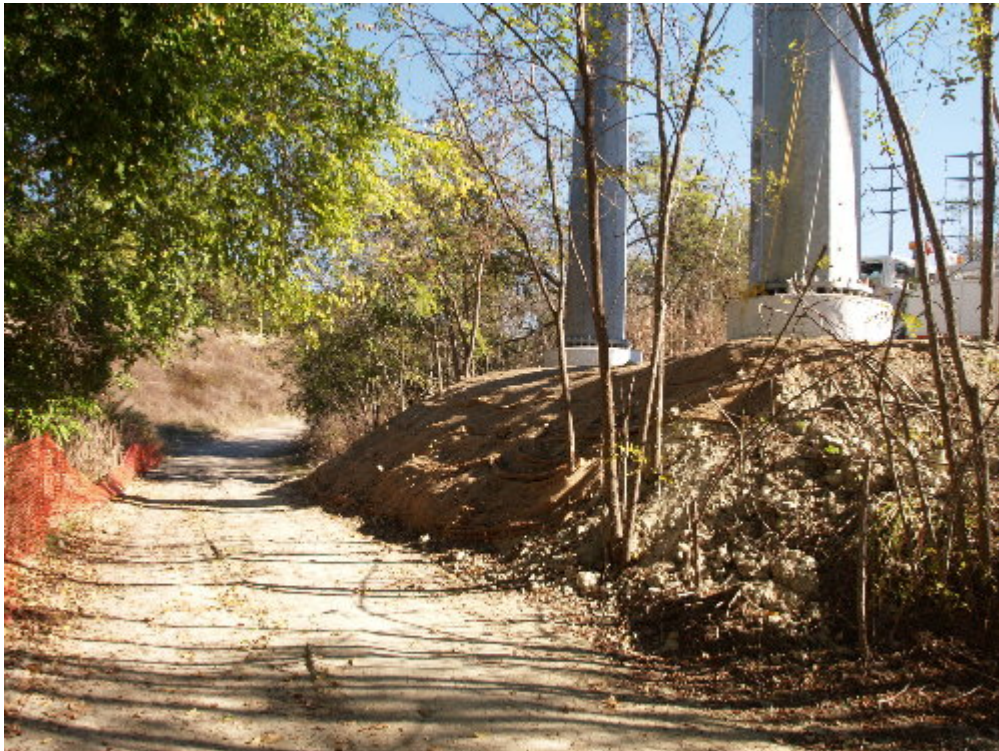
The slope below the pad for Structure 1 has been covered with jute netting in preparation for restoration and is devoid of vegetation despite the time passed since disturbance to the area (see Figure 4).

Figure 4 – No recruitment of native species was observed on the slope below Structure 1. This slope will require restoration.
