PROJECT MEMORANDUM SCE – VIEJO SYSTEM PROJECT

To: Jensen Uchida, CPUC
From: Vida Strong, Aspen Project Manager
Date: December 6, 2005
Subject: Weekly Report #68, November 27 – December 3, 2005.
CPUC Environmental Monitor (EM): Christopher Meyer

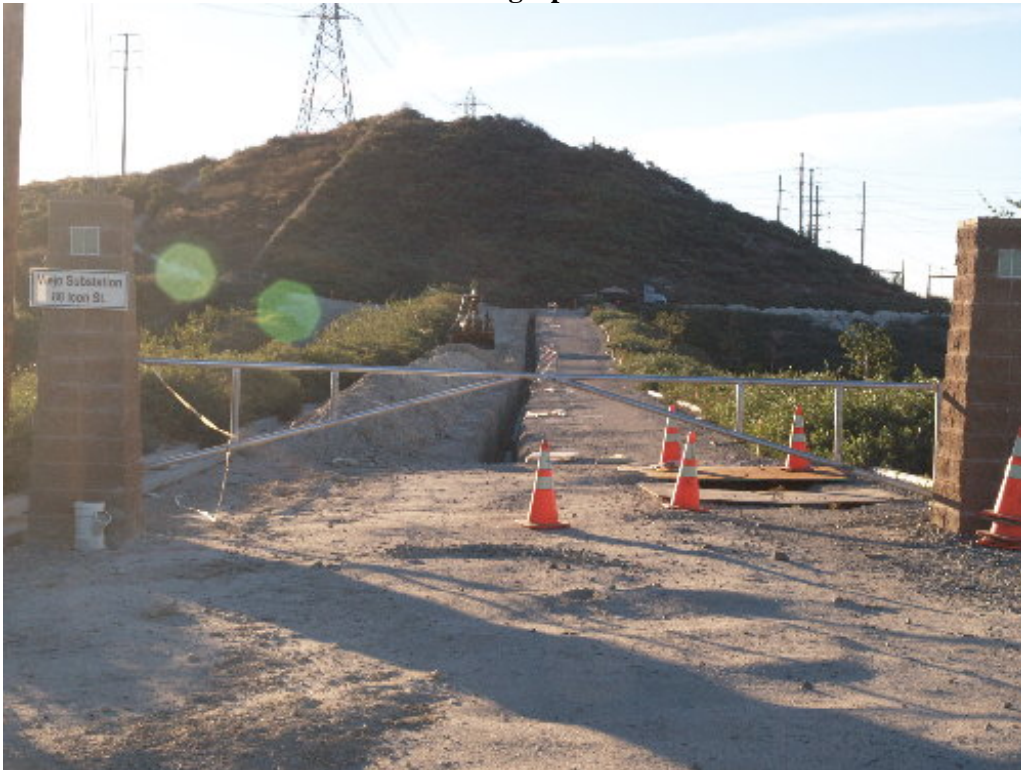
Figure 1 – The company installing a communication line along the main access road removed the spoils from the water line in order to trench along the east side of the line.

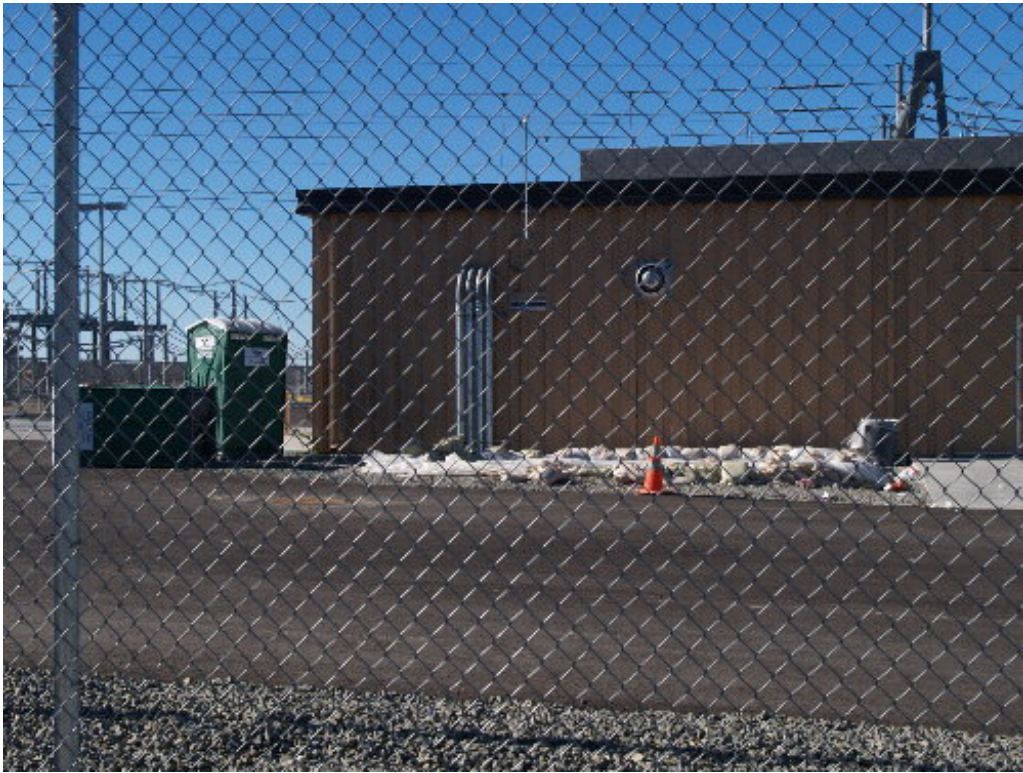
3. High winds over the weekend resulted in one portable toilet being blown over and trash blowing out of the trash can by MEER #1 (see Figure 3). SCE will remove the trash and secure the cover on the trash can. No water quality impacts resulted from the overturned portable toilet.

Figure 3 – One portable toilet was blown over by high winds and trash was spread around at MEER #1.

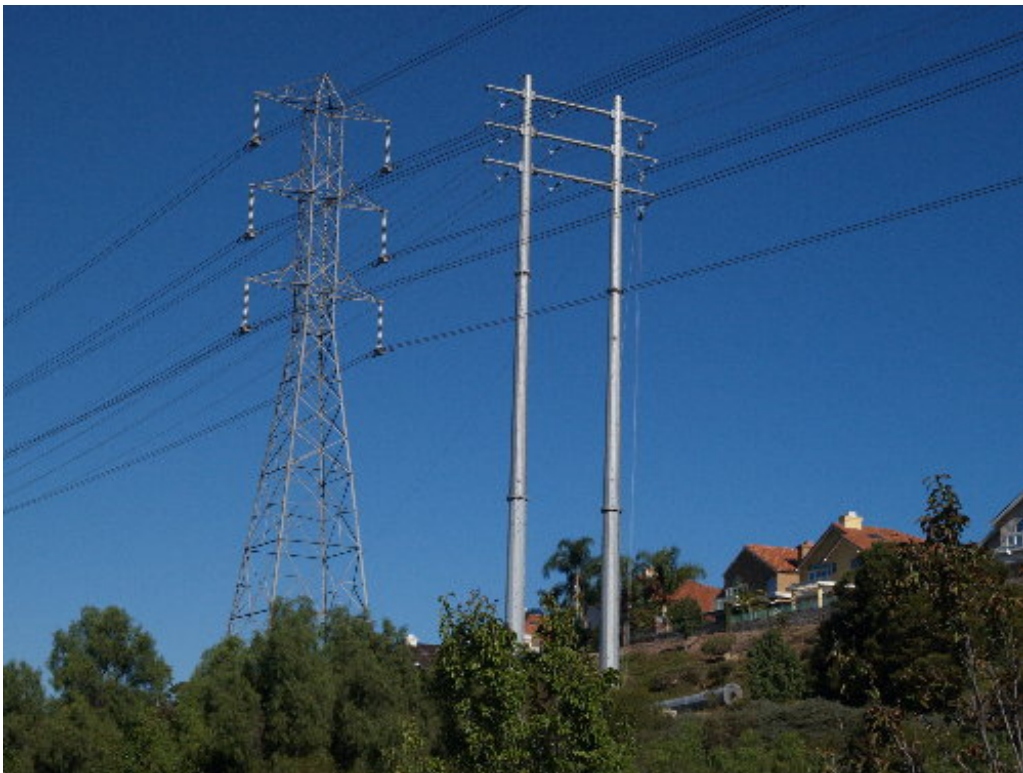
1. SCE transmission line crews prepared to pull conductor on the east arm of the H-Structures during the site visit (see Figure 4). Most of the old 66 kV steel poles have been wrecked out to make room for the east arms on the H-Structures and the stringing of the eastern circuit. Crews were working from Olympiad Park to the north pulling in the sock line that will be used to pull the new conductor in later in the week (see Figure 5). No other work was noted during the site visit.
2. SCE is working to bring a larger crane on-site for the removal of those old 66 kV steel poles that will require a greater reach to the pole site or have other complications that the current crane could not address.

Figure 4 – The east arm has been installed on the H-Structures now that many of the old 66 kV steel poles have been removed. Note the old steel pole on the ground.

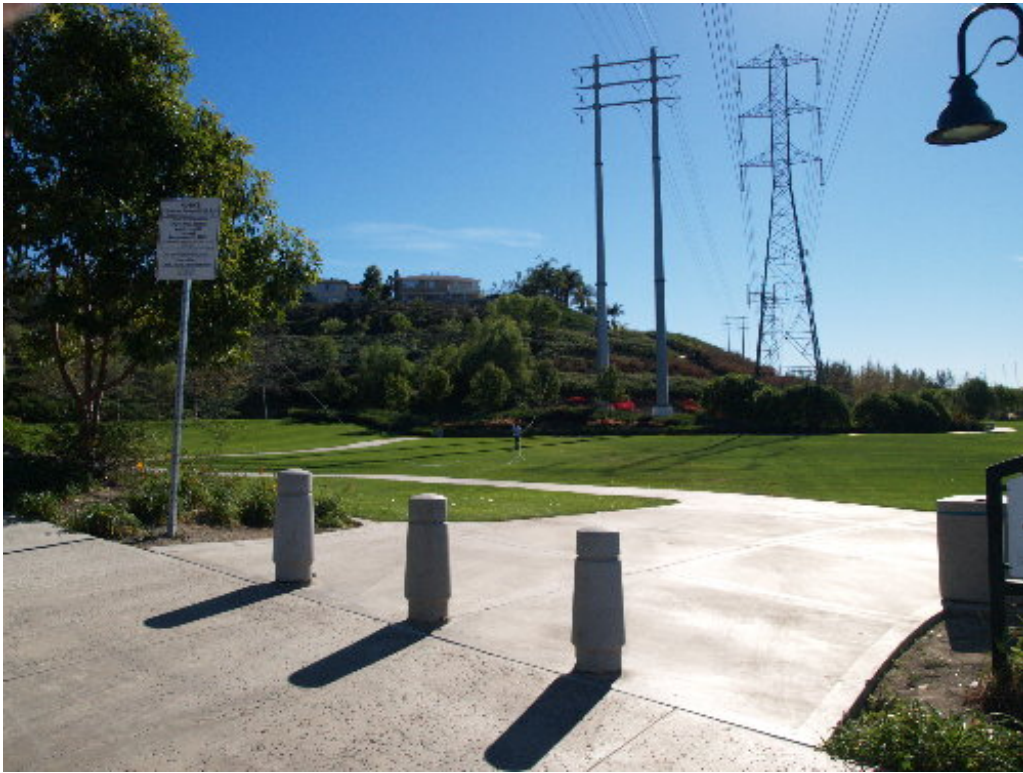
Figure 5 – SCE worked within Olympiad Park pulling sock line in preparation for stringing the new conductor on the east arm of the H-Structures.
