PROJECT MEMORANDUM
SDG&E VINE 69/12-KV SUBSTATION PROJECT

To: Eric Chiang, Project Manager, CPUC
From: Vida Strong, Aspen Project Manager
Date: October 25, 2017
Subject: Monitoring Report #18: September 10 to October 6, 2017

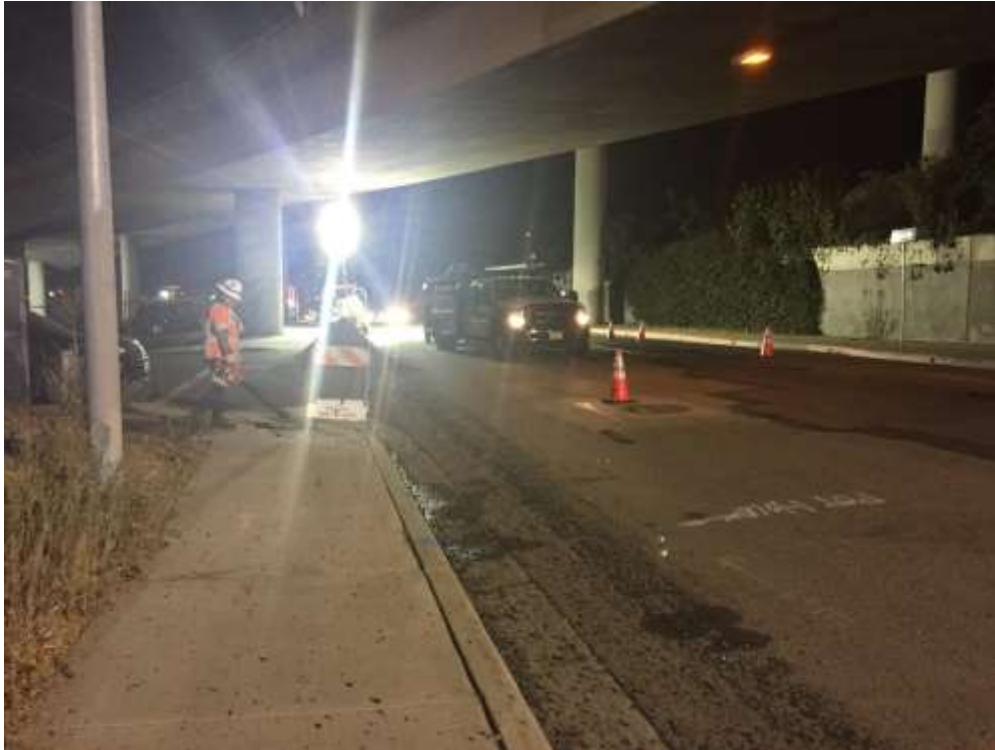
Figure 1 – NPL crews used leaf blowers to remove dislodged cold mix from the sidewalks adjacent to Kettner Blvd.

6. NPL crews continued the underground work along Kettner Boulevard. Potholing, saw cutting, trenching, conduit installation, backfilling, and vault installation took place between the hours of 7:00 pm and 5:00 am, Monday through Friday.
7. Crews used leaf blowers to remove dislodged cold mix used to cover trench plates from adjacent sidewalks (see Figure 1).
8. Excavation and removal of historic trolley tracks continued (see Figure 2).
9. Grinding and paving took place along India Street.
10. 3-way switch installation took place at the State Street and Laurel Street intersection.
11. NPL crews are staging equipment and material at the Kettner Yard.

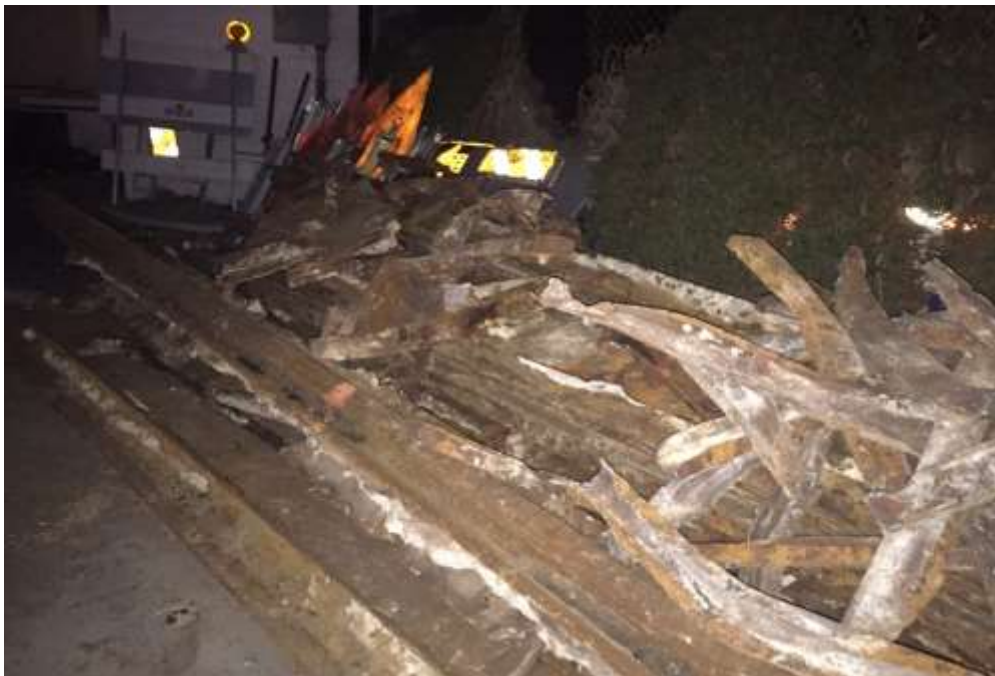
Figure 2 – NPL crews working along Kettner Boulevard salvaged abandoned rail segments from the trench and vault excavations. These sections are put aside for recycling and for collection by the Pacific Southwest Railway Museum.

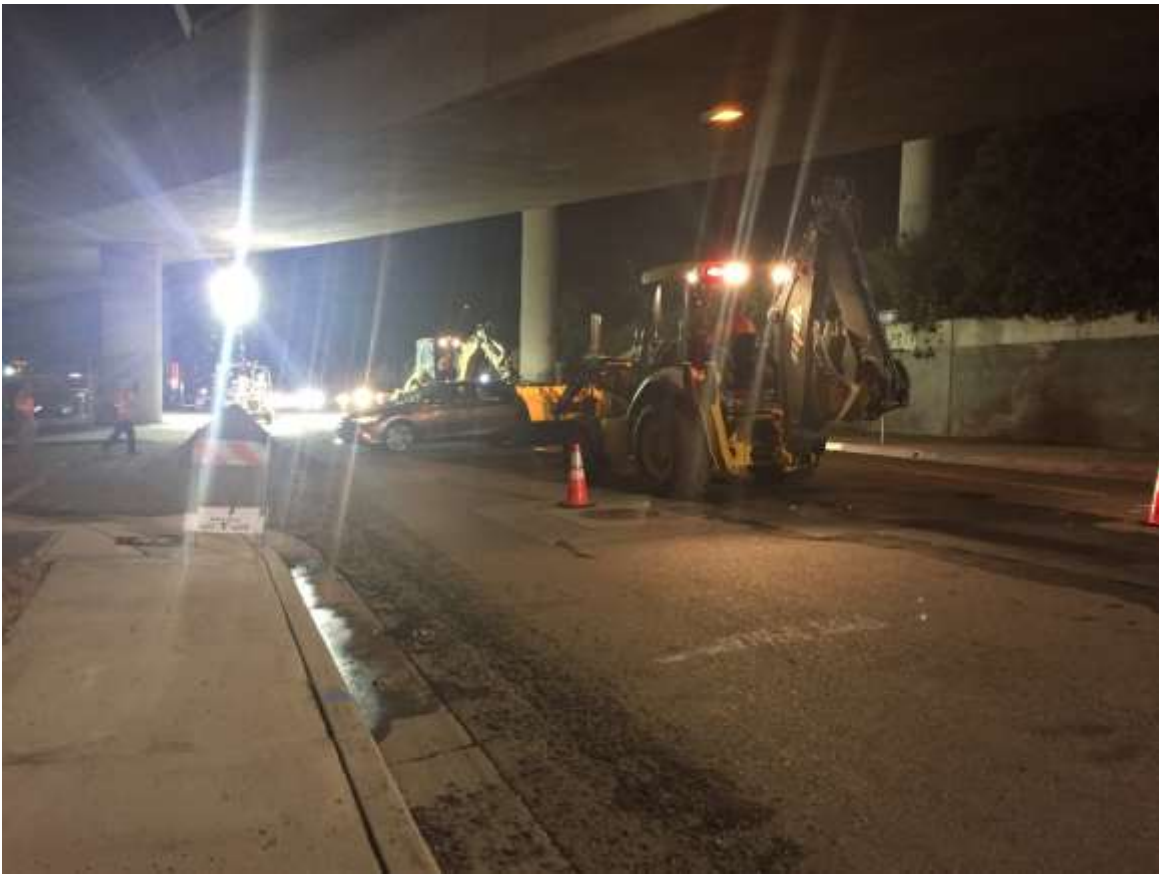
1. On October 5, the CPUC EM observed unsafe conditions during night work along Kettner Boulevard (see Figure 3). Traffic control was set up and NPL crews were removing plates to begin trenching activities on Kettner crossing the intersection of W. Redwood Street. The CPUC EM observed several vehicles leaving parking lots located on W. Redwood Street drive directly into the work area on Kettner. There were no flaggers, signs, or cones present to stop traffic from entering the active work area. In addition, NPL crews had blocked the access to W. Redwood Street with traffic control cones, but cars needing to access W. Redwood were turning into the coned area (with open trenches) to access W. Redwood Street. Again, no flaggers were present to assist public traffic. Upon inspection of the approved Traffic Control Permits, it was determined that NPL had not set up traffic controls consistent with the permits. Access to W. Redwood Street was shown on the approved permits, and did not reflect was set up in the field on October 5. The CPUC EM notified the SDG&E site representative of the concerns and the SDG&E representative directed the NPL crews to shut down at that location. CPUC Project Memorandum #2 was issued to SDG&E on October 9 for the significant safety concerns relating to the traffic control problems, and construction was ordered to stand down by the CPUC until a Remedial Action Plan was submitted by SDG&E. The Remedial Action Plan included steps taken by NPL and SDG&E to ensure that the Traffic Control Permits were reviewed each day prior to the onset of work. Remedial Action Plan was provided to the CPUC on October 13 and construction was authorized to recommence on October 17.

Figure 3 – Traffic control and construction activity the night of October 5 at the intersection of Kettner and W. Redwood Street. A vehicle drove through the work area to access a parking lot on W. Redwood Street. Open access to Redwood Street was not provided, inconsistent with Traffic Control Permits.
