Environmental Minor Project Refinement Form

New Splice Location for NTP #3

New Pole Installation for NTP #4

Southern California Edison West of Devers Upgrade Project

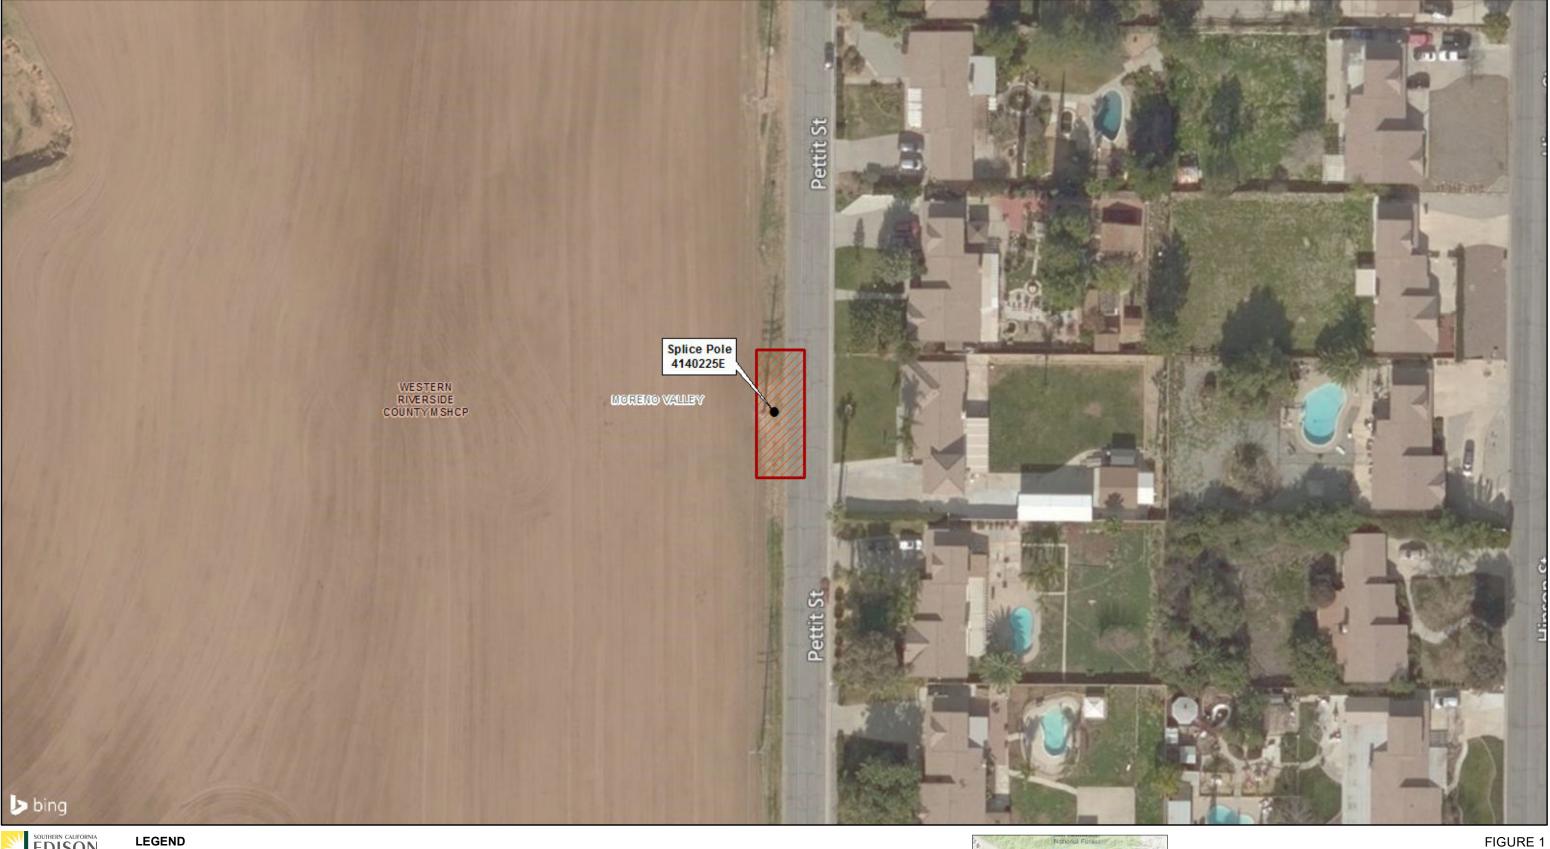
One overhead fiber optic cable splice, on Pole 4140225E, on Pettit Street, in Moreno Valley is required for the Vista-Moreno tap to El Casco. The cable crew will drive to existing Pole 4140225E, park on along the paved street curb and walk along the shoulder of the road to access the existing splice box located on the pole. The work area will be approximately 40- feet in each direction from the pole parallel with the pole line, from the edge of pavement to approximately 10-feet past the pole line. See Figure 1.

MPR #8 -Vista-Moreno Tap to El Casco Fiber Optic Cable Splicing

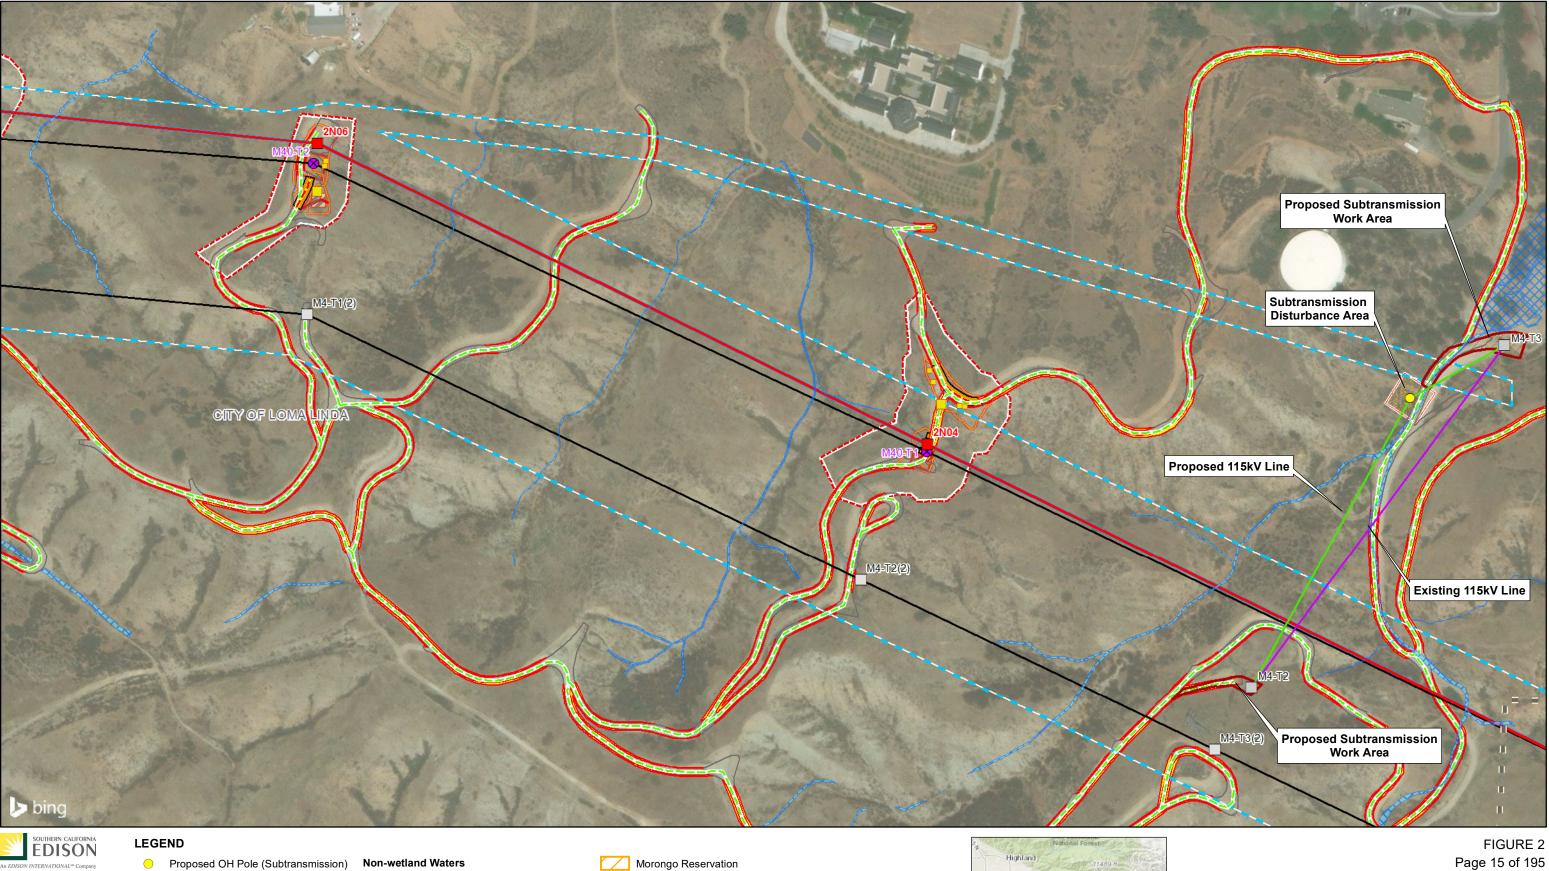
One 80-foot light weight steel pole will be installed west of the existing Valley - Mayberry - Moreno - Vista 115 kV-line line, between Towers M4-T3 and M4-T2. The existing wire between those two towers will be dead ended into the new steel pole to relocate the wire to a lower elevation, to maintain proper clearances between the 115-kV line and the new 220-kV lines that will be installed overhead. Existing conductor will be reused for this work, and new conductor will be spliced in, to maintain adequate tension between the new pole and the existing towers on each side. See Figure 2.

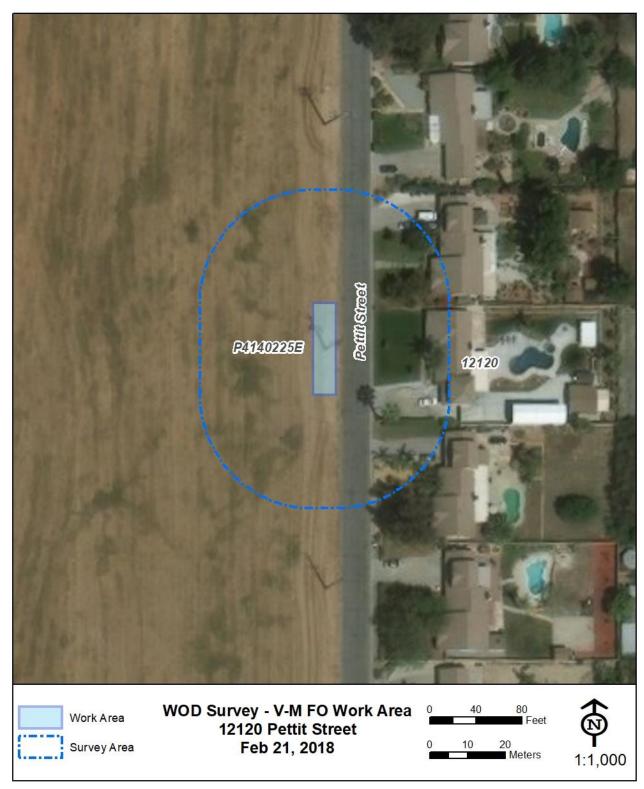
Figure 2: Survey Area Map

An intensive pedestrian survey of the splice site footprint and the 30 m buffer which constituted the APE was conducted by PanGIS archaeologist Annemarie Cox on February 21, 2018. Utility pole P4140225E formed the central point of the splice site footprint, which measured 80 feet north to south, and 20 feet east to west. The full APE expansion area was intensively surveyed in 10 m intervals (Figure 2). A GPS device running ArcGIS Collector software was used to ensure that accurate project boundaries were recognized and that the entire APE was completely surveyed.

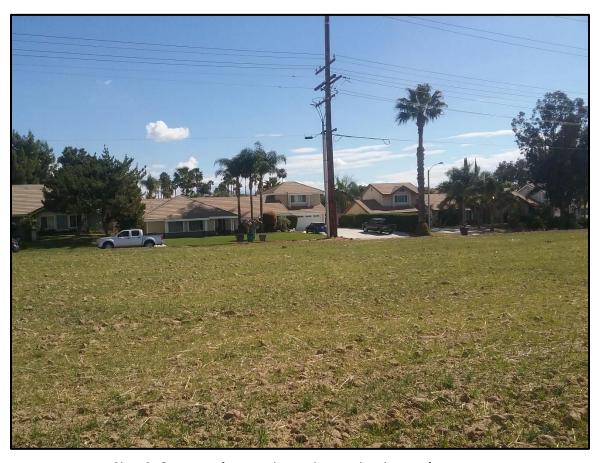
Plate 1: Overview of surveyed area showing disturbances, facing east

No cultural resources were discovered during the survey of the splice site APE. The area was found to be heavily disturbed by residential development and agricultural activities. Homes and paved roads covered the eastern portion of the APE, while the splice site footprint and the western portion of the APE were on a recently plowed field (Plate 1). Table 1 lists the results of the surveys and the recommendations resulting from it.
