PROJECT MEMORANDUM
SCE WEST OF DEVERS (WOD) UPGRADE PROJECT

To: Billie Blanchard, Project Manager, CPUC
From: Vida Strong, Aspen Project Manager
Date: April 11, 2018
Subject: Monitoring Report #13: March 26 to April 8, 2018

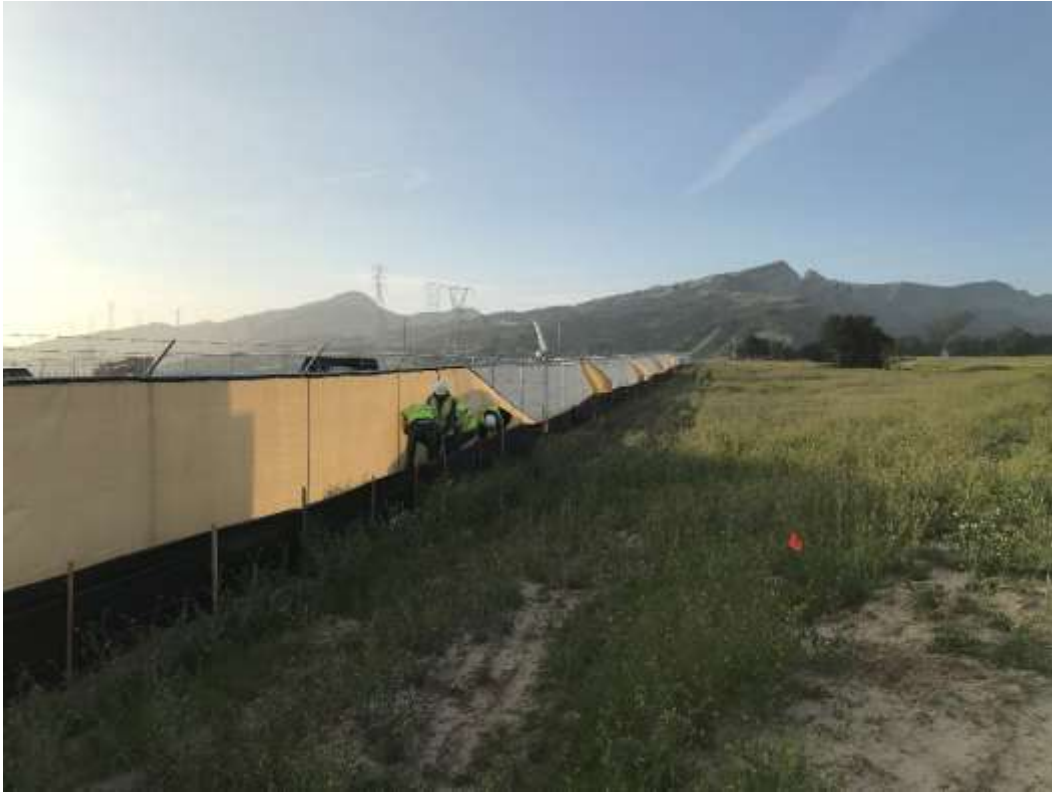
Photo 1 – Installing privacy screening around perimeter of Poultry MY (April 4, 2018).

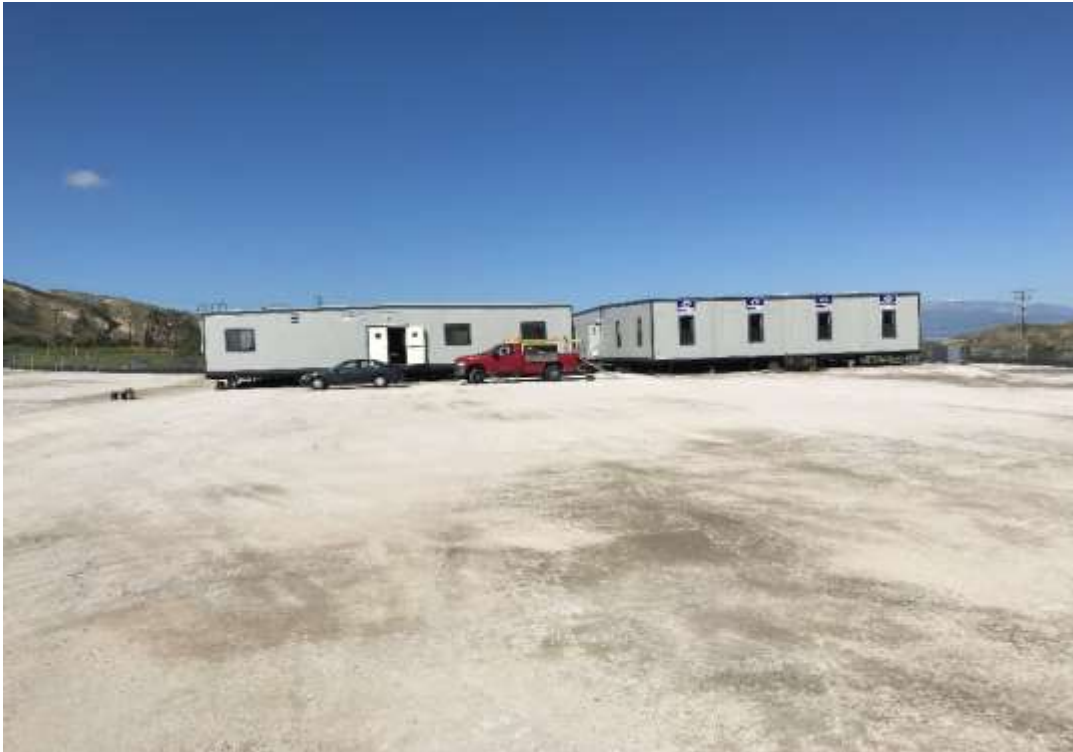
Photo 2 –Installation of office trailers at Poultry MY (March 26, 2018).

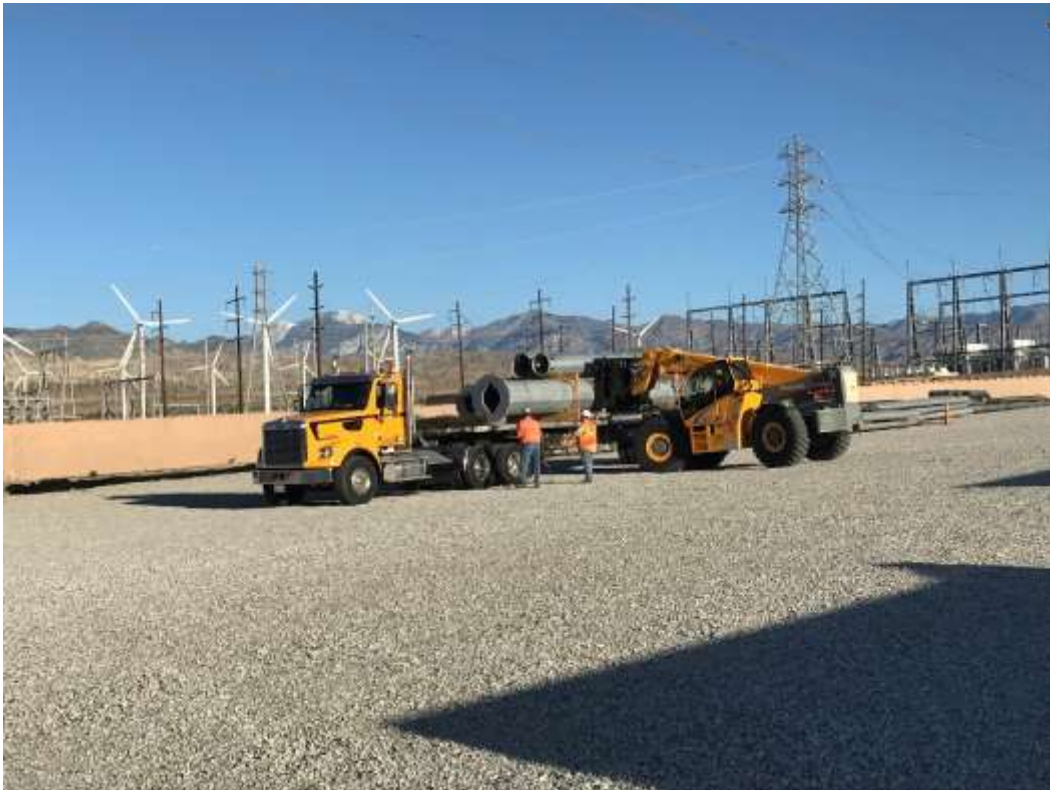
4. Work associated with the Devers MY included ongoing deliveries of construction materials (see Photo 3).
5. The Beaumont #2 MY is being utilized by CJ Drilling as their primary base of operations and material storage location. No construction activities occurred at the Beaumont #2 MY during the subject reporting period.

Photo 3 – Materials being transferred from Devers MY to Mountain View MY (March 29, 2018).

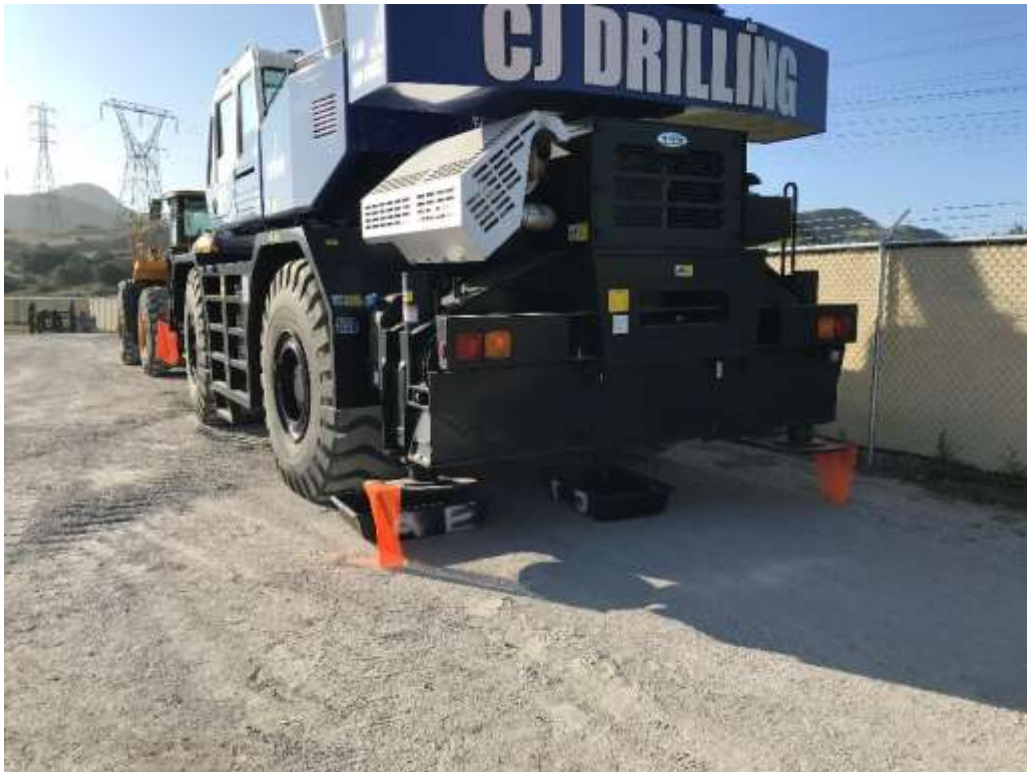
1. All construction activities associated with NTP #1 were in compliance with Project mitigation measures, permit conditions, and plan requirements throughout the monitoring period (see Photo 4).
2. There were no SWPPP maintenance items associated with NTP #1 recorded during the monitoring period. To date, there are no open SWPPP maintenance items associated with NTP #1.
3. No new nests associated with NTP #1 were reported during the monitoring period. To date, there are no active nests within work areas associated with NTP #1. In the event nests are established, nest buffers for non-special-status bird species will be implemented by SCE per the requirements of the Project Nesting Bird Management Plan (NBMP).

Photo 4 – Proper secondary containment observed at Poultry MY (April 5, 2018).

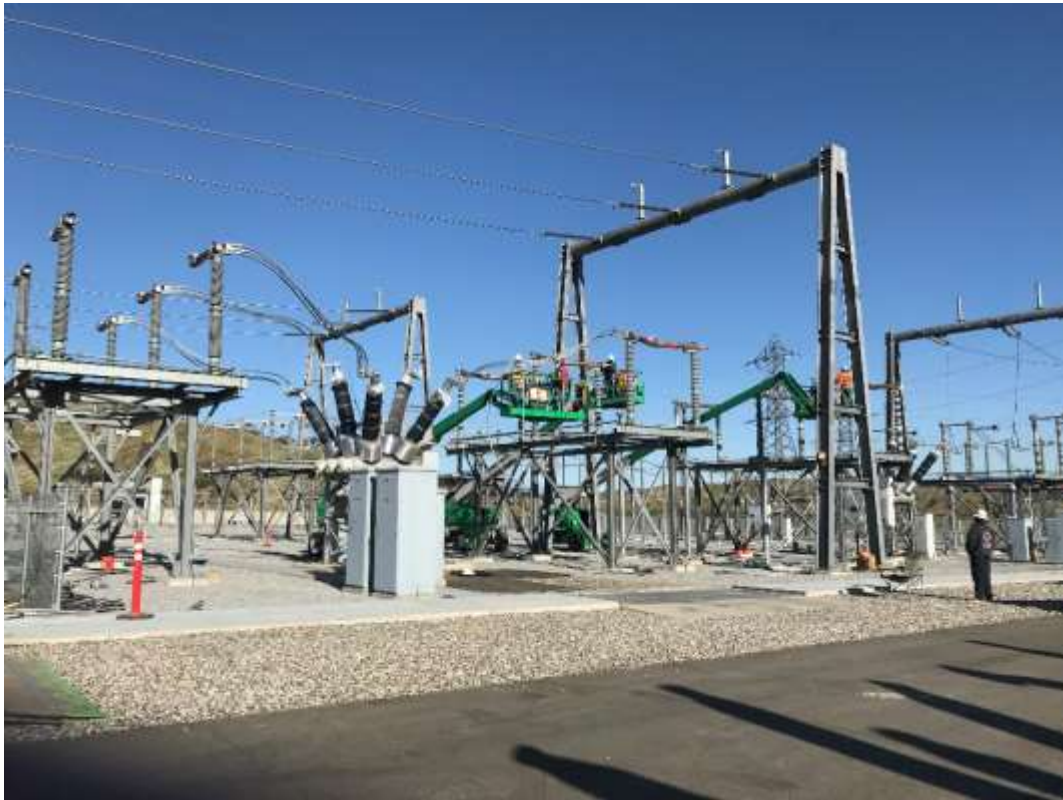
1. For the current substation construction activities, site supervision is being provided by Circle Wood Services and bus position replacement, reconductoring, and CCVT installation is being conducted by TTR Substations.
2. Work associated with the El Casco Substation upgrades included demolishing jumpers and installation of new breakers at bus positions #1 and #7 (see Photo 5).

Photo 5 – Crews working at bus position #7 at El Casco Substation (March 27, 2018).

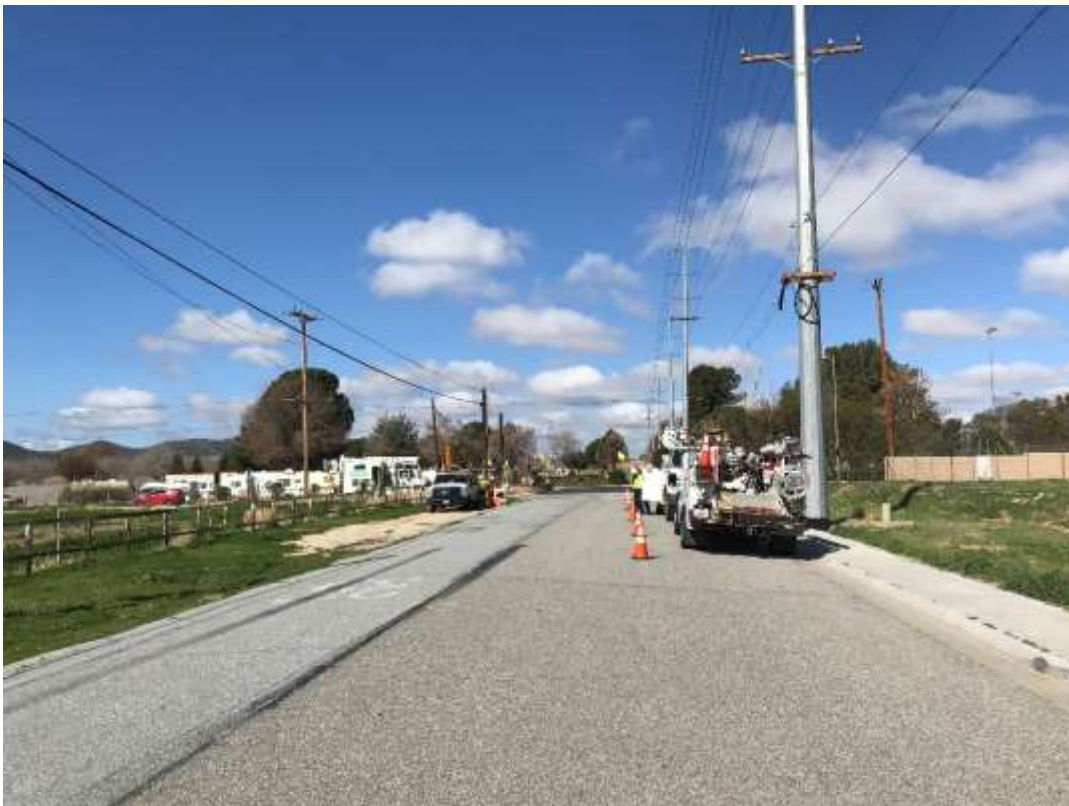
5. Work associated with the Banning Connection telecom improvements included installing and splicing fiber along Wesley Street and San Gorgonio Avenue (see Photo 6).

Photo 6 – SCE crew splicing fiber along Wesley Avenue (March 26, 2018).

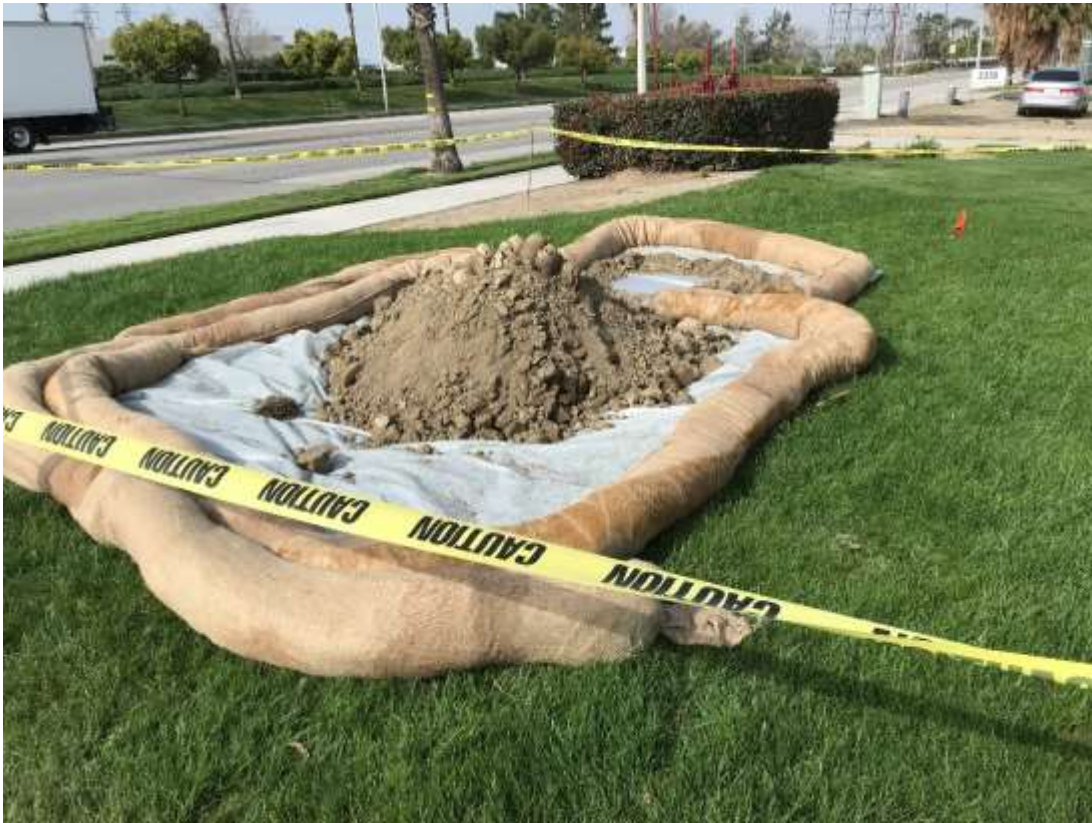
1. All construction activities associated with NTP #3 were in compliance with Project mitigation measures, permit conditions, and plan requirements throughout the monitoring period (see Photo 7).

Photo 7 – Lightweight TSP foundation hole properly covered along San Bernardino Avenue (April 6, 2018).
