PROJECT MEMORANDUM
SCE WEST OF DEVERS (WOD) UPGRADE PROJECT

To: Billie Blanchard, Project Manager, CPUC
From: Vida Strong, Aspen Project Manager
Date: April 26, 2018
Subject: Monitoring Report #14: April 9 to 22, 2018

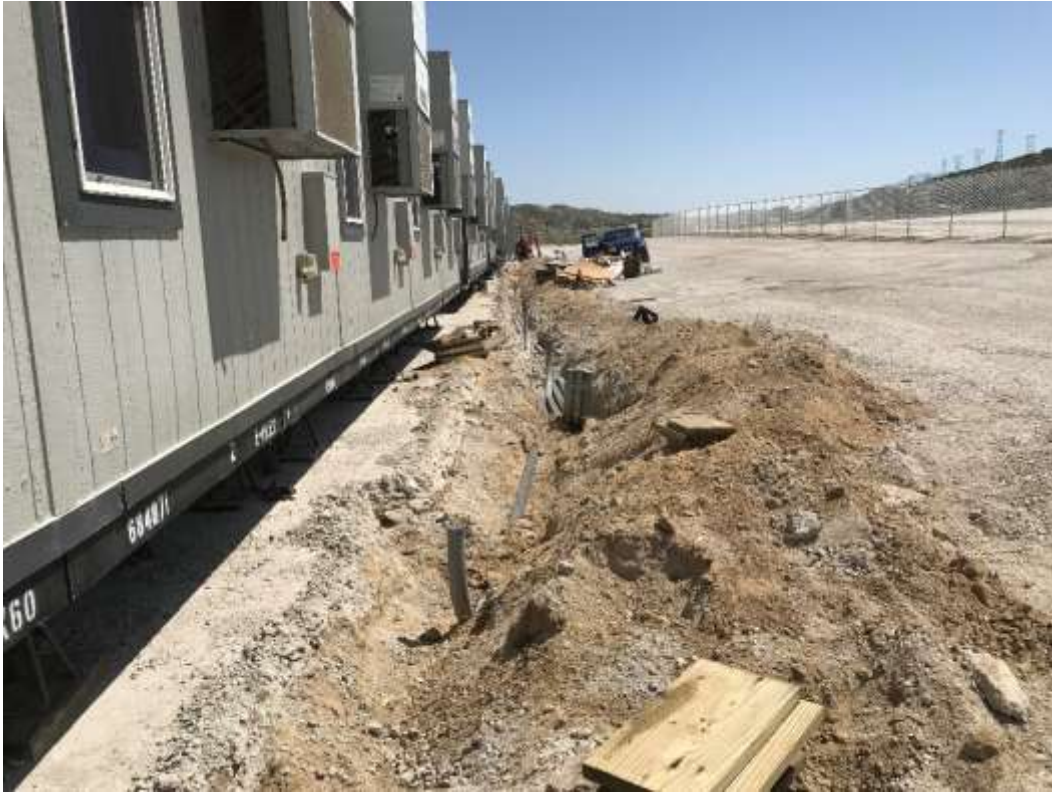
Photo 1 – Installing conduit for telecommunication fiber at the Poultry MY (April 9, 2018).

3. The Poultry MY is being utilized by Barnard Construction as their primary base of operations and material storage location. Work associated with the Poultry MY included installation of the chain link gate, installation of temporary distribution power and telecommunication fiber, and construction of office trailers (see Photo 1). Material/equipment deliveries and general yard maintenance were also conducted throughout the monitoring period.

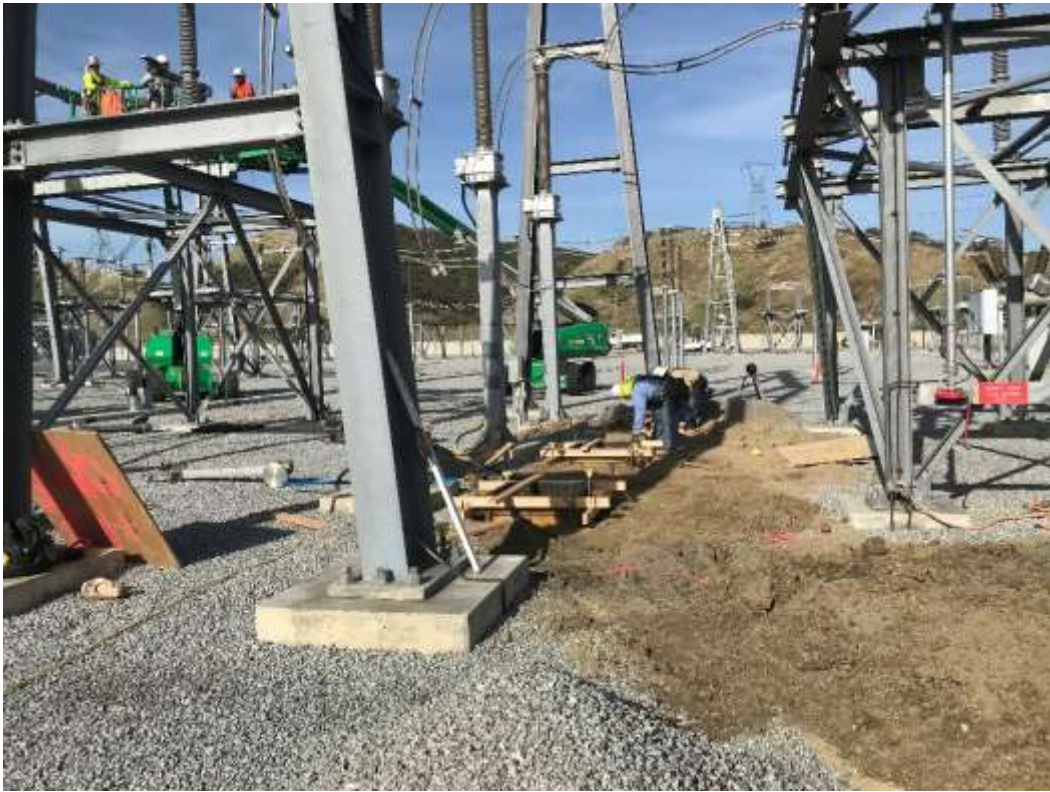
1. For the current substation construction activities, site supervision is being provided by Circle Wood Services and bus position replacement, reconductoring, and CCVT installation is being conducted by TTR Substations.
2. Work associated with the El Casco Substation upgrades included demolishing jumpers and installation of new breakers at bus positions #1 and #7 (see Photo 3).

Photo 3 – Framing for new foundations at Position #7 at El Casco Substation (April 10, 2018).

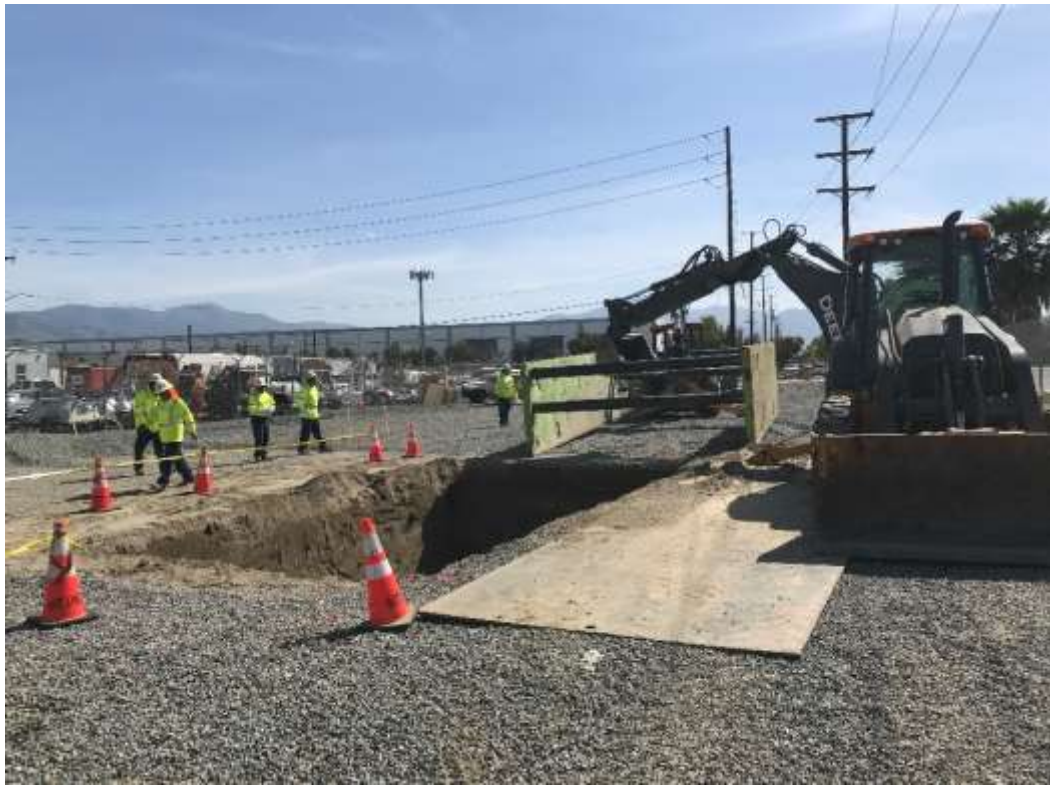
2. Work associated with the Timoteo Relocation subtransmission improvements included potholing for existing utilities, excavation and installation of underground vaults, conduit, and lightweight tubular steel poles (LWTSPs), and excavation for tubular steel poles (TSPs) (see Photo 4).

Photo 4 – Excavation complete for vault installation associated with the Timoteo Relocation (April 10, 2018).

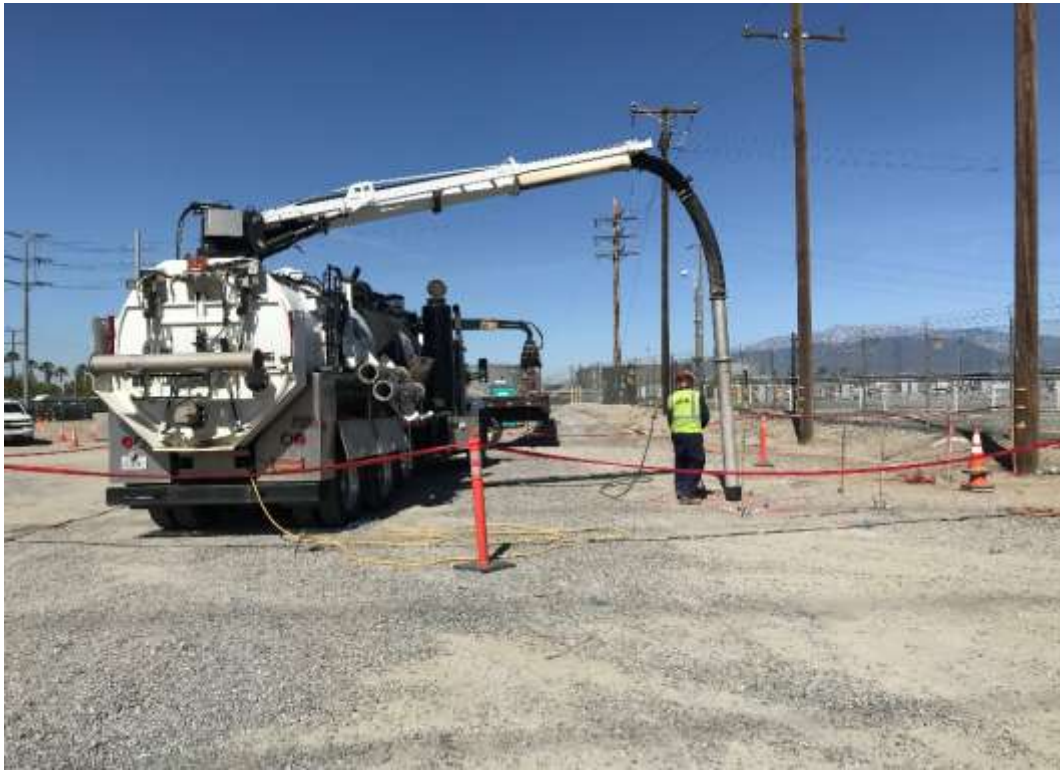
3. Work associated with the Tennessee Relocation subtransmission improvements included, potholing for existing utilities, excavation and installation of underground vaults, conduit, and LWTSPs, and excavation for TSPs (see Photos 5 and 6).

Photo 5 – Potholing for utilities ahead of TSP excavation associated with Tennessee Relocation (April 18, 2018).

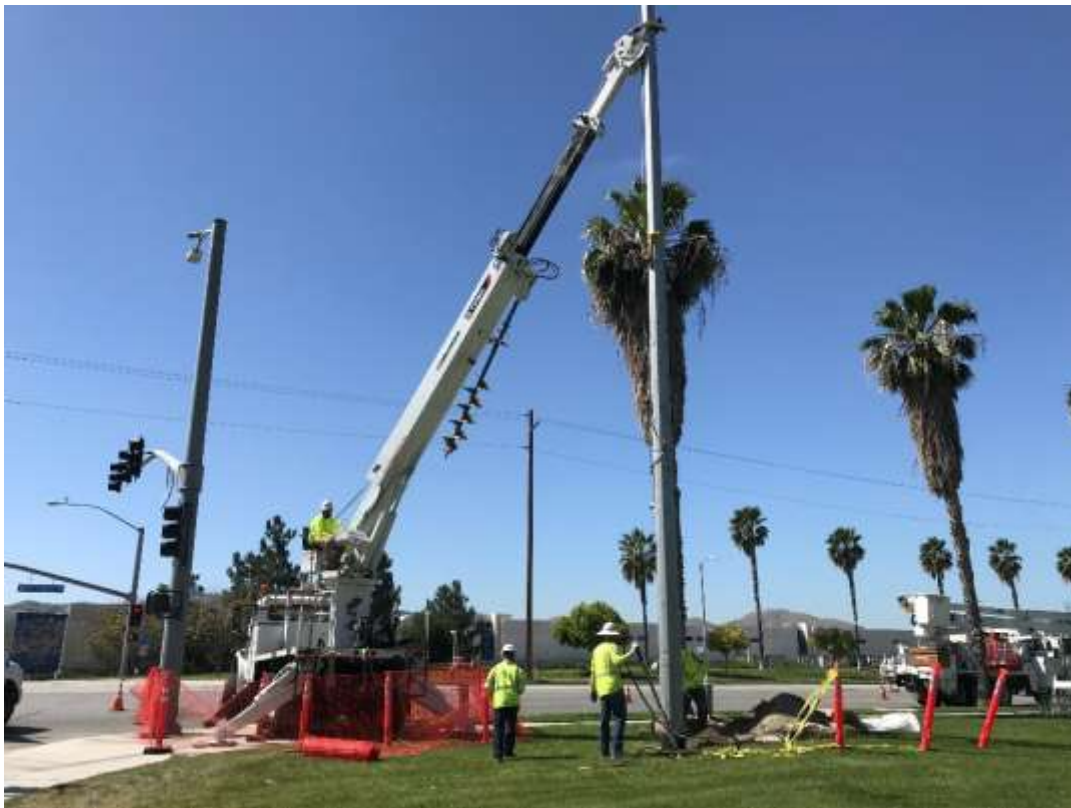
Photo 6 – Installing LWTSP associated with the Tennessee Relocation along San Bernardino Avenue (April 18, 2018).

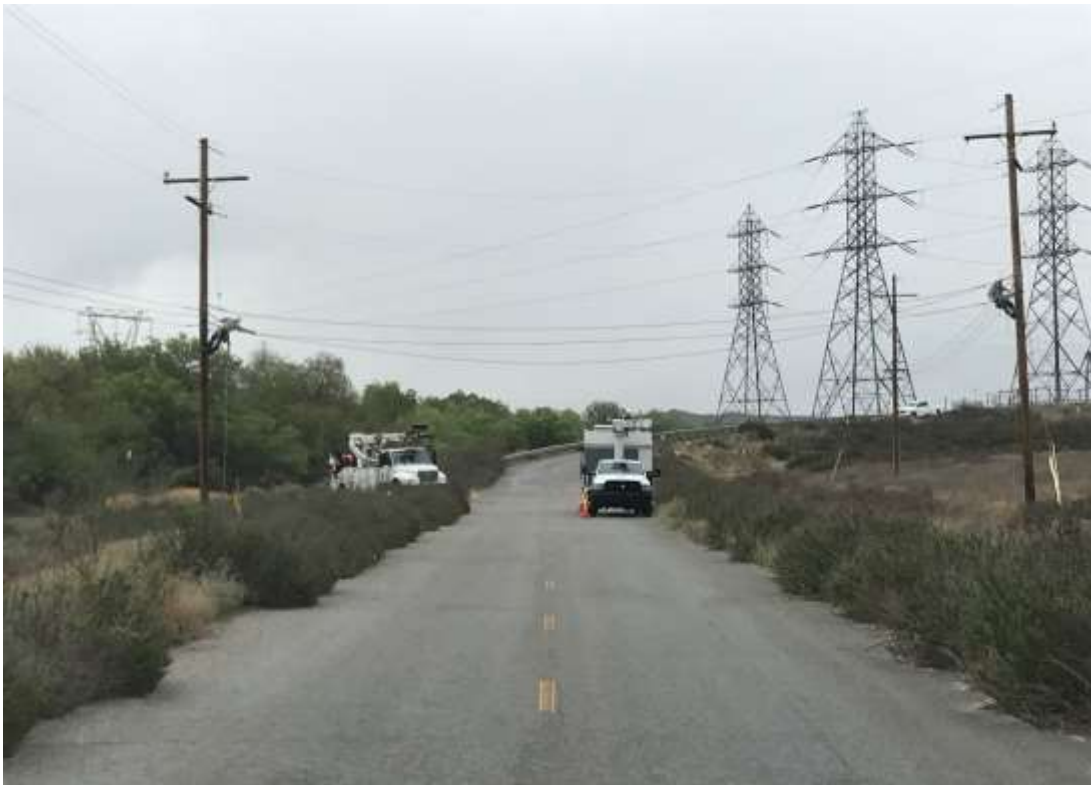
4. Work associated with the Maraschino Connection telecom improvements have been completed.
5. Work associated with the El Casco Connection telecom improvements included framing of wooden poles and installation of fiber along the El Casco Substation access road (see Photo 7).

Photo 7 – SCE crews installing fiber along the access road to El Casco Substation (April 19, 2018).

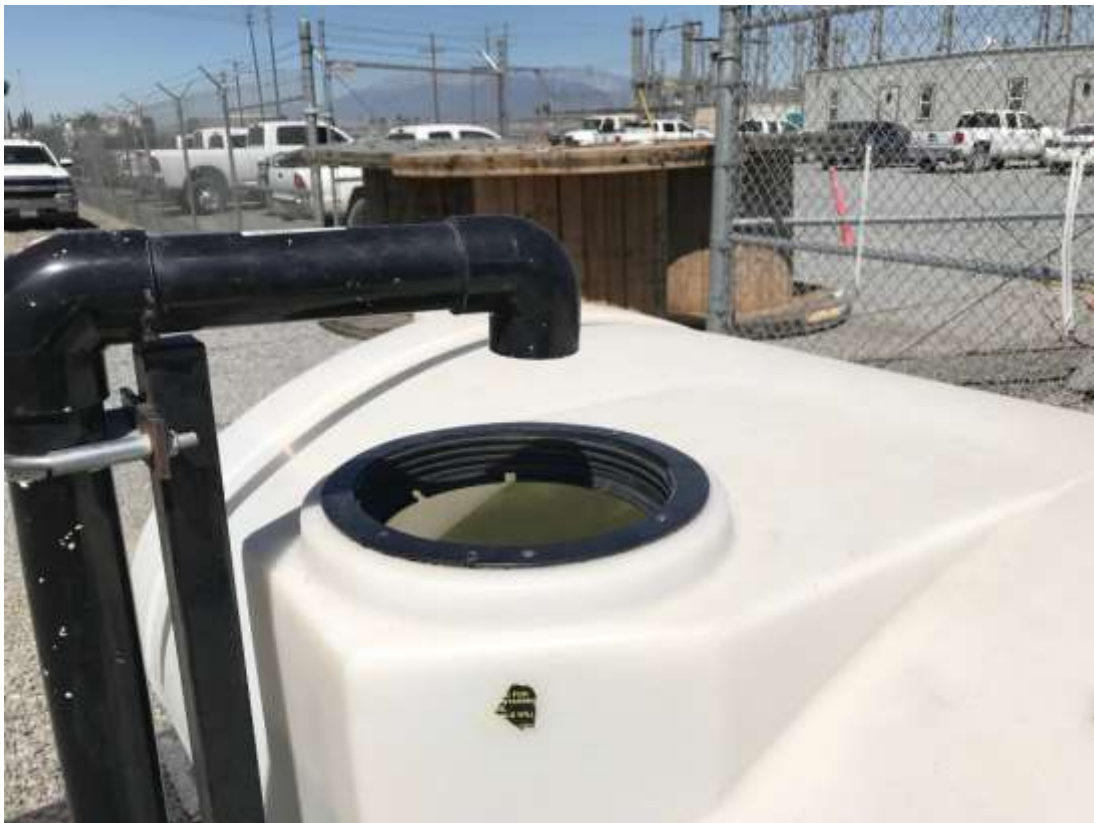
1. On April 16, the CPUC Lead Monitor observed an uncovered portable water tank associated with subtransmission improvements (see Photo 8). The CPUC EM notified the SCE EI regarding this issue, Mitigation Measure WIL-1b requires that water tanks be covered to prevent animal entrapment. The uncovered tank continued to be brought to the jobsite, so on Thursday April 19, a Level 1 Incident Report was provided to SCE documenting the issue. Upon receiving the incident report, construction personnel removed the equipment from the project alignment.
2. On April 19, the CPUC EMs checked on the Telecom work that was occurring along the driveway to the El Casco Substation. A biological monitor was present during the work. Because this area has had recent observations of least Bell's vireo, State and federally endangered species, and the area is

Incident/ PM/NCR	Regulatory Requirement	Date Issued	Phase	Description
Level 1 Incident	Traffic Control Plan	01-30-18	Banning Connection	Traffic control was set up in such a way that diverted flow into active work area and deviated from approved Traffic Control Plan.
Level 1 Incident	MM WIL-1b	04-19-18	Timoteo/ Tennessee Relocation	A portable water tank was observed uncovered for four consecutive days.

Photo 8 – Portable water tank observed uncovered (April 17, 2018).
