PROJECT MEMORANDUM
SCE WEST OF DEVERS (WOD) UPGRADE PROJECT

To: Billie Blanchard, Project Manager, CPUC
From: Vida Strong, Aspen Project Manager
Date: July 18, 2018
Subject: Monitoring Report #24: July 9 to 15, 2018

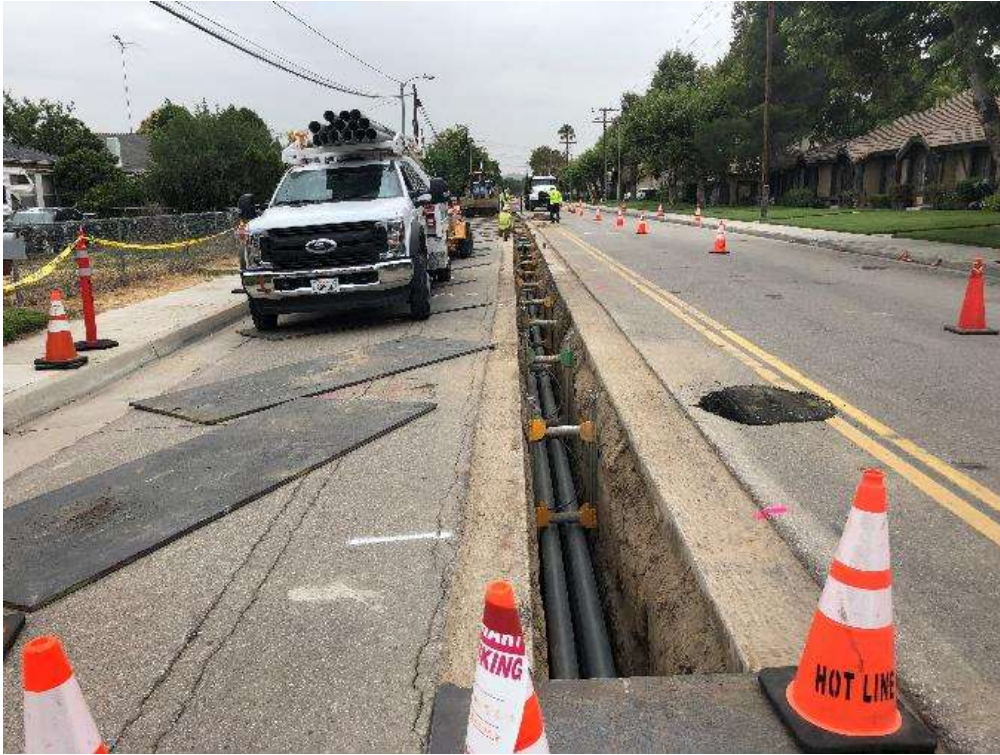
Photo 1 – Installing underground distribution conduit along Mission Road (July 10, 2018).

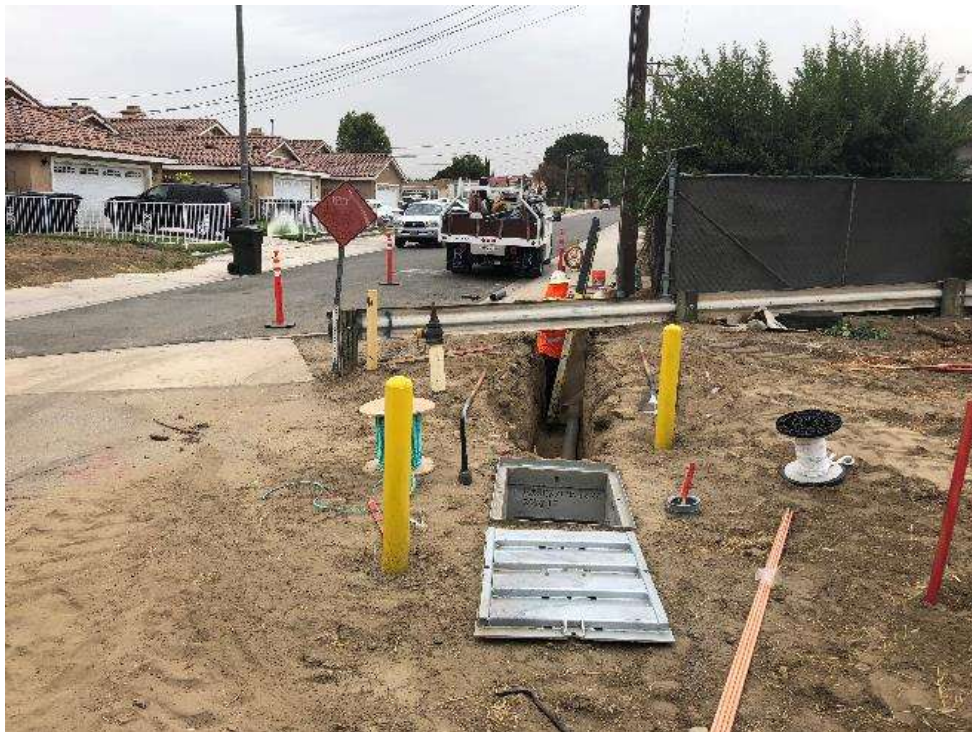
1. For the currently approved subtransmission and distribution components, major construction activities are being performed primarily by Hot Line Construction with support from CJ Drilling, Barnard Construction, Mowbray Tree Services, and SCE crews.
2. Distribution work associated with the Dental and Intern Circuits included trenching, installation of underground conduit, and repairing and patching of asphalt along Mission Road in the City of Loma Linda (see Photo 1).
3. Distribution work associated with the Juanita Reconductor included trenching, installing underground conduit, and replacing wooden poles and conductor wire along Juanita Street in the City of Loma Linda (see Photo 2).

Photo 2 – Working in trench next to riser pole for Juanita Reconstructor distribution (July 10, 2018).

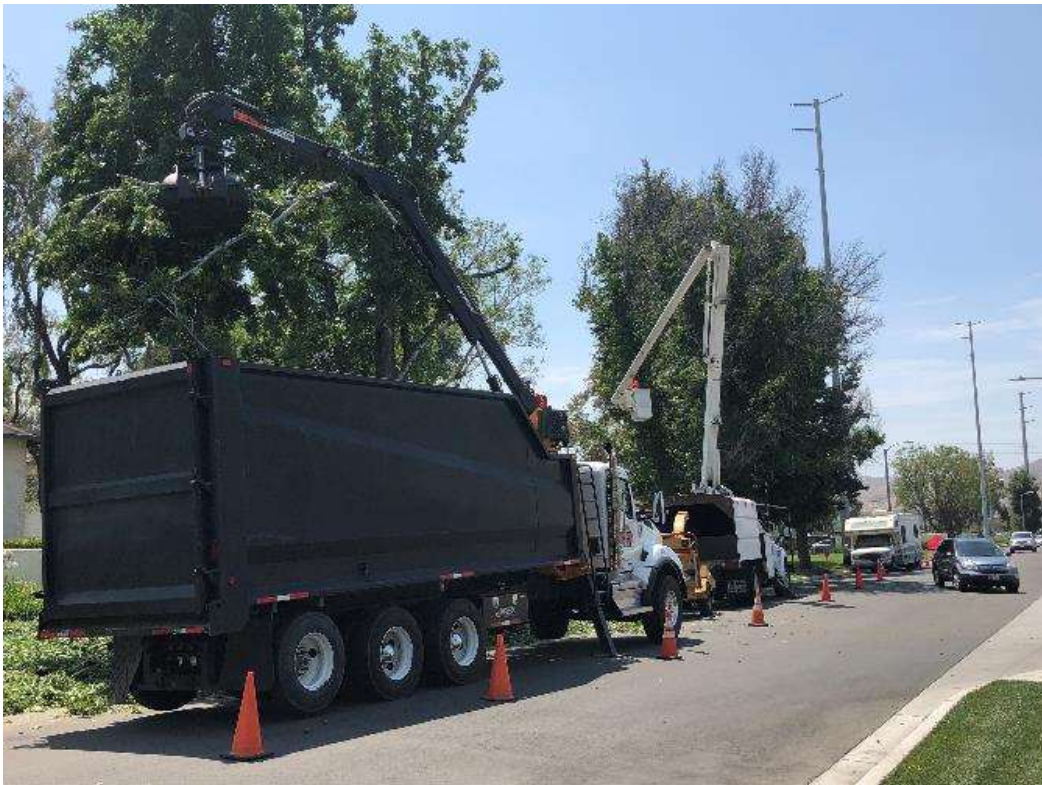
4. Work associated with the Timoteo Relocation subtransmission improvements included potholing for existing utilities, tree trimming, erecting lightweight tubular steel poles (LWTSPs), trenching for underground alignment, installation of underground conduit and conductor wire, and repairing and patching road asphalt (see Photos 3 and 4).

Photo 3 – Tree trimming along Bryn Mawr Avenue for the Timoteo Relocation subtransmission work (July 12, 2018).

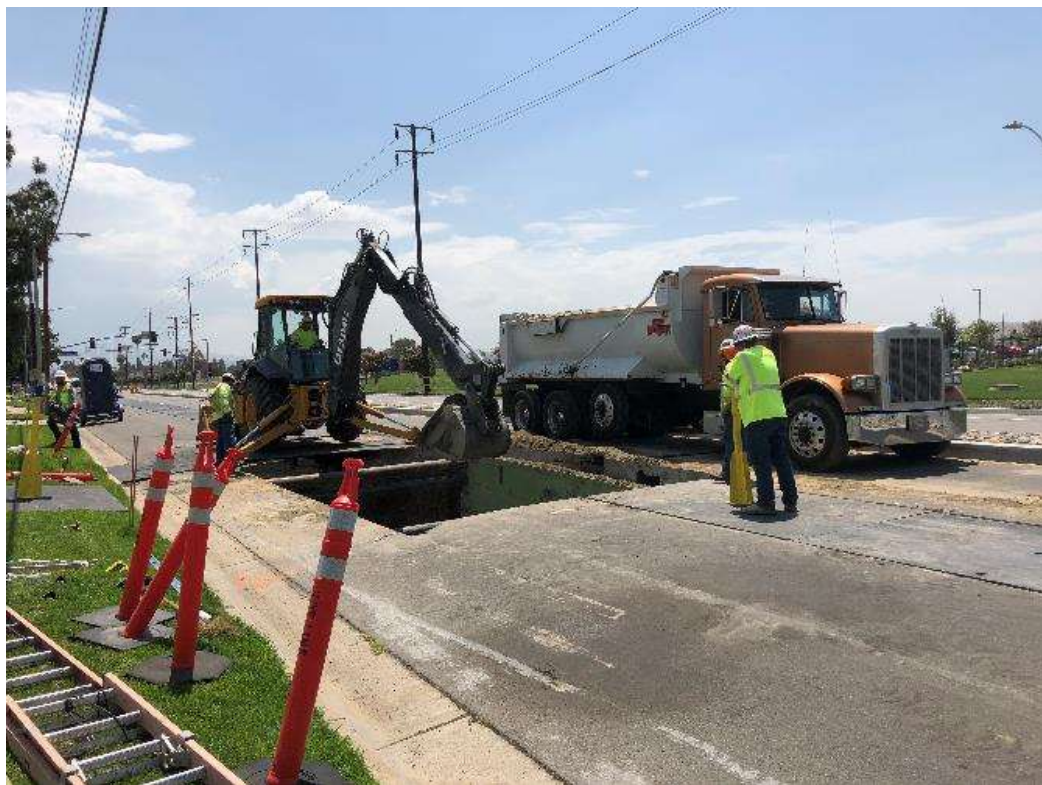
Photo 4 – Excavation of new vault location along Redlands Boulevard for the Timoteo Relocation subtransmission work (July 12, 2018).

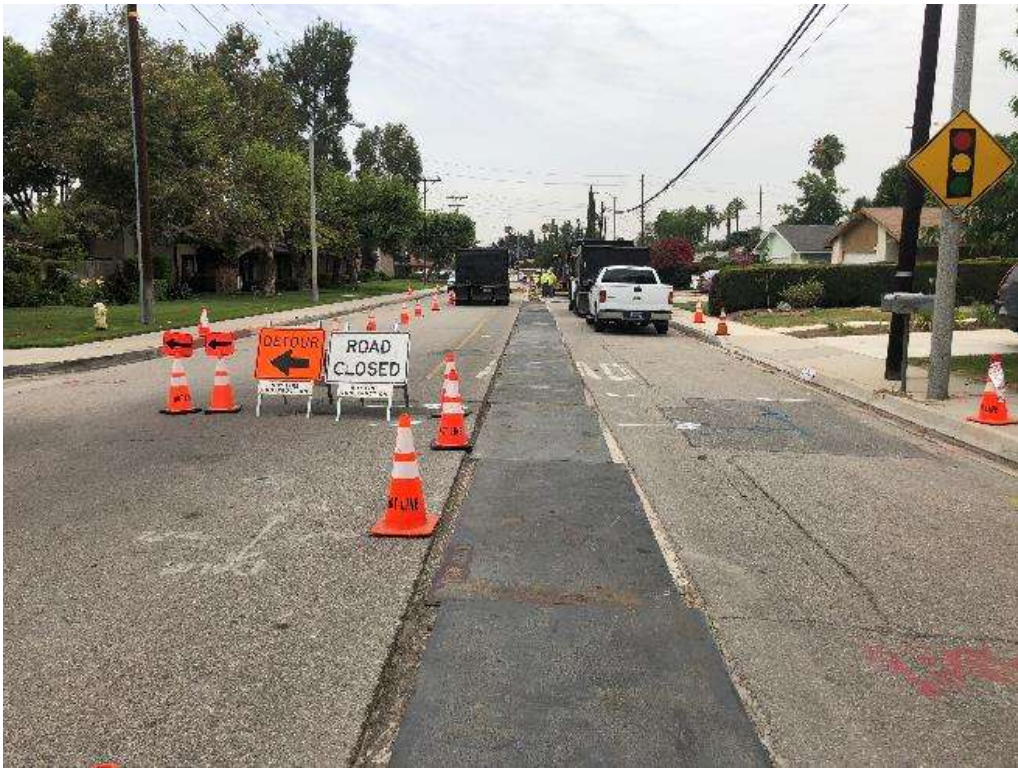
1. On July 10, the CPUC EM expressed concerns regarding inadequate traffic control during trenching activities associated with the Dental and Intern Circuits distribution work along Mission Road. Along a portion of the work area, eastbound traffic was restricted to one lane as westbound traffic was diverted through a detour on nearby side streets (see Photo 5). However, the CPUC EM observed four westbound vehicles travel into the one-way lane for eastbound traffic within a span of less than five minutes. The CPUC EM immediately notified Barnard management and the issue was immediately resolved by installing additional signage and flaggers along the route.

Photo 5 – Ineffective traffic control established along Mission Road for the Dental and Intern Circuits distribution work (July 10, 2018).

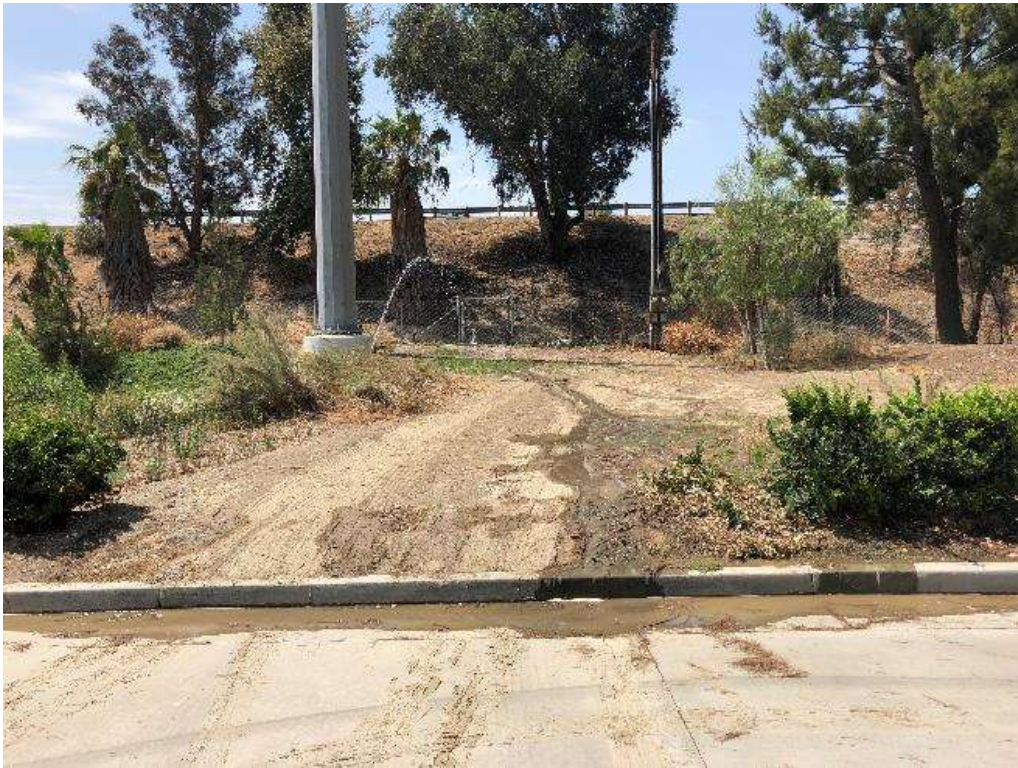
3. On July 12, the CPUC EM observed a broken sprinkler head associated with an irrigation line immediately adjacent to the new tubular steel pole installed at the intersection of Bryn Mawr Avenue and Interstate 10. Consequently, water flow from the broken sprinkler head was causing non-Project sedimentation to flow along a gutter and into a storm drain inlet immediately adjacent to the Project work area (see Photo 6). Although Project personnel were not responsible for the broken equipment or offsite sedimentation, Hot Line crews arrived onsite and repaired the broken sprinkler head and additional BMPs were installed.

Photo 6 – Broken sprinkler head resulting in minor offsite sedimentation at Bryn Mawr Avenue and Interstate 10 (July 12, 2018).

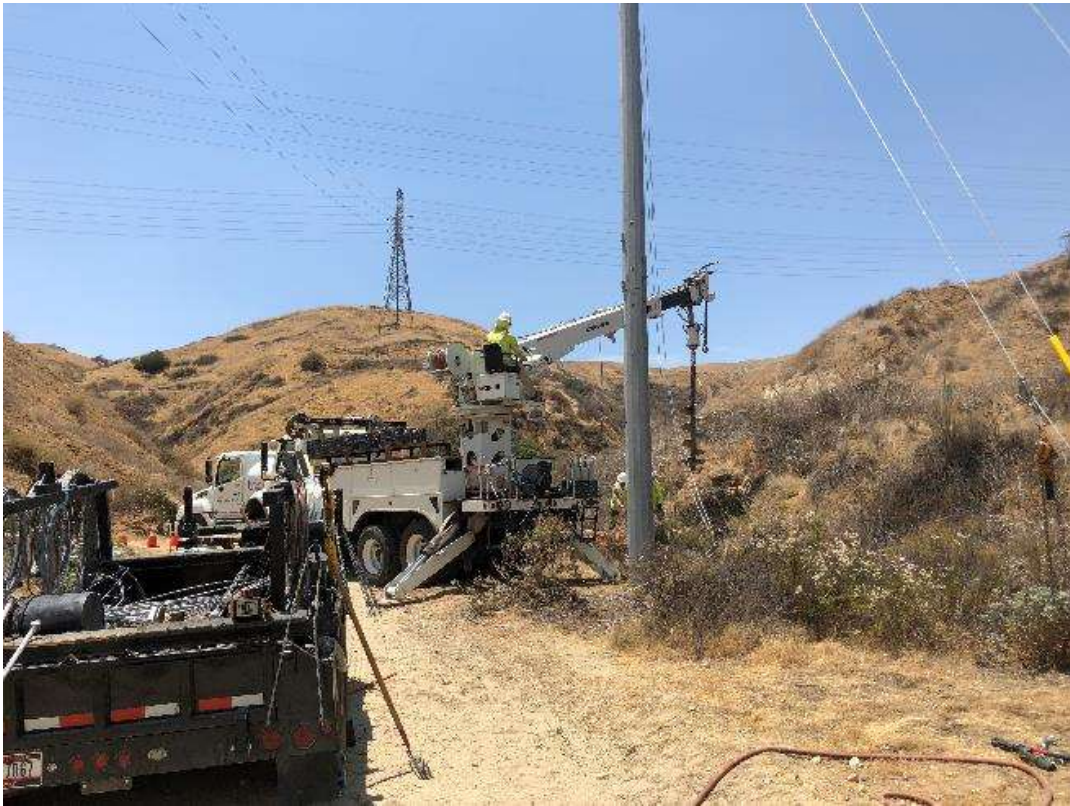
Photo 7 – Installation of one new LWTSP along transmission Segment 2 (July 12, 2018).

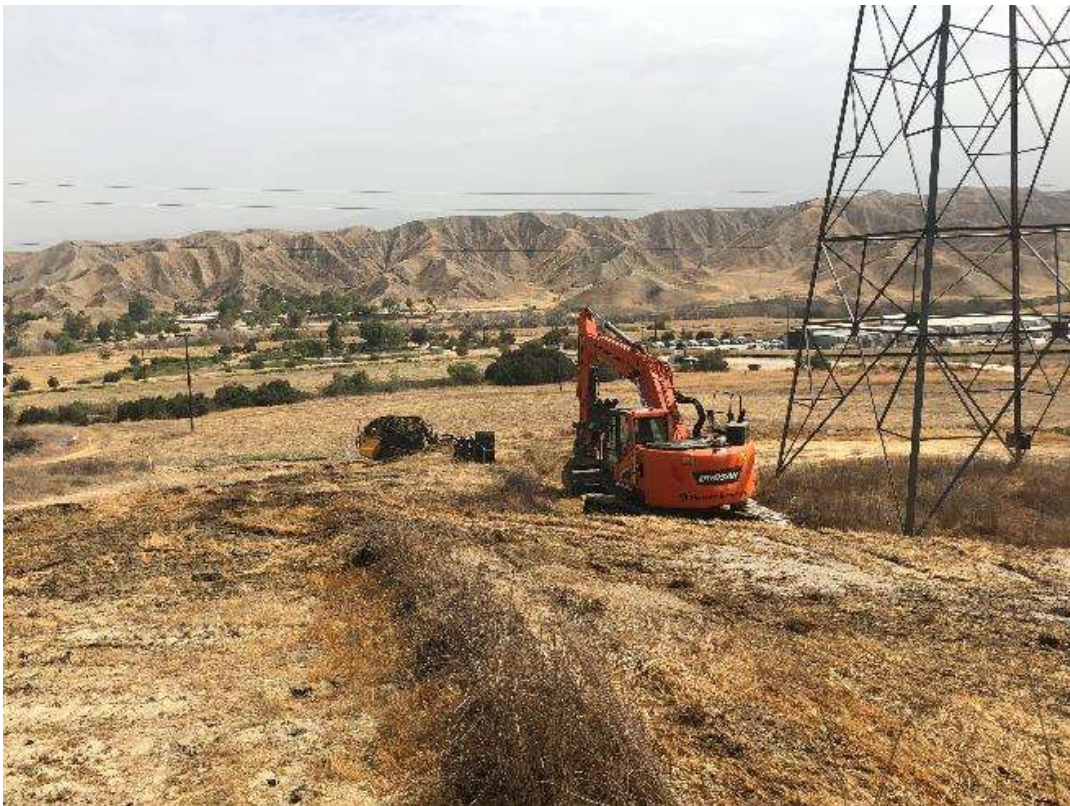
Photo 8 – Grading activities occurring at Tower Site 3X29, transmission Segment 3 (July 10, 2018).
