PROJECT MEMORANDUM
SCE WEST OF DEVERS (WOD) UPGRADE PROJECT

To: Billie Blanchard, Project Manager, CPUC
From: Vida Strong, Aspen Project Manager
Date: August 9, 2018
Subject: Monitoring Report #27: July 30 to August 5, 2018

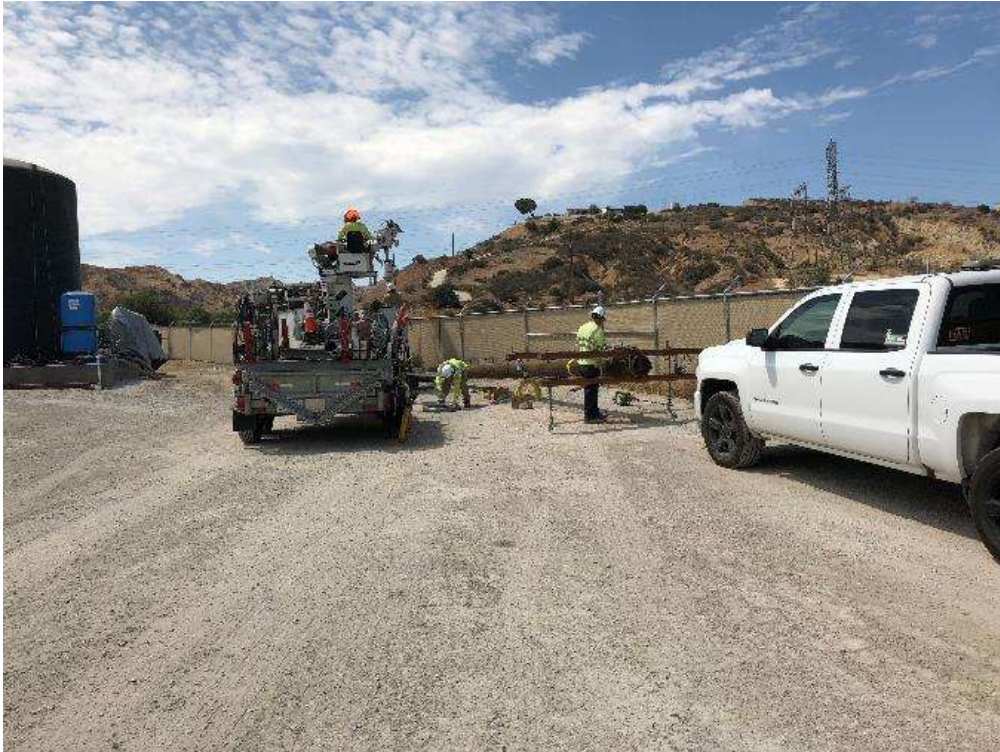
Photo 1 – Installation of wooden distribution pole at Poultry MY (July 31, 2018).

2. The Poultry MY is being utilized by Barnard Construction and Power Grade Incorporated as their primary base of operations and material/equipment storage location. Work associated with the Poultry MY included installation of a wooden power pole and associated hardware leading to office trailers, materials/equipment deliveries, and general yard maintenance throughout the monitoring period (see Photo 1).

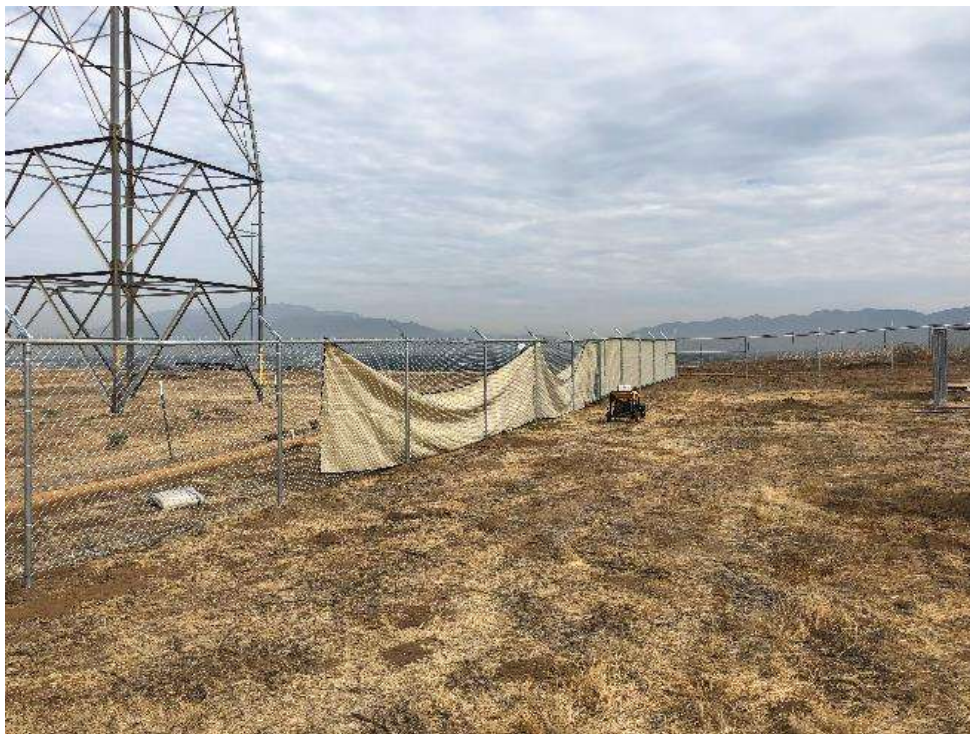
Photo 2 – Cold Smoke Fencing crew installing privacy screening at Grand Terrace MY (July 30, 2018).

6. The Grand Terrace MY is being used primarily as a show-up location for project construction crews. Work associated with the Grand Terrace MY during the reporting period included the installation of chain link perimeter fencing and privacy screening (see Photo 2).

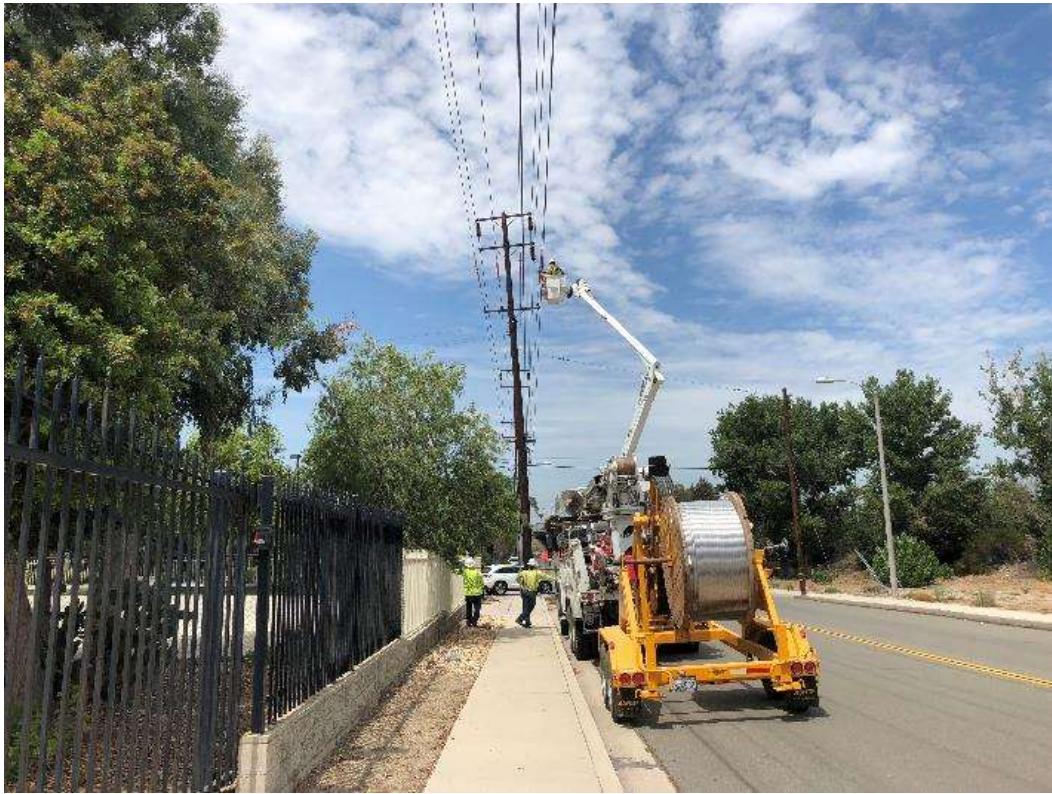
Photo 3 – Replacing conductor along Mayberry Street for Juanita Reconductor (July 30, 2018).

3. Work associated with the Juanita Reconductor included replacing conductor wire along Mayberry Street in the City of Loma Linda (see Photo 3).
4. Work associated with the Timoteo Relocation subtransmission improvements included trenching for underground alignment, installation of underground conduit and conductor wire, installation of overhead conductor wire, repairing curbs and gutters, and general clean-up (see Photo 4).

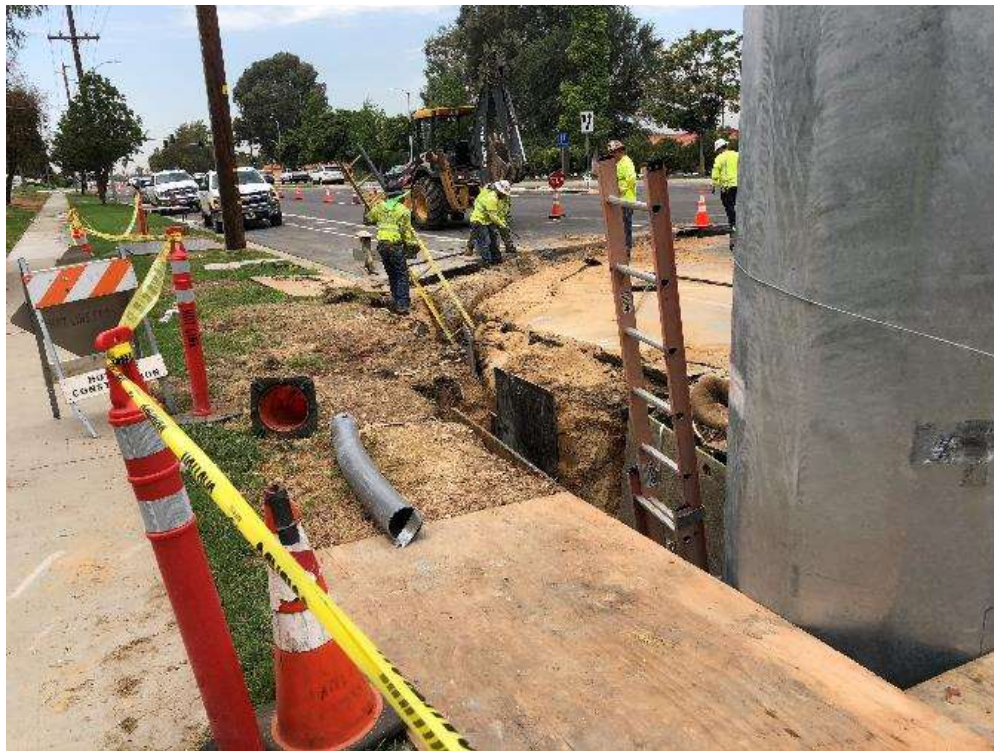
Photo 4 – Underground work being performed at Iowa Street and Barton Road along Tennessee Relocation (July 31, 2018).

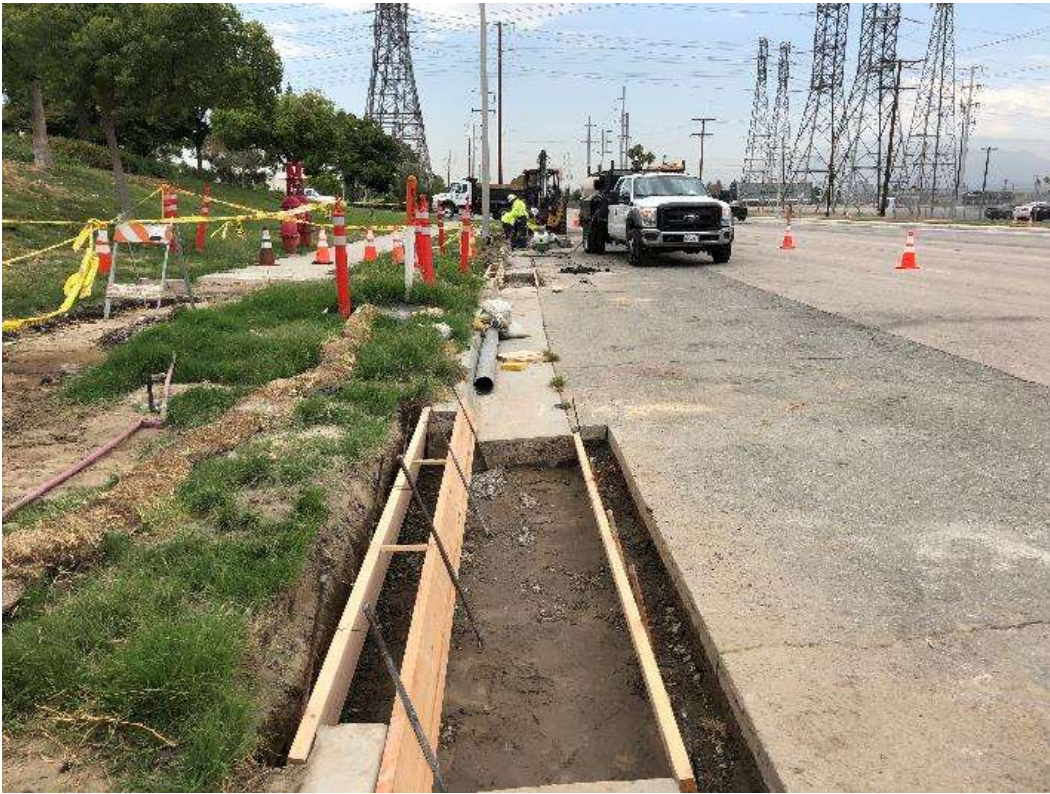
Photo 5 – Curb and gutter repairs along San Bernardino Avenue for Timoteo Relocation (July 31, 2018).

5. Work associated with the Tennessee Relocation subtransmission improvements included trenching for underground alignment, installation of underground conductor wire, repairing curbs and gutters, repaving roads, and general clean-up (see Photo 5).

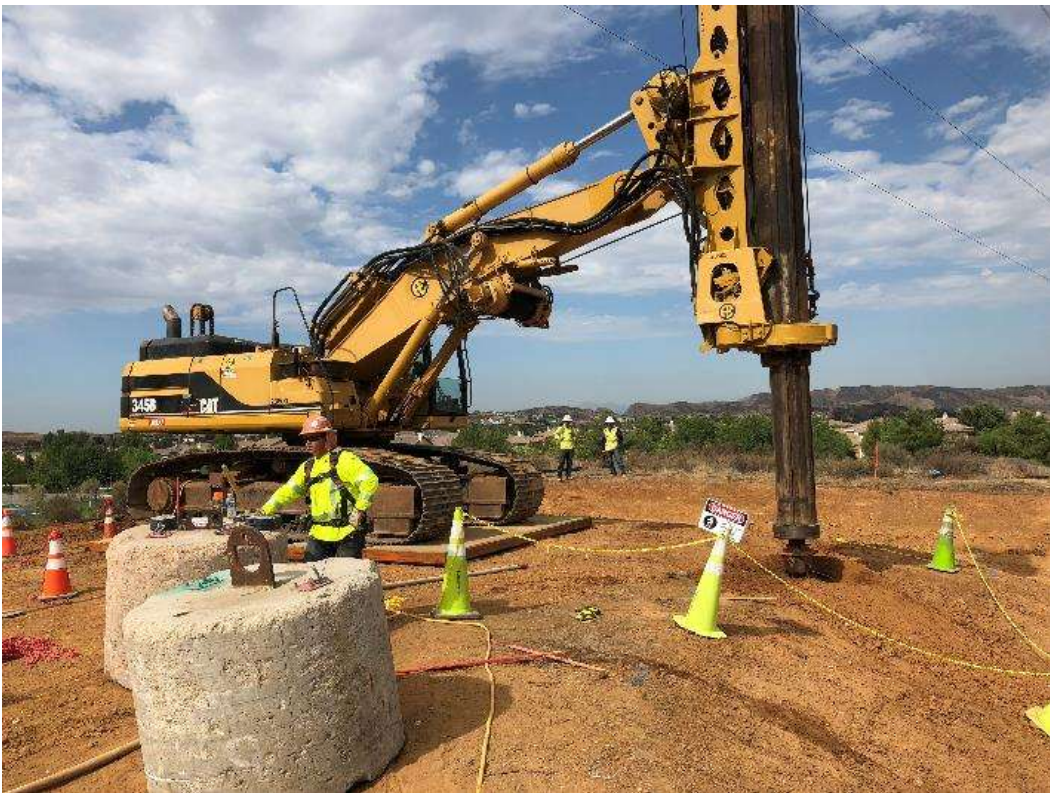
Photo 6 – Foundation drilling at Tower Site 4X48, Segment 4 transmission (July 31, 2018).

1. For the currently approved transmission components, Power Grade Incorporated is conducting access road maintenance/stabilization, BMP installation, vegetation removal, and site grading. CJ Drilling is performing foundation drilling and concrete pouring.
2. Work associated with Segment 3 included access road maintenance and installing BMPs at Tower Sites 3X19, 3X31, 3X32, 3X36, 3X37, 3X43, 3X44, 3X46, 3X51, and 3X56. Vegetation removal was conducted at Tower Site 3X13, 3X14, 3X15, and 3X19. Grading activities were conducted at Tower Sites 3X21 and 3X23.
3. Work associated with Segment 4 included installing BMPs at Tower Sites 4X47 and 4N62. Grading activities were conducted at Tower Sites 4N57 and 4N62. Foundation drilling and concrete pouring occurred at Tower Sites 4X47, 4X48, 4X51, and 4X53 (see Photo 6).

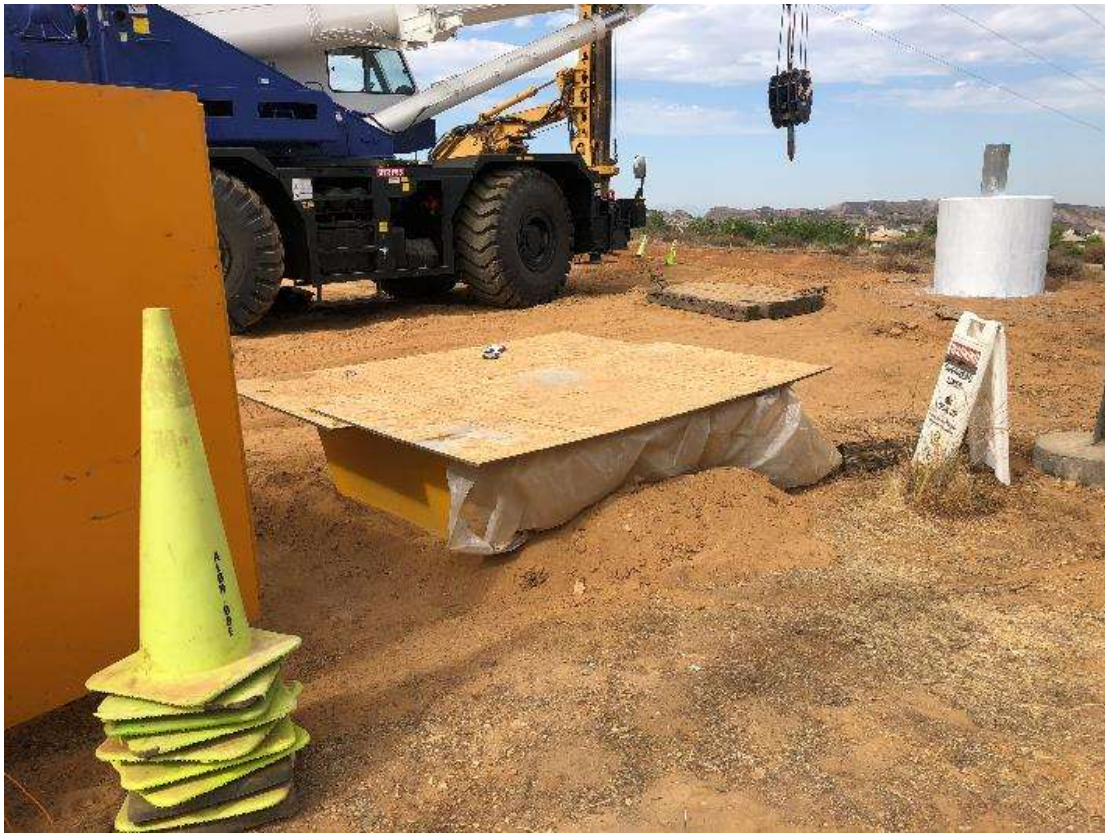
2. There were no SWPPP maintenance items and one corrective action associated with NTP #4 reported by SCE during the monitoring period. On July 31, the CPUC EM observed a concrete washout pan that was inadequately contained at Tower Site 4X48 (see Photo 7). The CPUC EM immediately notified the SCE QSP and the issue was relayed to construction crews. Proper containment was implemented the same day. To date, there are no open SWPPP maintenance items or corrective actions associated with NTP #4.

Photo 7 – Inadequate secondary containment for concrete washout pan at Tower Site 4X48, Segment 4 transmission (July 31, 2018).
