PROJECT MEMORANDUM
SCE WEST OF DEVERS UPGRADE PROJECT

Date: October 19, 2018
To: Billie Blanchard, Project Manager, CPUC
From: Vida Strong, Aspen Project Manager
Subject: Monitoring Report #36: October 8 to 14, 2018

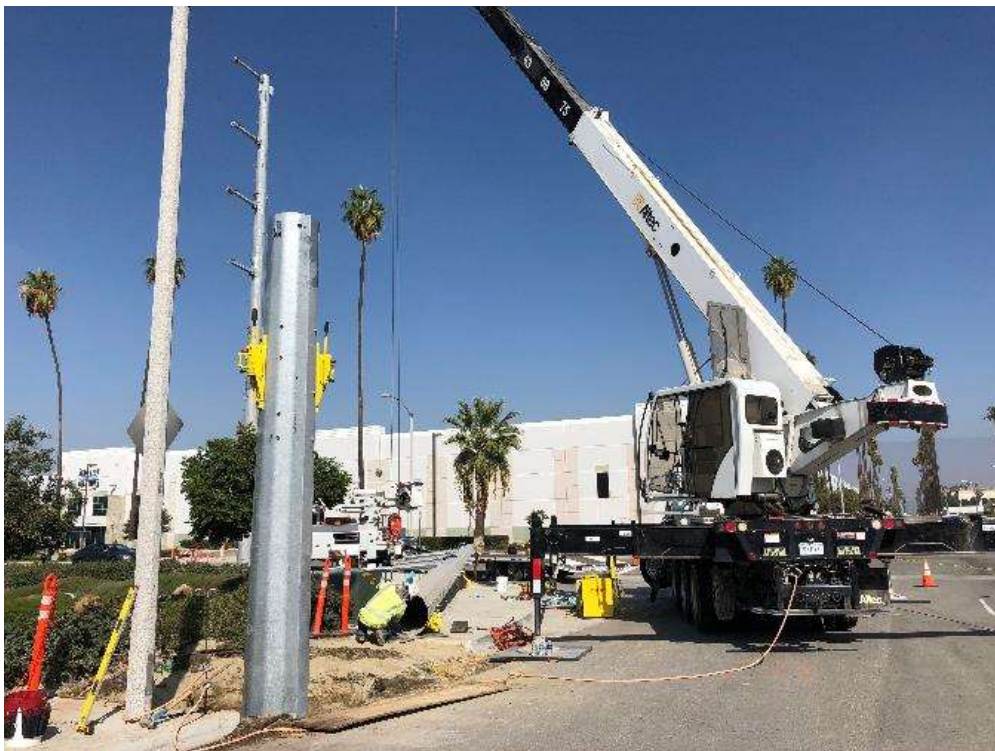
Photo 2 – Erection of LWTSP along Tennessee Relocation (October 9, 2018).

4. Work associated with the Tennessee Relocation subtransmission improvements included potholing for existing utilities, erection of lightweight tubular steel poles (LWTSPs) and tubular steel poles (TSPs), installation of overhead conductor wire, and concrete restoration (see Photo 2).

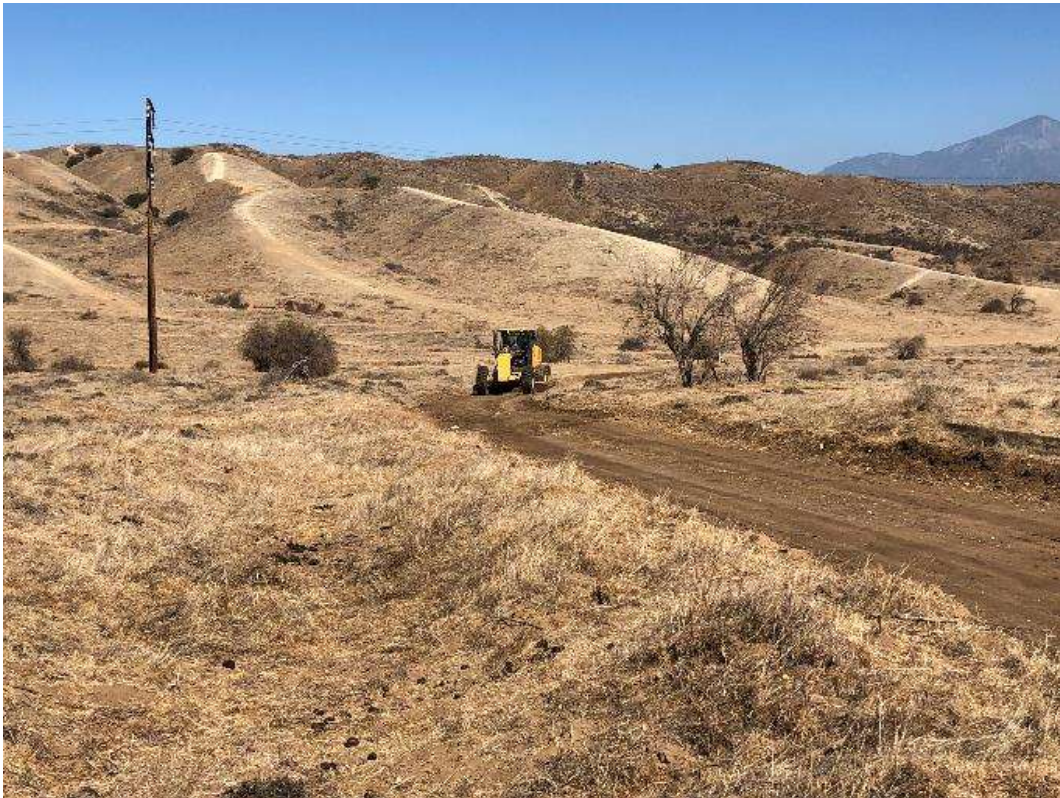
Photo 3 – Conducting road maintenance between Sites 3X50 and 3X62, Segment 3 (October 9, 2018).

4. Work associated with Segment 3 included access road maintenance between Sites 3X50 and 3X62 (see Photo 3). BMP installation occurred at Sites 3X59, 3X60, 3X61, 3X62-S, and 3X64-S. Grading activities occurred at Sites 3X46, 3X57, 3X59, 3X60, and 3X61 (see Photo 4). No access road improvements were conducted.

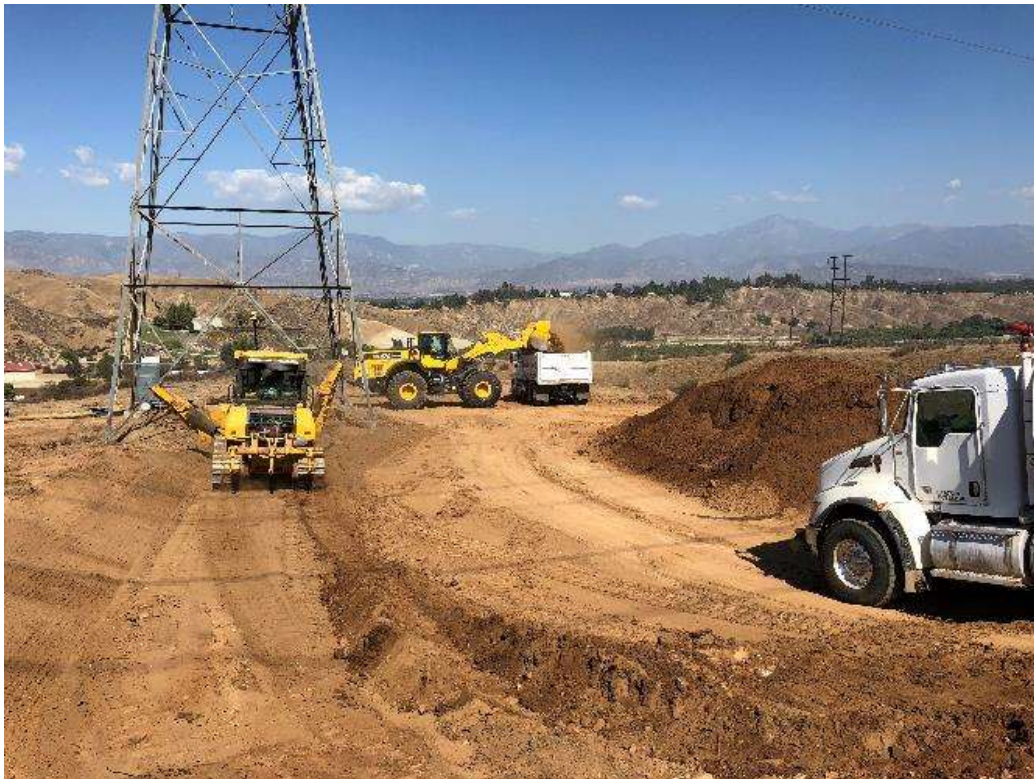
Photo 4 – Grading activities occurring at Site 3X57, Segment 3 (October 8, 2018).

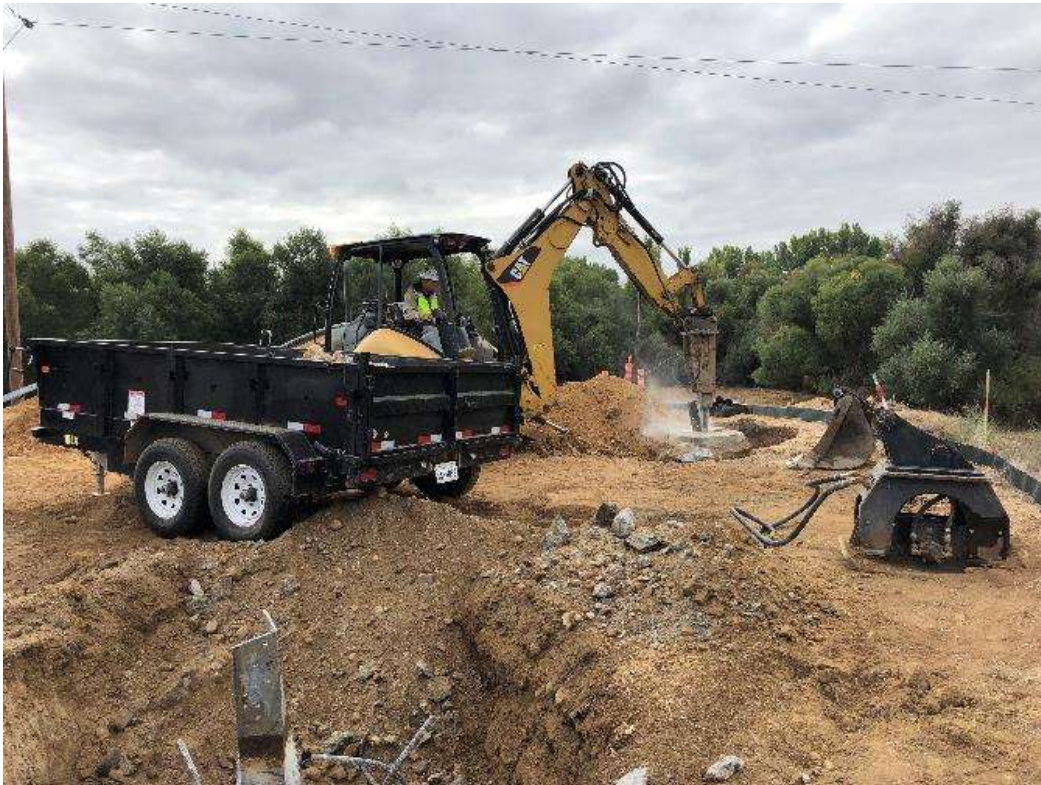
Photo 5 – CDC crew performing foundation demolition at Site 4N62, Segment 4 (October 11, 2018).

5. Work associated with Segment 4 included vegetation removal at Site WSS-4N64. Grading activities were performed at Site 4N64. Foundation drilling was conducted at Site 4S60. Concrete foundation pouring occurred at Sites 4S60 and 4N61. Tower assembly and/or erection was performed at Sites 4X54 and 4N64. Tower and foundation demolition was conducted at Sites 4N62 and 4N63 (see Photo 5). Wire stringing activities occurred between Sites 4X55 and 4N64 (see Photo 6). No access road improvements were conducted.

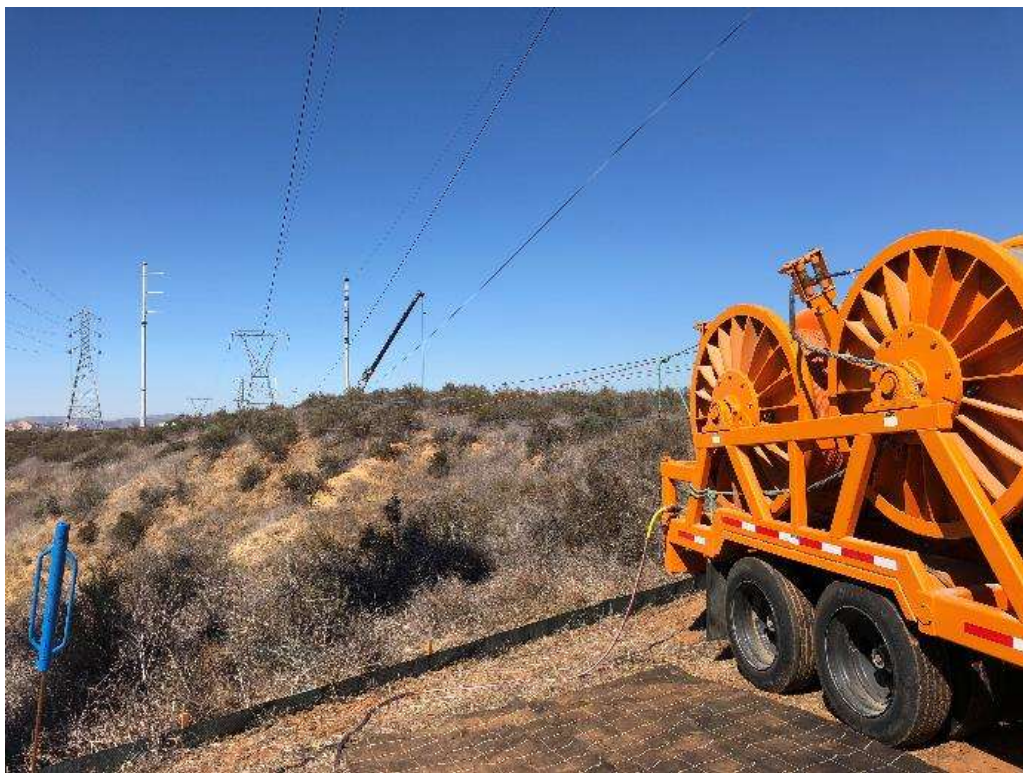
Photo 6 – Reeler set up for wire pulling activities between Sites 4X55 and 4N64, Segment 4 (October 8, 2018).

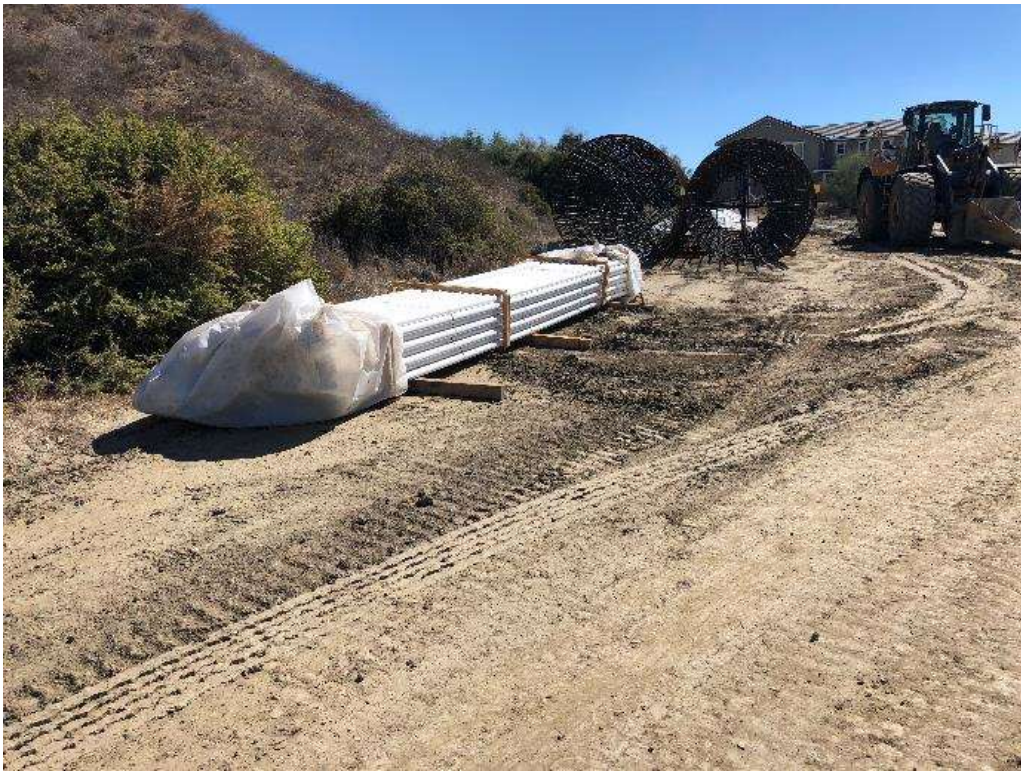
Photo 7 – Proper covering of pipes observed at Site 4S60, Segment 4 (October 8, 2018).

1. There were no SCE self-reported and no CPUC incidents documented for construction activities associated with NTP #4 throughout the monitoring period (see Photo 7).

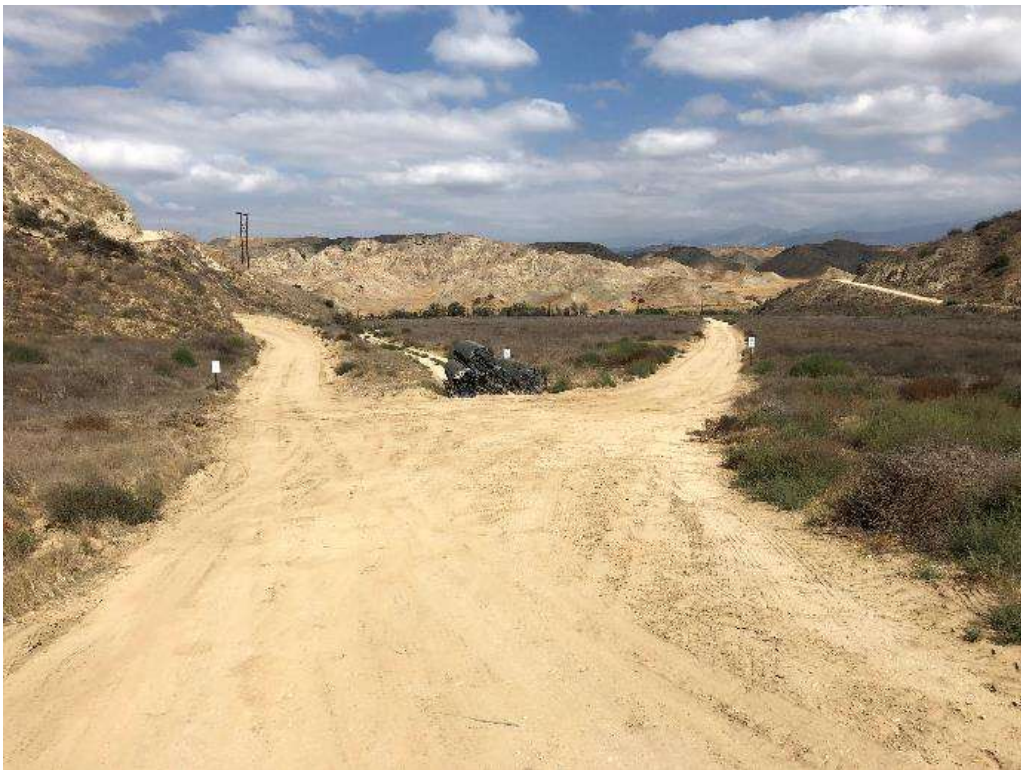
2. On October 11, the CPUC EM observed foundation cages that had been staged outside of approved disturbance limits near the access road associated with Site 3X20 (see Photo 8). The CPUC EM immediately notified the SCE Lead Field Biologist who coordinated with construction crews to relocate the material to an approved location. According to SCE, construction has since instituted a new protocol where SCE Environmental Monitors will be notified prior to staging materials outside of staked tower sites.

Photo 8 – Foundation cages staged outside approved limits near Site 3X20, Segment 3 (October 11, 2018).
