**PROJECT MEMORANDUM**  
**SCE WEST OF DEVERS UPGRADE PROJECT**

**Date:** October 26, 2018  
**To:** Billie Blanchard, Project Manager, CPUC  
**From:** Vida Strong, Aspen Project Manager  
**Subject:** Monitoring Report #37: October 15 to 21, 2018

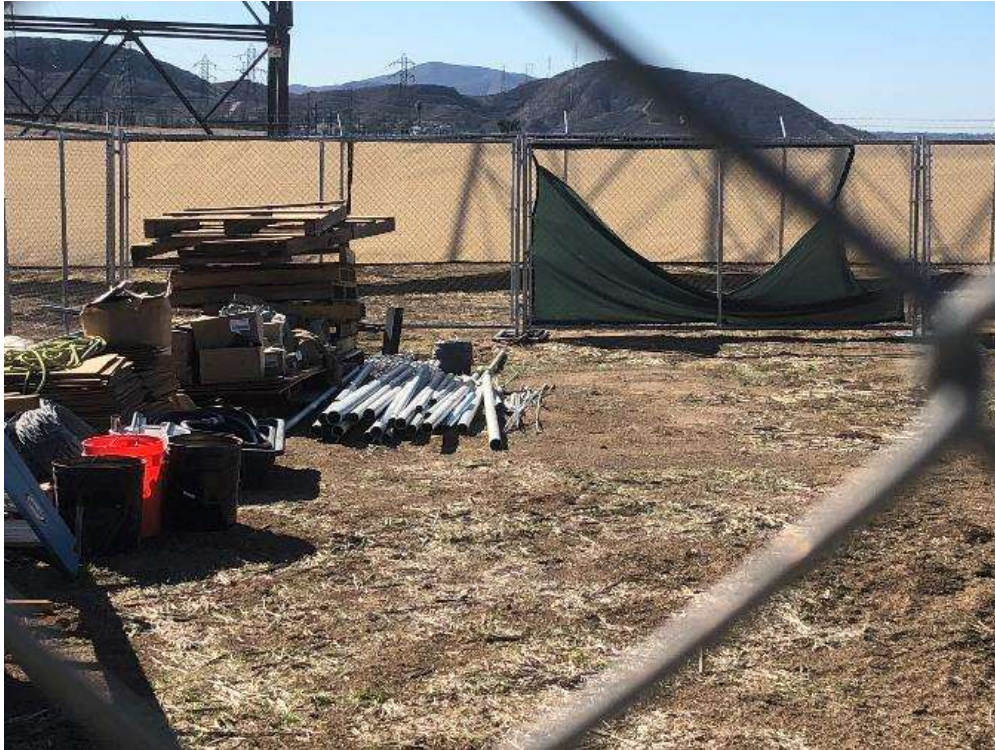
1. There was one SCE self-reported and one CPUC incident documented for construction activities associated with NTP #1 throughout the monitoring period. On October 18, the CPUC EM observed several uncovered/uncapped fence posts staged on the ground at the Grand Terrace MY and recorded the issue as a Level 1 Incident (see Photo 1). The CPUC EM immediately notified the SCE Lead Field Biologist and SCE also recorded the issue as a Level 1 Incident. SCE has since reported that the fence posts were covered and the incident was discussed with construction.

Photo 1 – Fence posts without adequate covering at the Grand Terrace MY (October 18, 2018).

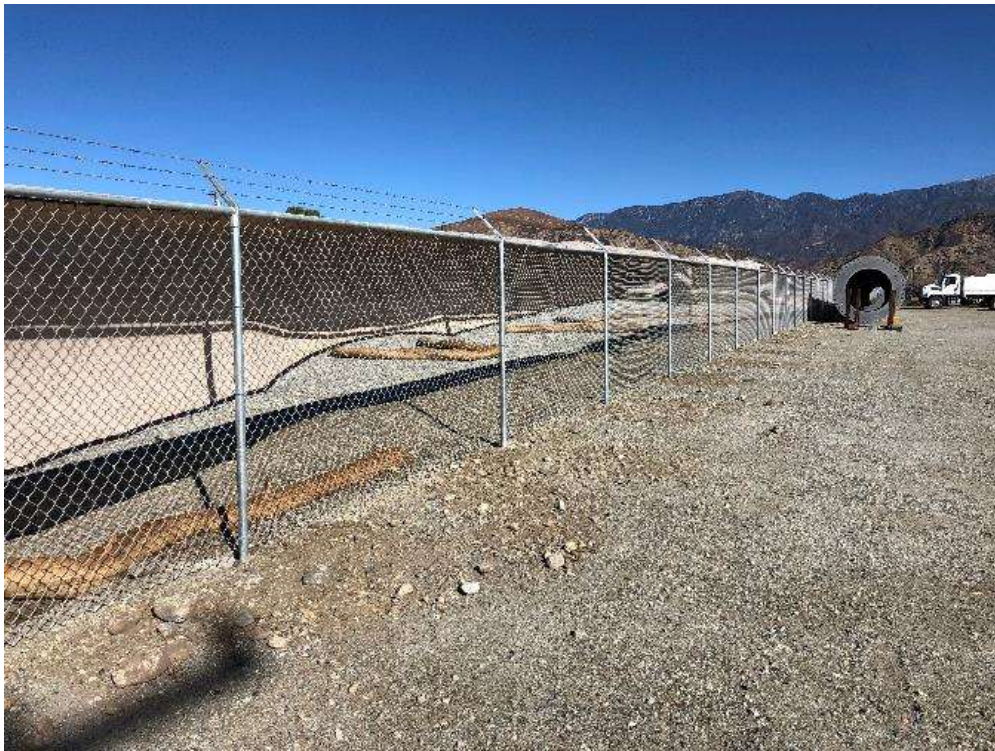
2. There was one SWPPP maintenance items and no corrective actions associated with NTP #1 recorded during the monitoring period. Due to high winds, fiber rolls became dislodged along the western perimeter of the Matich MY (see Photo 2). According to the SCE, the fiber rolls were reinstalled and secured within the required 72-hour notification timeframe. To date, there are no open SWPPP maintenance items or corrective actions associated with NTP #1.

Photo 2 – Fiber rolls dislodged due to high winds at the Match MY (October 16, 2018).

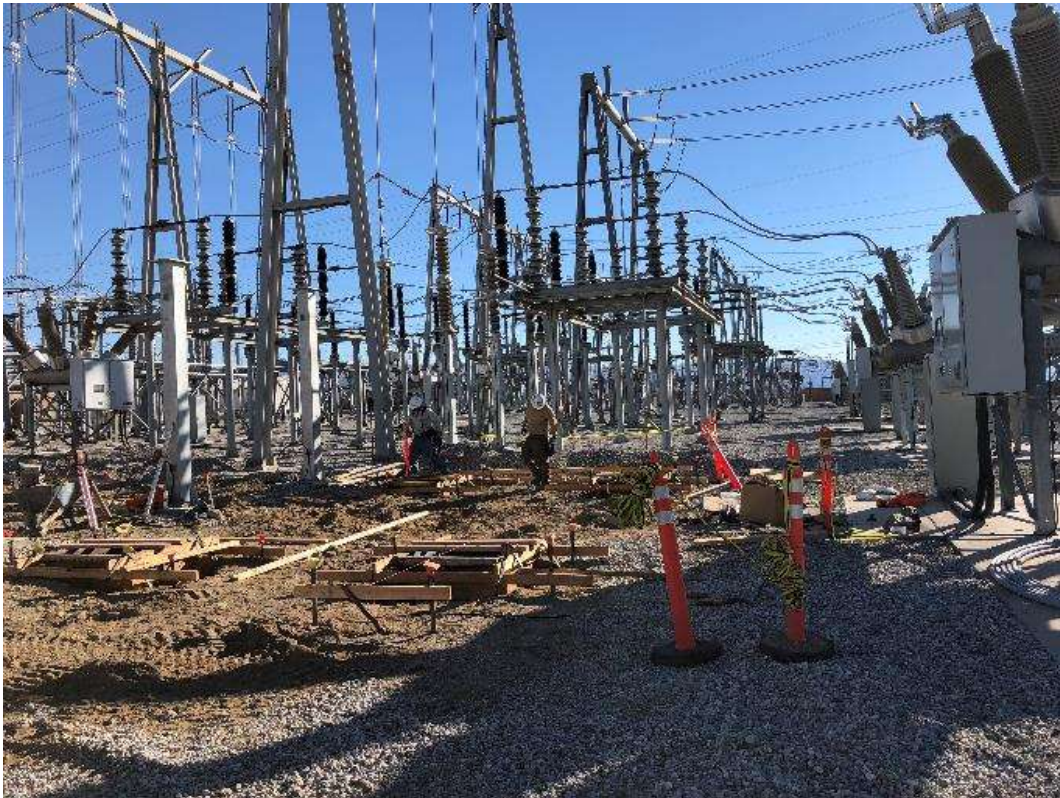
1. For the currently approved substation components, all work is being managed by Circle Wood Services with construction support from TTR Substations.
2. Work associated with the Devers Substation was limited to adjusting disconnects at Position #9 (see Photo 3).
3. No construction activities associated with the Vista Substation occurred throughout the monitoring period.
4. No construction activities associated with the Etiwanda Substation occurred throughout the monitoring period.
5. No construction activities associated with the San Bernardino Substation occurred throughout the monitoring period.
6. No construction activities associated with the El Casco Substation occurred throughout the monitoring period.

Photo 3 – Forming for new foundations at Position #9 at Devers Substation (October 16, 2018).

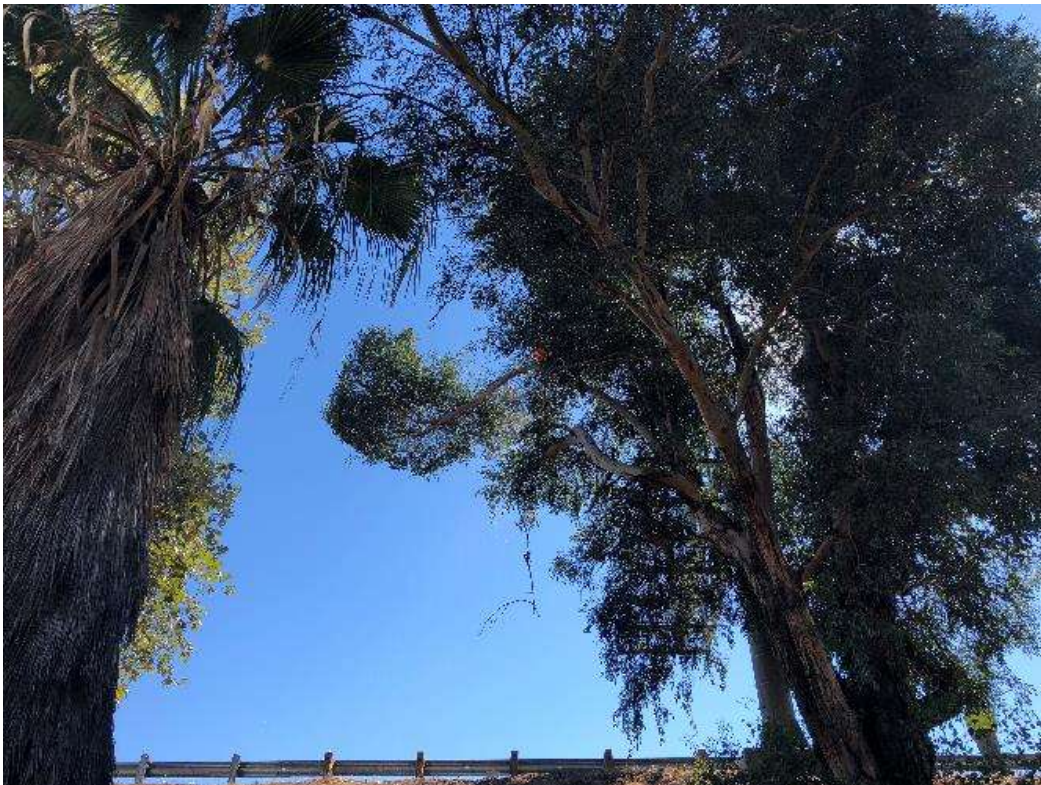
3. Work associated with the Timoteo Relocation subtransmission improvements included potholing for existing utilities, installation of overhead conductor wire, tree trimming, block wall repairs, and sidewalk restoration (see Photo 4).

Photo 4 – Crew trimming branches adjacent to Interstate 10 along the Timoteo Relocation (October 17, 2018).

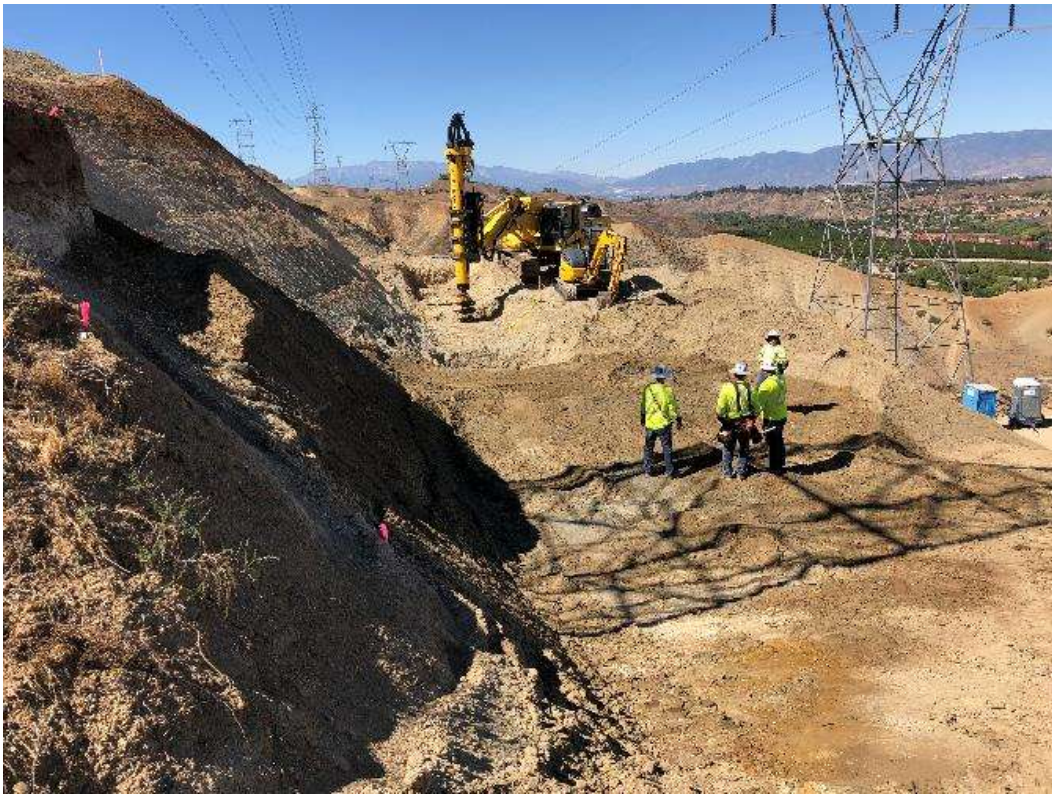
4. Work associated with Segment 3 included access road maintenance between Sites 3X55 and 3X62. Grading activities occurred at Sites 3X37, 3X46, 3X59, 3X60, and 3X61. Retaining wall construction occurred at Site 3X37 (see Photo 5). Foundation drilling was performed at Sites 3X14 and 3X15. Concrete foundation pouring occurred at Site 3X15. No access road improvements were conducted.

Photo 5 – Foundation drilling for retaining wall at Site 3X37, Segment 3 (October 16, 2018).

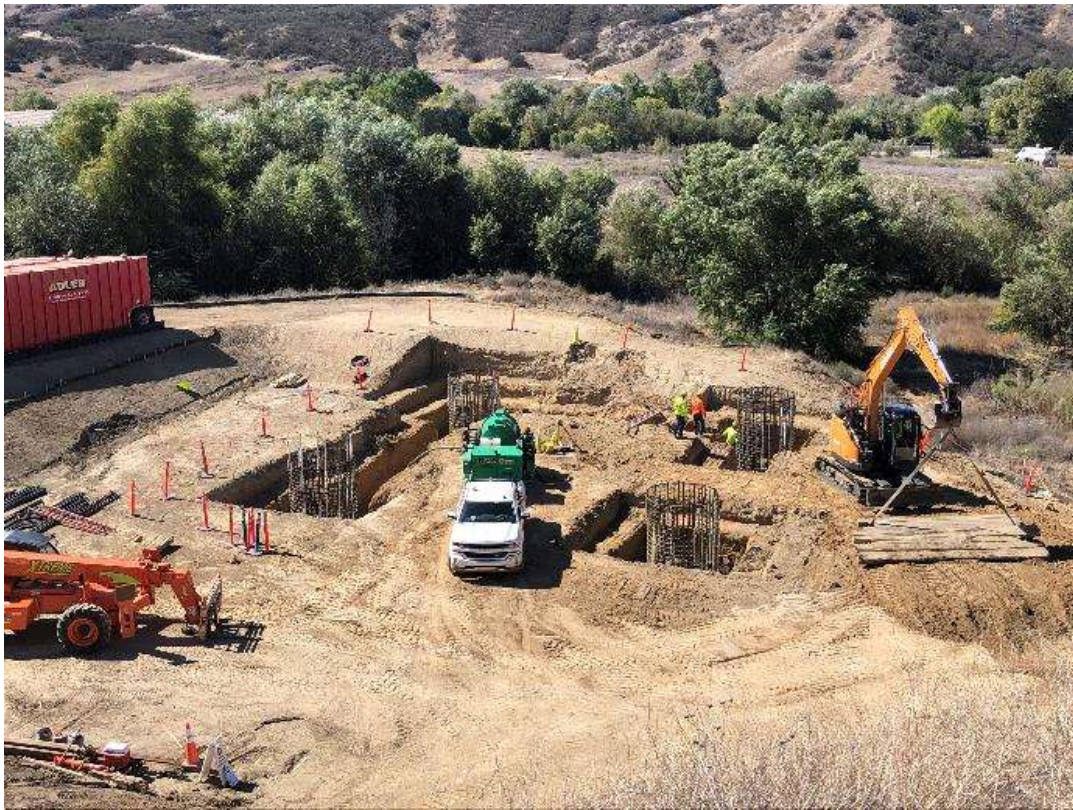
5. Work associated with Segment 4 included grade beam construction at Site 4S60 (see Photo 6). Tower assembly and/or erection was performed at Sites 4N60, 4N61, and 4N64. Wire stringing activities occurred between Sites 4X55 and El Casco Substation (see Photo 7). No access road improvements were conducted.

Photo 6 – Grade beam construction at Site 4S60, Segment 4 (October 17, 2018).

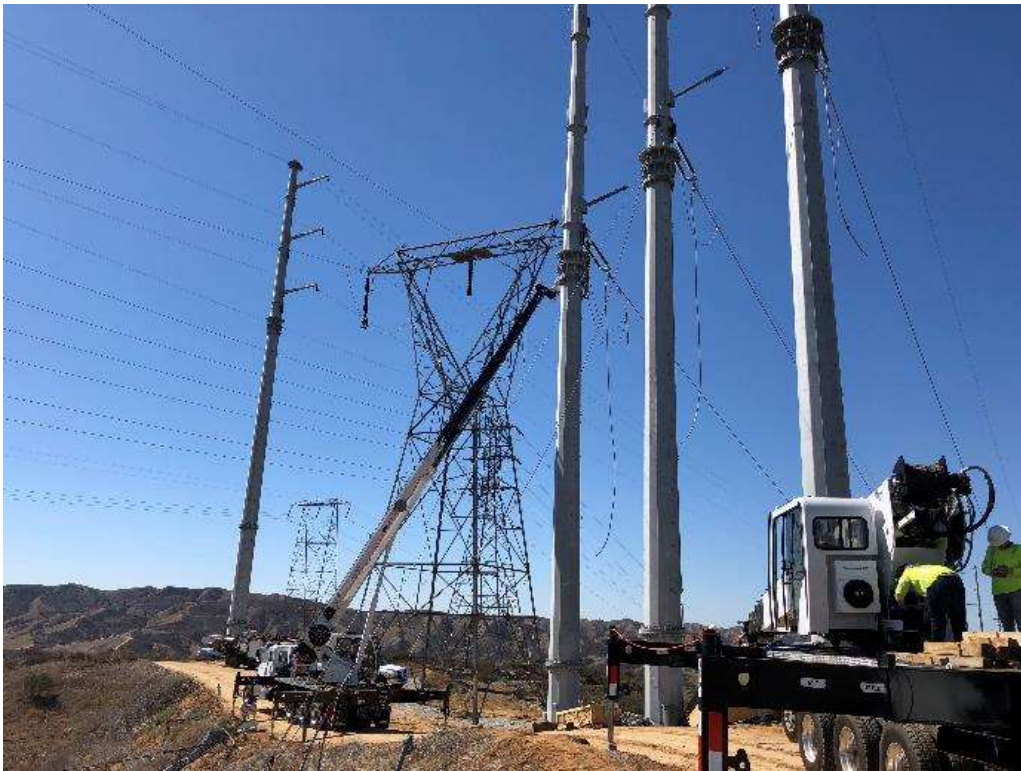
Photo 7 – Transferring conductor wire to shoofly poles at Site 4X56, Segment 4 (October 15, 2018).

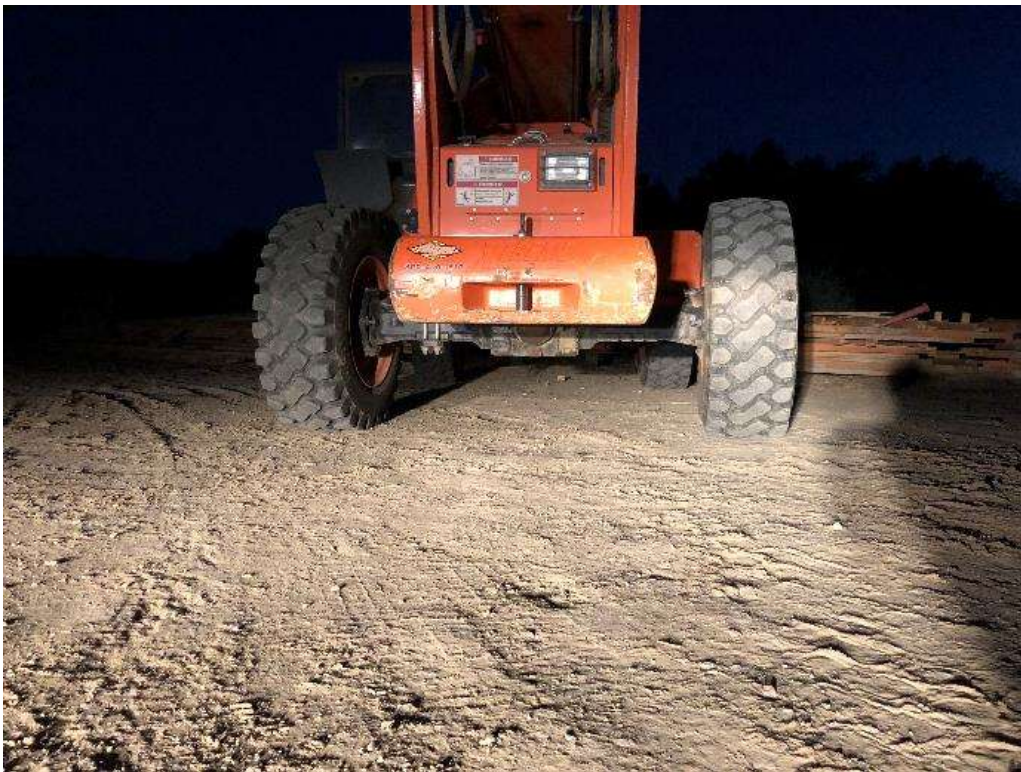
2. On October 17, the CPUC EM observed a total of four pieces of heavy equipment staged overnight at Sites 4N64 and WSS-4-4N64-MPR-19 (Segment 4) without required secondary containment (see Photo 8). The CPUC EM recorded the issue as a Level 1 Incident. The observation occurred as the CPUC EM was accompanying the SCE Biological Monitor during morning clearance sweeps. The SCE Biological Monitor also recorded this as a Level 1 Incident.

Photo 8 – Forklift staged overnight at Site 4N64 (Segment 4) without proper secondary containment (October 17, 2018).

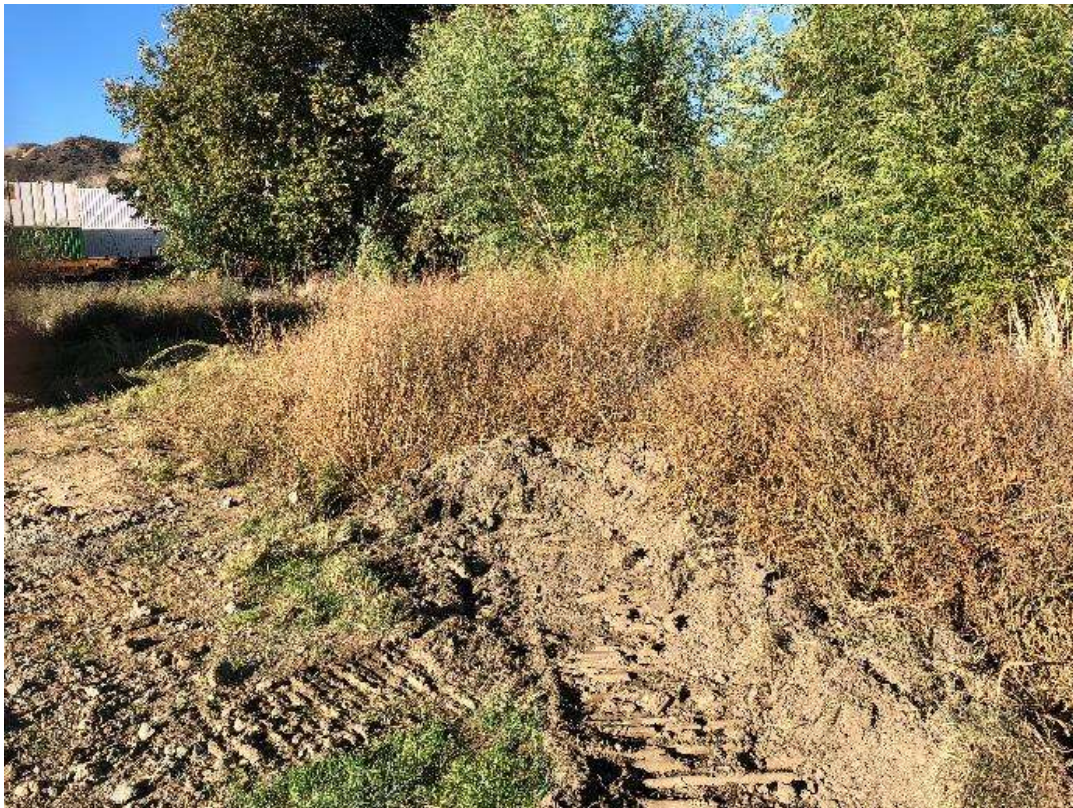
4. On October 17, the SCE Biological Monitor observed drilling equipment staged on vegetation and equipment tracks outside of approved work limits near Site 4S60 (Segment 4) (see Photo 9). A Level 1 Incident was issued by SCE. According to that report, no impacts to sensitive resources were identified.

Photo 9 – Equipment tracks observed outside of approved disturbance limits near Site 4S60, Segment 4 (October 18, 2018).

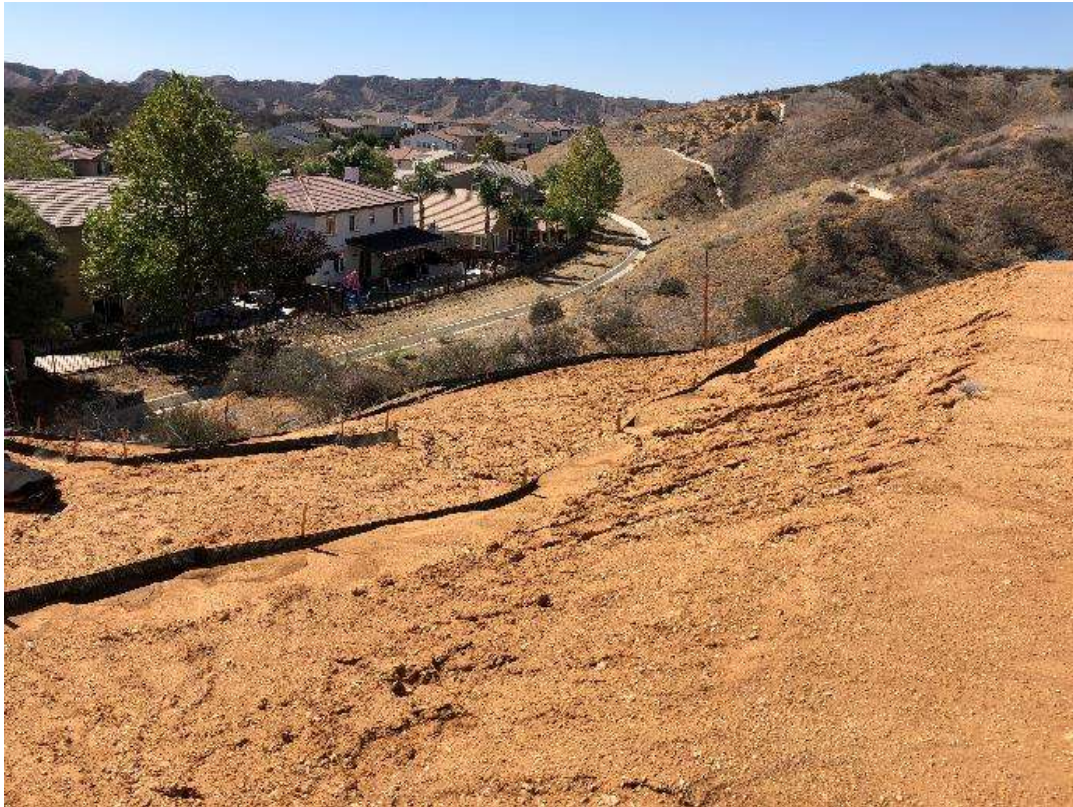
6. There were nine SWPPP maintenance items and no corrective actions associated with NTP #4 recorded during the monitoring period. The maintenance items were all identified on October 15 and 17 and consisted of accumulated sediment at BMPs established at various sites along Segments 3 and 4 (see Photo 10). Additionally, a pile of unsecured trash was reported at Site 4N60 along Segment 4. SCE reported that all maintenance items had been resolved within the required 72-hour timeframe. To date, there are no open SWPPP maintenance items or corrective actions associated with NTP #4.

Photo 10 – Accumulated sediment behind BMPs at Site 4X53, Segment 4 (October 15, 2018).
