**PROJECT MEMORANDUM**  
**SCE WEST OF DEVERS UPGRADE PROJECT**

**Date:** November 29, 2018  
**To:** Billie Blanchard, Project Manager, CPUC  
**From:** Vida Strong, Aspen Project Manager  
**Subject:** Monitoring Report #41: November 12 to November 25, 2018

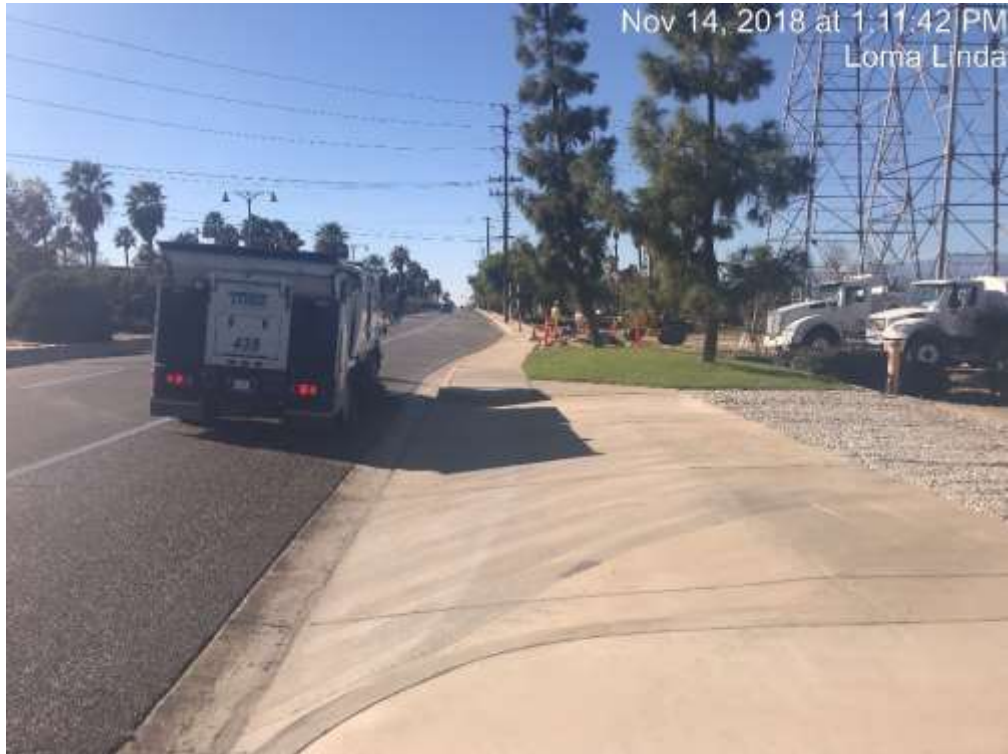
Photo 1 – Street sweeping to remove track out was conducted along Segment 1. (November 14, 2018).

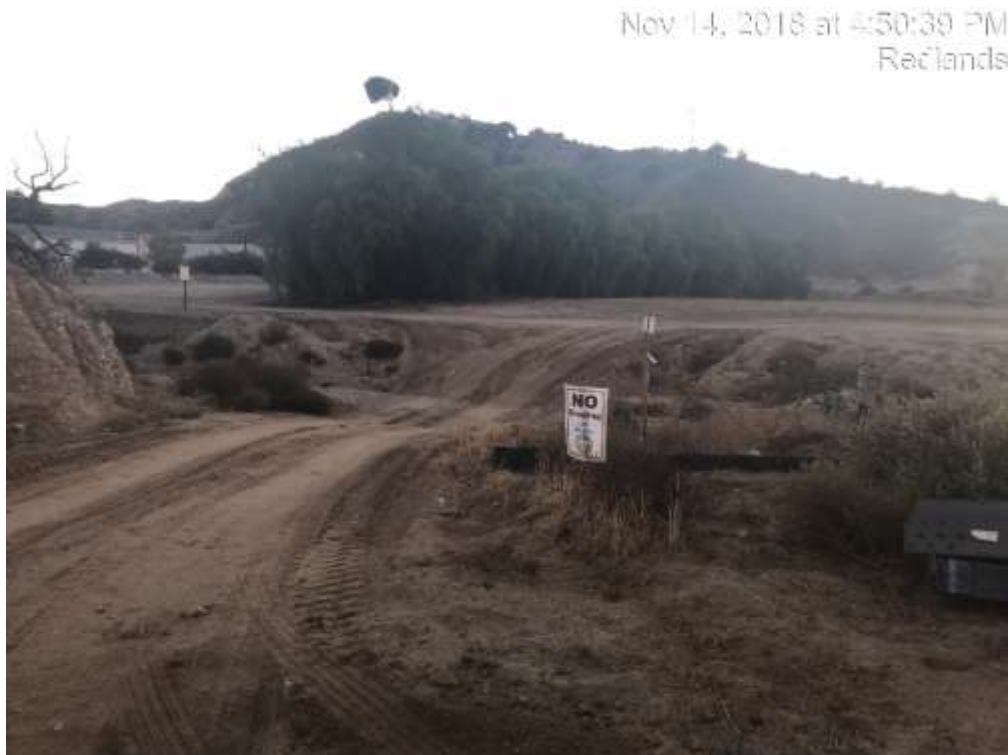
Photo 2 – Segment 3 access to tower site crossing jurisdictional drainage near the Poultry Yard (November 14, 2018).

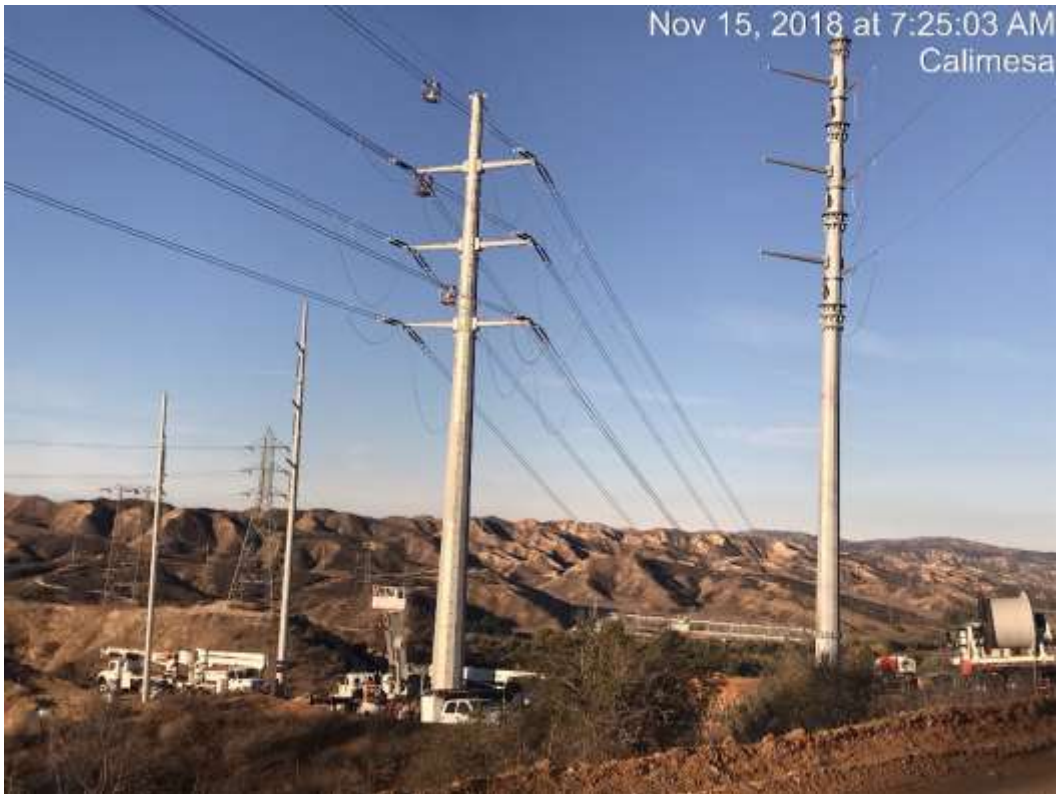
5. Work associated with Segment 4 included clipping and sagging, shoofly pole installation, and diverter installation (see Photo 3). Work associated with the outage continued with wire stringing activities occurred between Site 4X55 and El Casco Substation via helicopter.

Photo 3 – Wire clipping in Segment 4 (November 15, 2018).

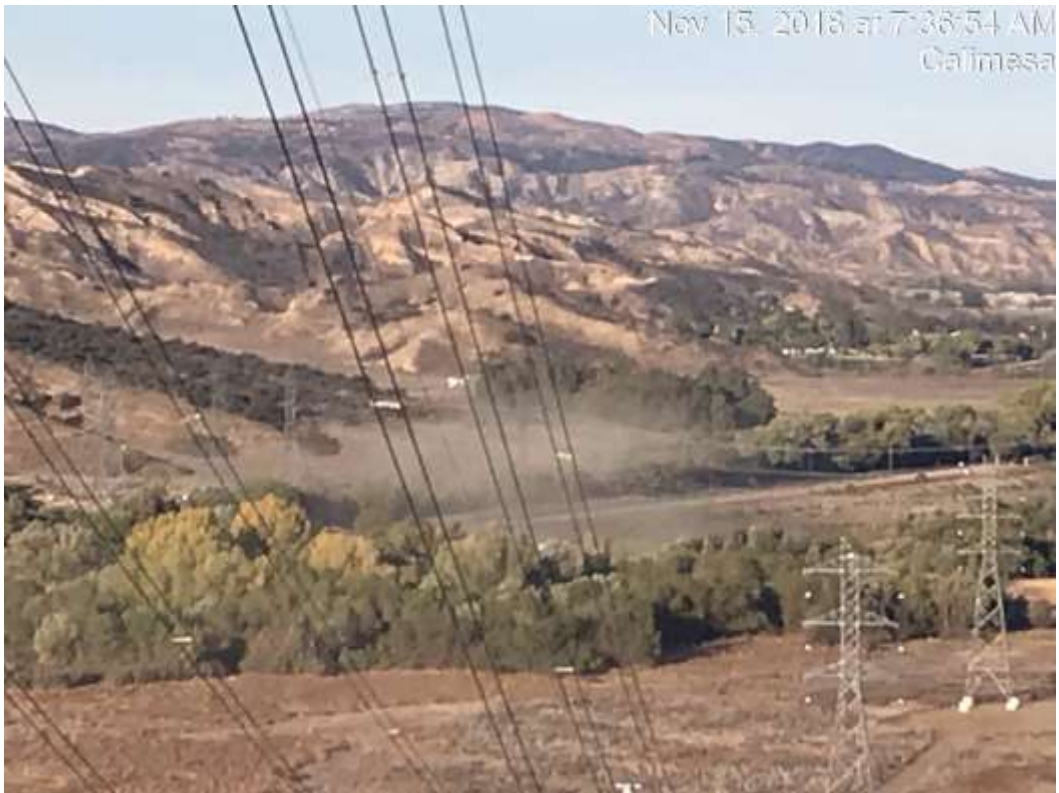
1. One SCE self-reported and no CPUC incidents documented for construction activities associated with NTP #4 throughout the monitoring period. On November 15, the CPUC EM noted a large dust cloud resulting from helicopter operations in Segment 4 near San Timoteo Canyon Road (see Photo 4) and notified the Environmental Monitor who quickly notified Barnard and water trucks were sent to that location to wet the area.

Photo 4 – The CPUC EM noted a large dust plume resulting from helicopter activity adjacent to San Timoteo Road. (November 15, 2018).

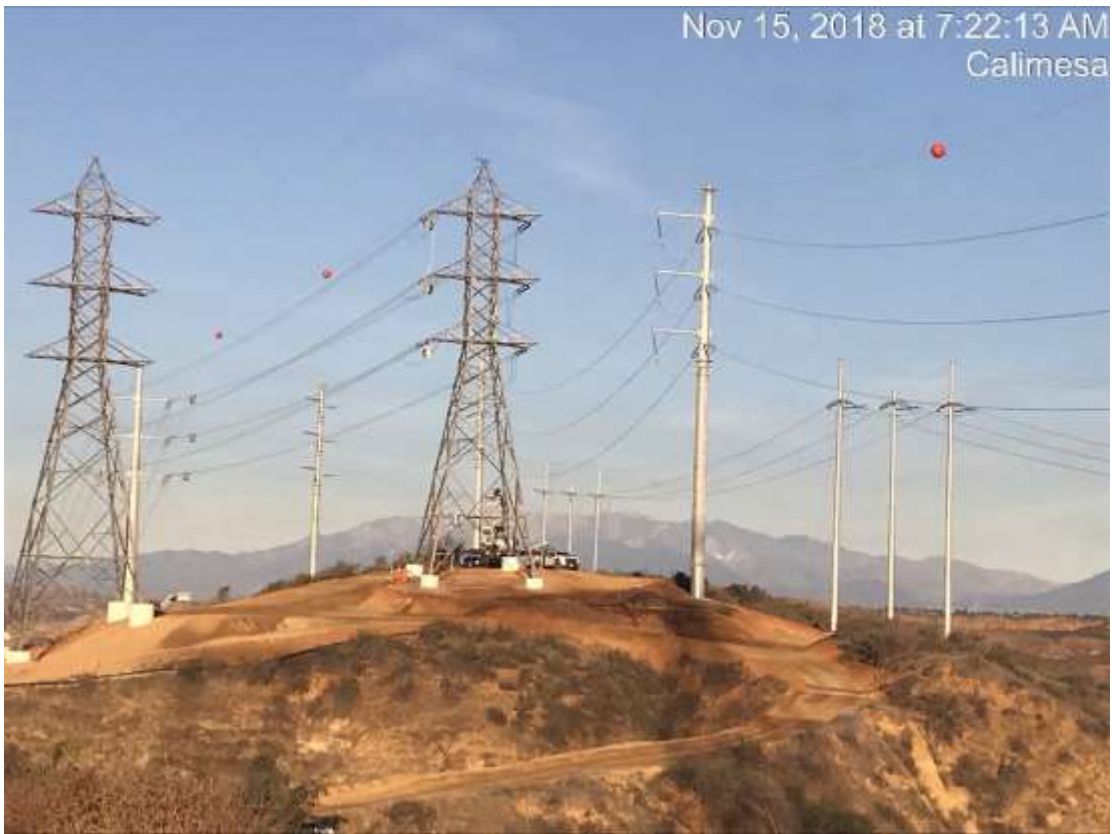
2. Documentation of FAA Determinations for Segment 4 was provided on September 17. Additional information was provided on September 26 and is currently under review. FAA recommended marker balls have been installed on the shoofly spans near El Casco Substation (see Photo 5).

Photo 5 – Marker balls have been installed in the Segment 4 tower spans as recommended by the FAA. (November 15, 2018).
