PROJECT MEMORANDUM
SCE WEST OF DEVERS UPGRADE PROJECT

Date: January 21, 2019
To: Billie Blanchard, Project Manager, CPUC
From: Vida Strong, Aspen Project Manager
Subject: Monitoring Report #46: December 31 to January 12, 2019

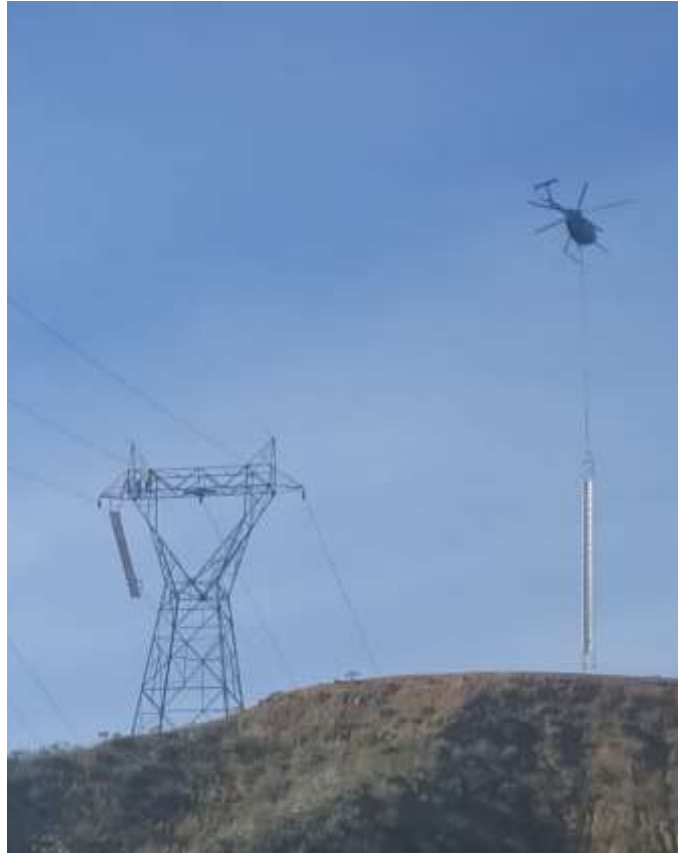
Photo 1 – Delivery of materials to wreck-out towers in Segment 3 using a helicopter.

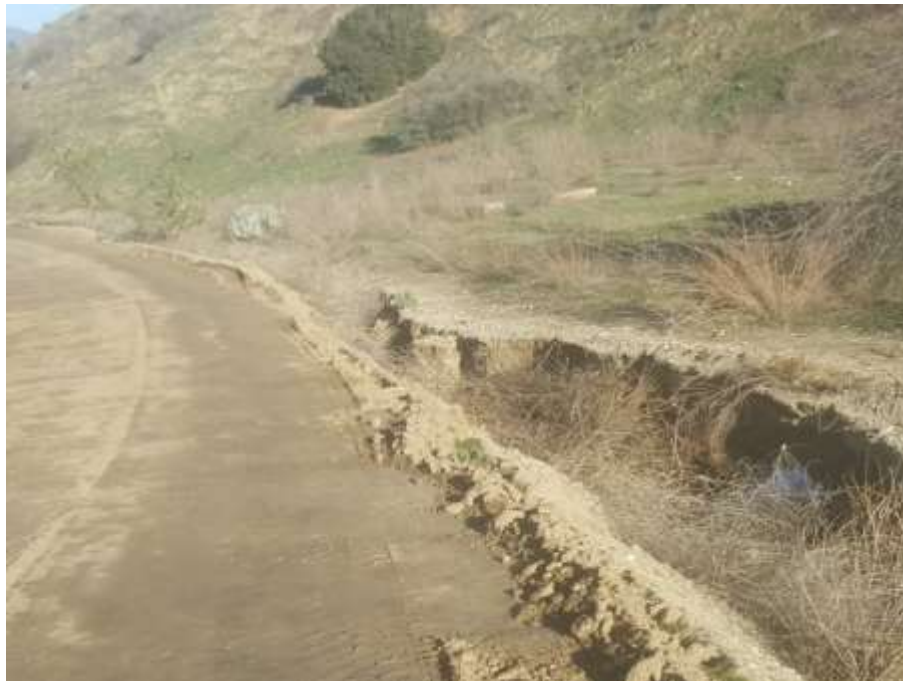
2. The CPUC EM identified a previously unidentified drainage east of Segment 3, Site 3X50 (see Photo 2). The CPUC EM reported the drainage to SCE and they are determining if permitting will be required for any impacts to the feature.

Photo 2 – Previously unidentified drainage near Site 3X55, Segment 3, reported to SCE by CPUC EM.

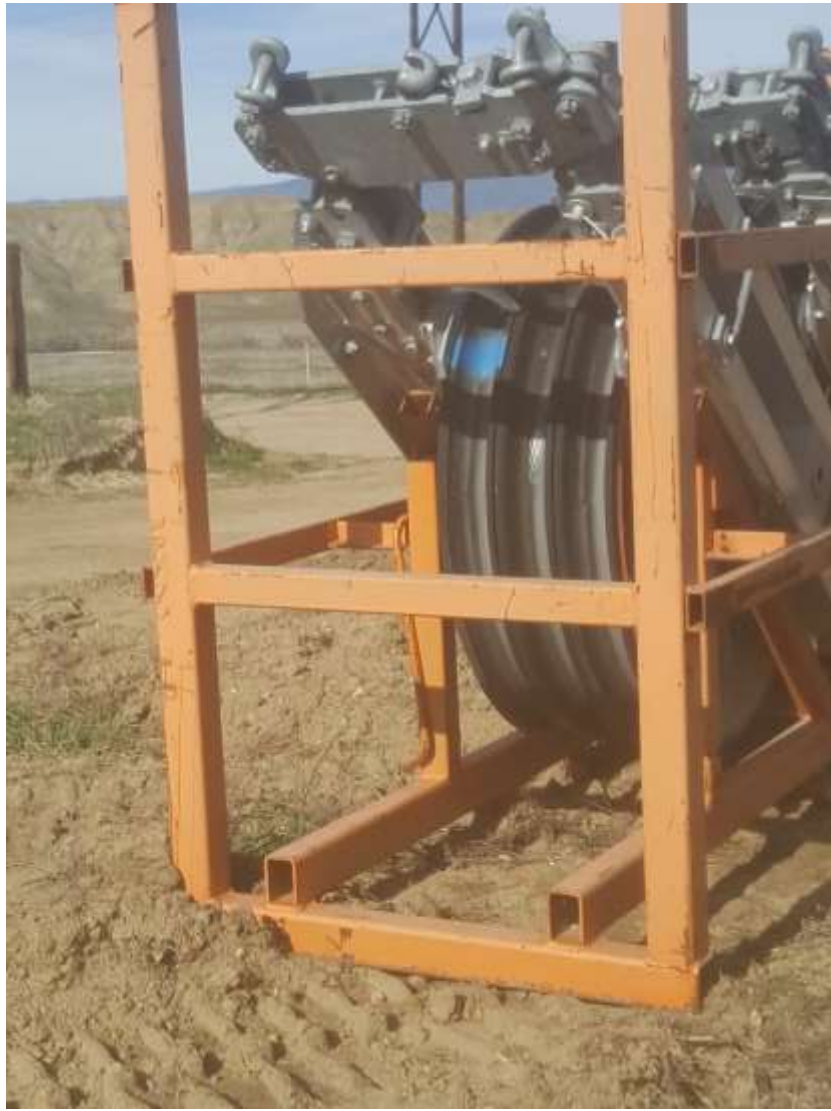
3. The CPUC EM noted that some equipment was delivered to Segment 3 areas with uncovered holes (see Photo 3). Per Mitigation Measure WIL-1b, all pipes or other construction materials or supplies will be covered or capped in storage or laydown areas in order to prevent wildlife entrapment. The observation was reported to SCE.

Photo 3 – Uncovered holes potentially creating a wildlife entrapment hazard in Segment 3. These were reported to SCE and the pipe ends were eventually covered.
