PROJECT MEMORANDUM
SCE WEST OF DEVERS UPGRADE PROJECT

Date: March 11, 2019
To: John Forsythe, Project Manager, CPUC
From: Vida Strong, Aspen Project Manager
Subject: Monitoring Report #53: February 24 to March 2, 2019

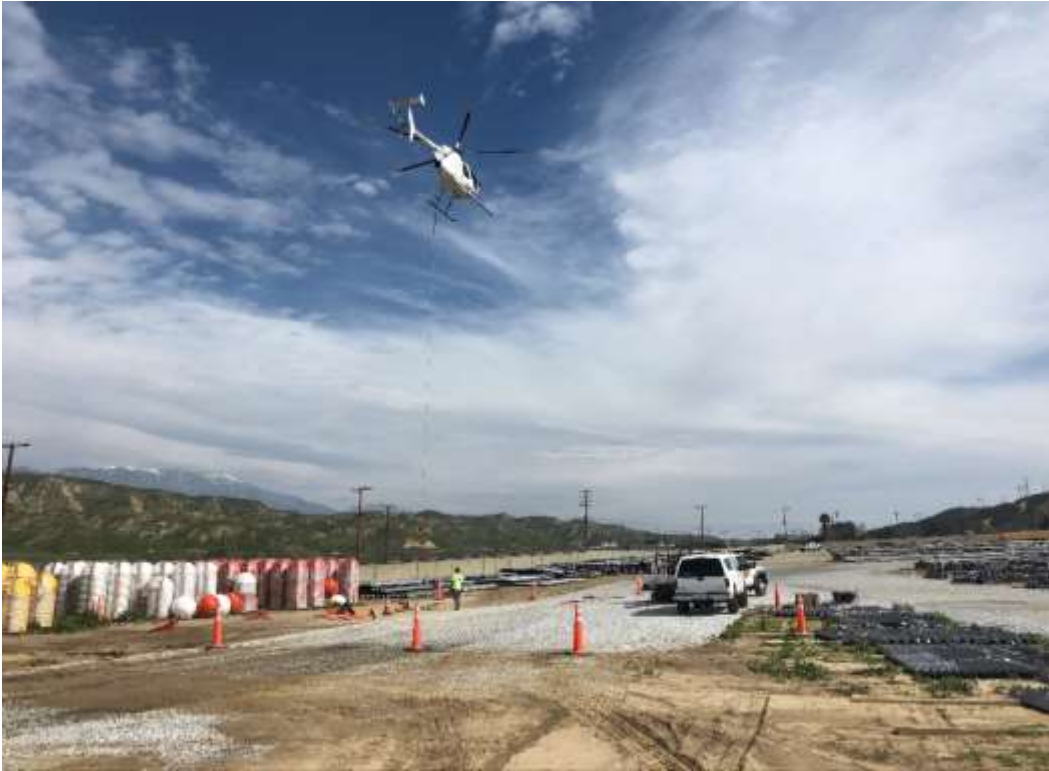
Photo 1 – Helicopter operations supporting wire installation and removal at the Poultry Yard on San Timoteo Canyon Road.

2. The Poultry MY is being utilized by Barnard Construction and Power Grade Incorporated as their primary base of operations and material/equipment storage location. Work associated with the Poultry MY included material/equipment deliveries and general yard maintenance throughout the monitoring period. Helicopter operations out of Poultry MY occurred during the monitoring period (see Photo 1).

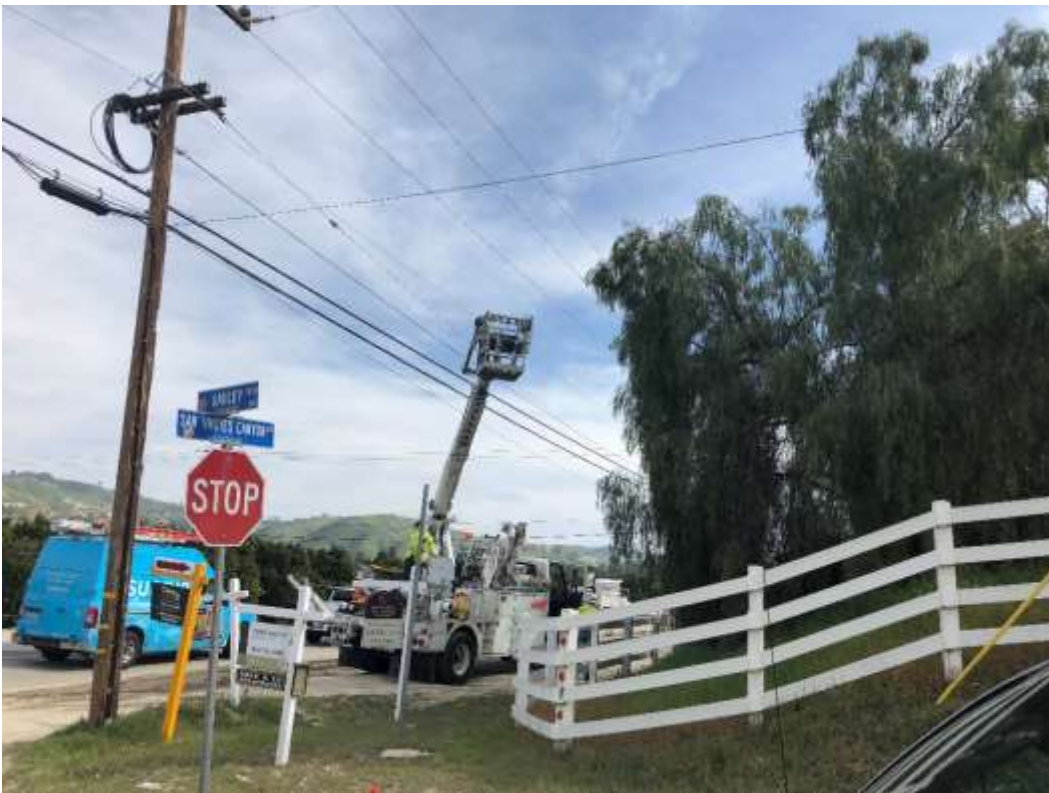
Photo 2 – SCE crew installing telecom fiber along San Timoteo Canyon Road for the El Casco Connection.

1. For the currently approved subtransmission and distribution components, construction activities are being performed by Hot Line Construction and SCE crews.
2. Telecom work associated with the El Casco Connection included clipping of fiber optic line along San Timoteo Canyon Road (see Photo 2).

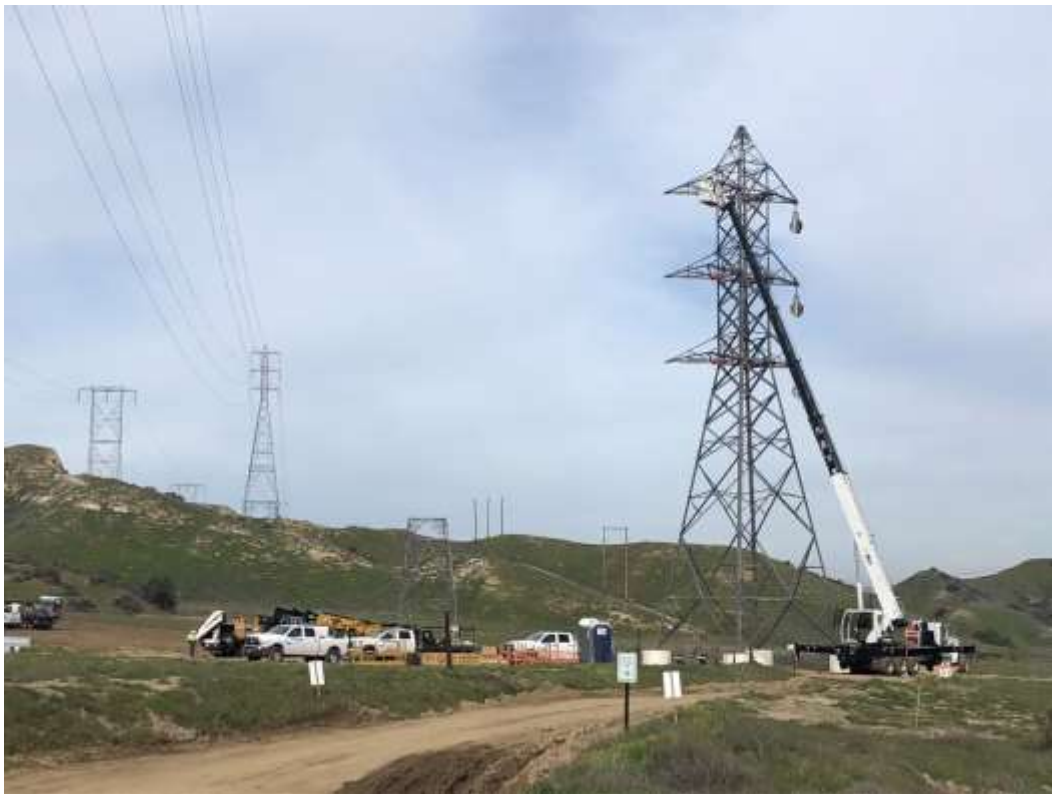
Photo 3 – Wire stringing operations between Sites 3N02 and 3X06, Segment 3.

occurred at Sites 3N04, 3X14, 3X25, 3X39-3X41, 3X51, and 3X62-3X64. Tower removal activities were performed at Site 3N33. Wire stringing activities were conducted between Sites 3N02 and 3X06 (see Photo 3).

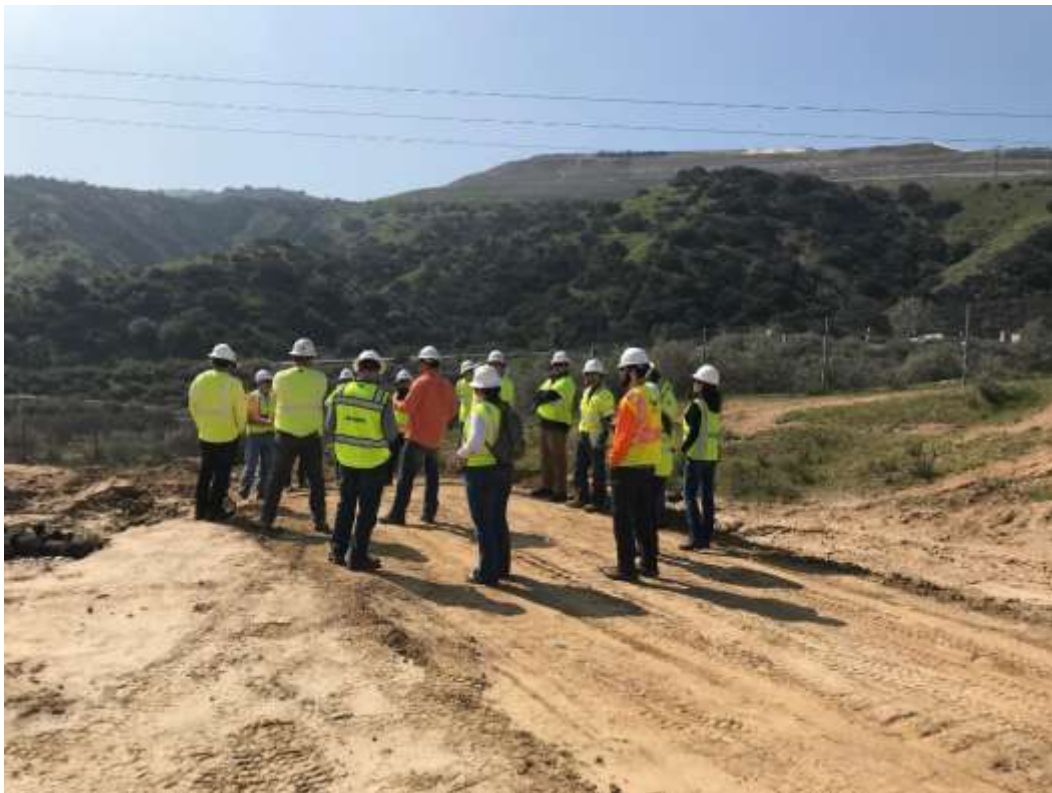
Photo 4 – Site visit to Segment 3 Site 3X55 with SWRCB, CDFW, SCE, Aspen, Jacobs. Discussions specific to this site included run on control and additional BMPs which would be implemented to reduce erosion.

1. A site visit between SCE, SWQCB, CDFW, Aspen, Jacobs, and Barnard took place on February 27 to review specific sites in Segments 3 and 4. The group toured Sites 3X65, 3X55, 4X51, and 4N63, and the access road to Site 3N06. Areas of recent sediment discharges were reviewed as well as sites currently showing signs of erosion. Discussions took place regarding mapping of jurisdictional features, additional measures that could be implemented, particularly along access roads, to minimize erosion and sedimentation, encouraging runoff from access roads in frequent intervals, and controlling run on into construction sites. SCE will be distributing meeting notes.

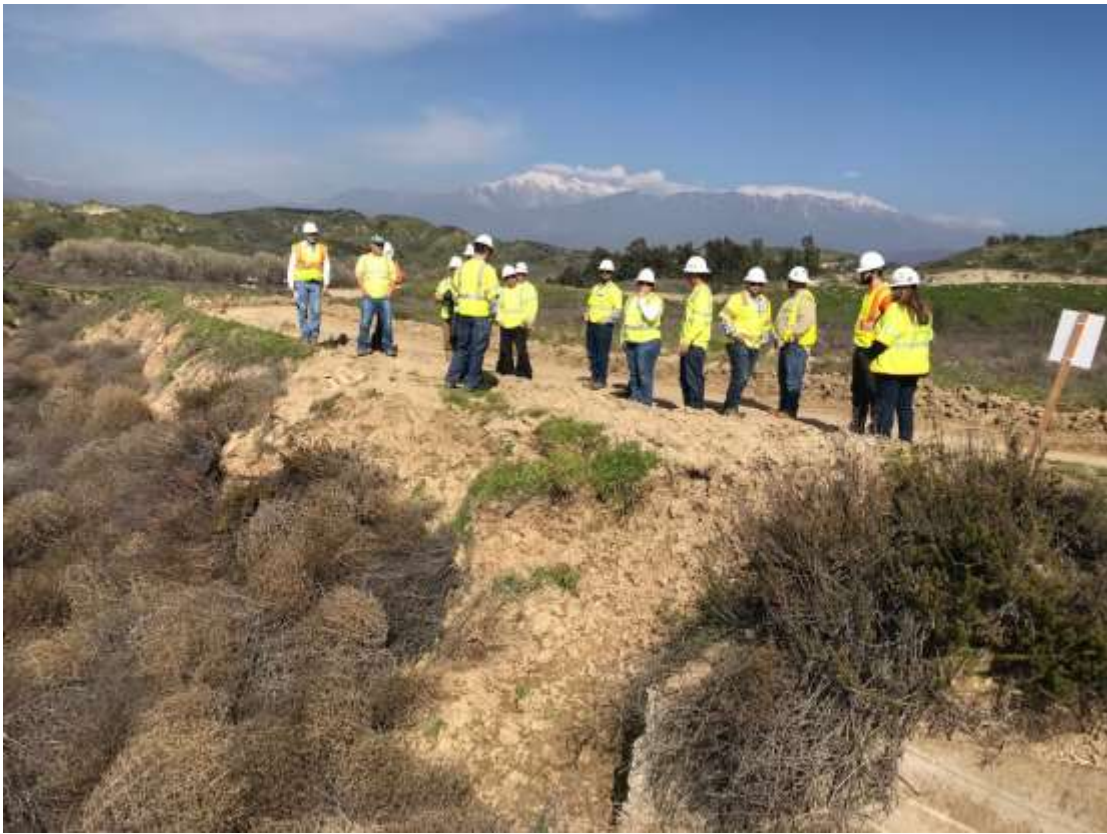
Photo 5 – Site visit to Segment 3 access road to Site 3N06 with SWRCB, CDFW, SCE, Aspen, Jacobs. Discussions specific to this site included allowing increased opportunity for runoff from access roads into upland areas, controlling sedimentation into drainage feature located adjacent to the access road, and modifying drainage patterns due to repeated access road grading and berm construction.
