PROJECT MEMORANDUM
SCE WEST OF DEVERS UPGRADE PROJECT

Date: March 26, 2019
To: John Forsythe, Project Manager, CPUC
From: Vida Strong, Aspen Project Manager
Subject: Monitoring Report #55: March 10 to March 16, 2019

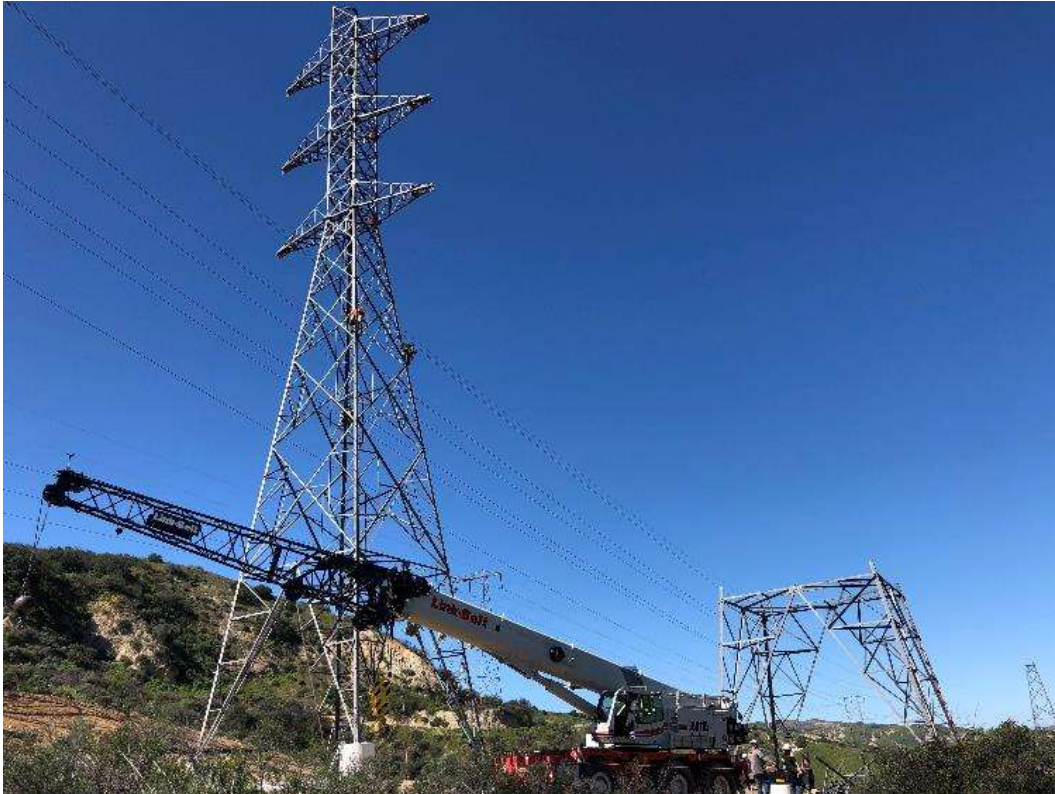
Photo 1 – Completing tower assembly at Site 3X21, Segment 3.

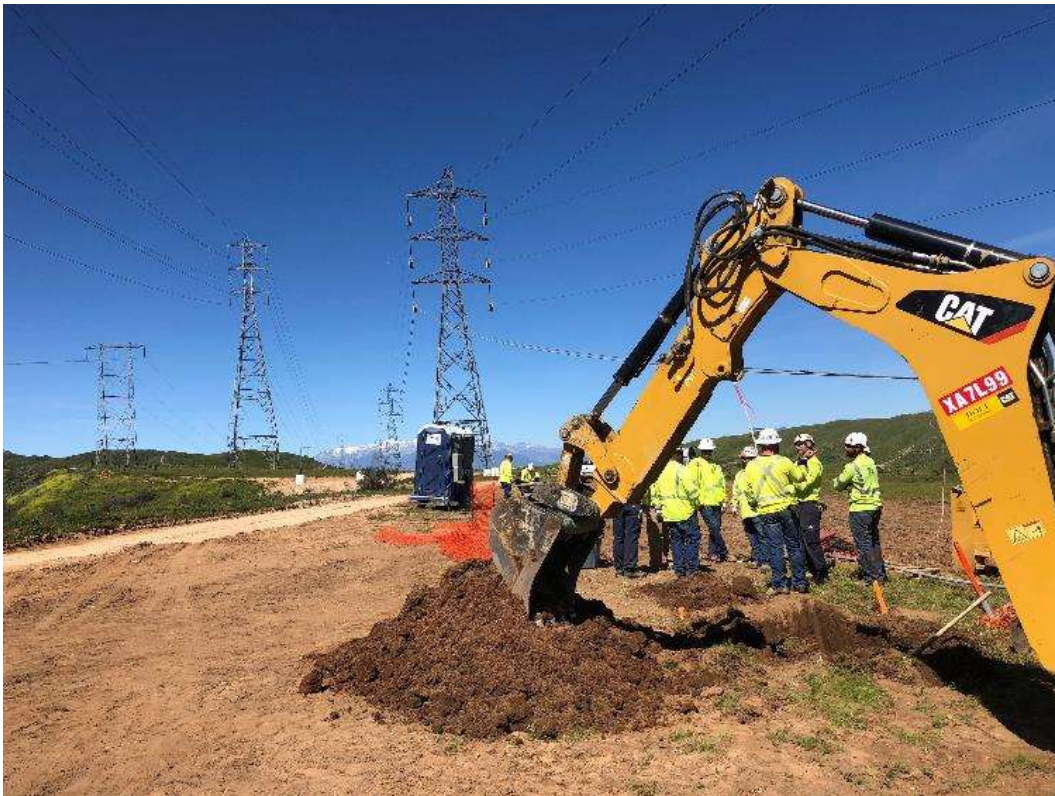
Photo 2 – Wire stringing between Sites 3X55 and 3X65, Segment 3.

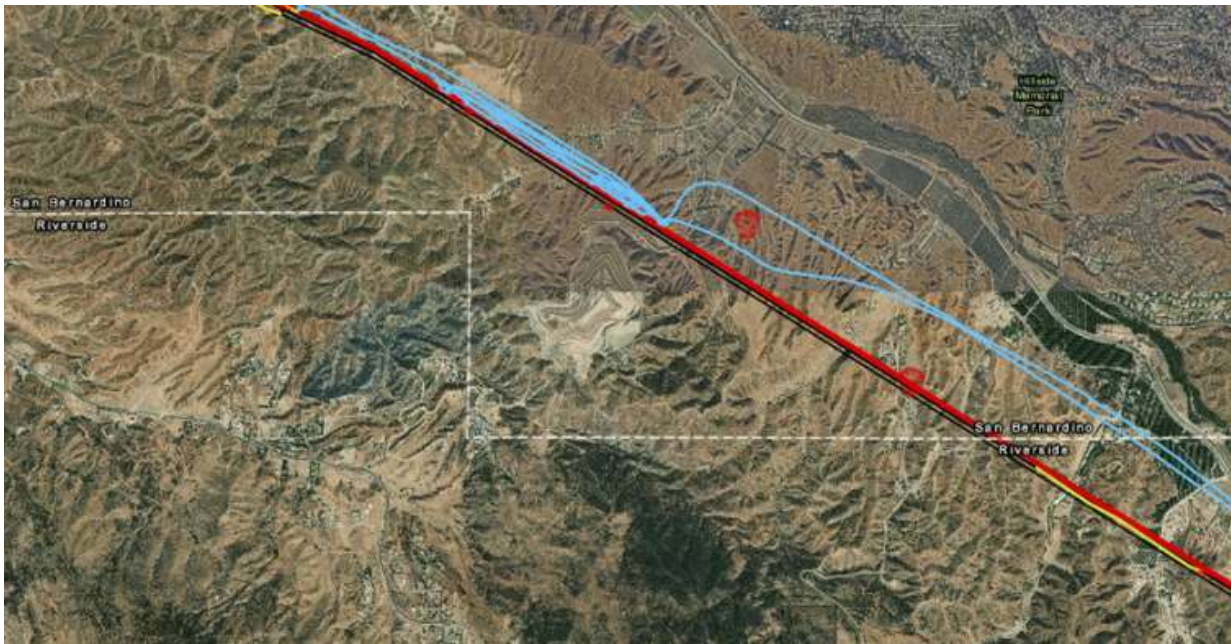
3. Regular meetings are scheduled to review helicopter flight tracks for compliance with noise regulations and nesting bird buffer avoidance. A review of flight tracks revealed that the helicopter used for wire stringing work entered the nest buffer for a red-tailed hawk on March 8. A buffer reduction had been implemented for this nest; however, there was no biological monitoring undertaken to assess the tolerance level of the nesting birds at the time of the helicopter work (see Photos 3 and 4).

Photo 3 – Example of flight tracks indicating helicopter flight path (light blue line) and nest buffer (red circle) (March 14, 2019).

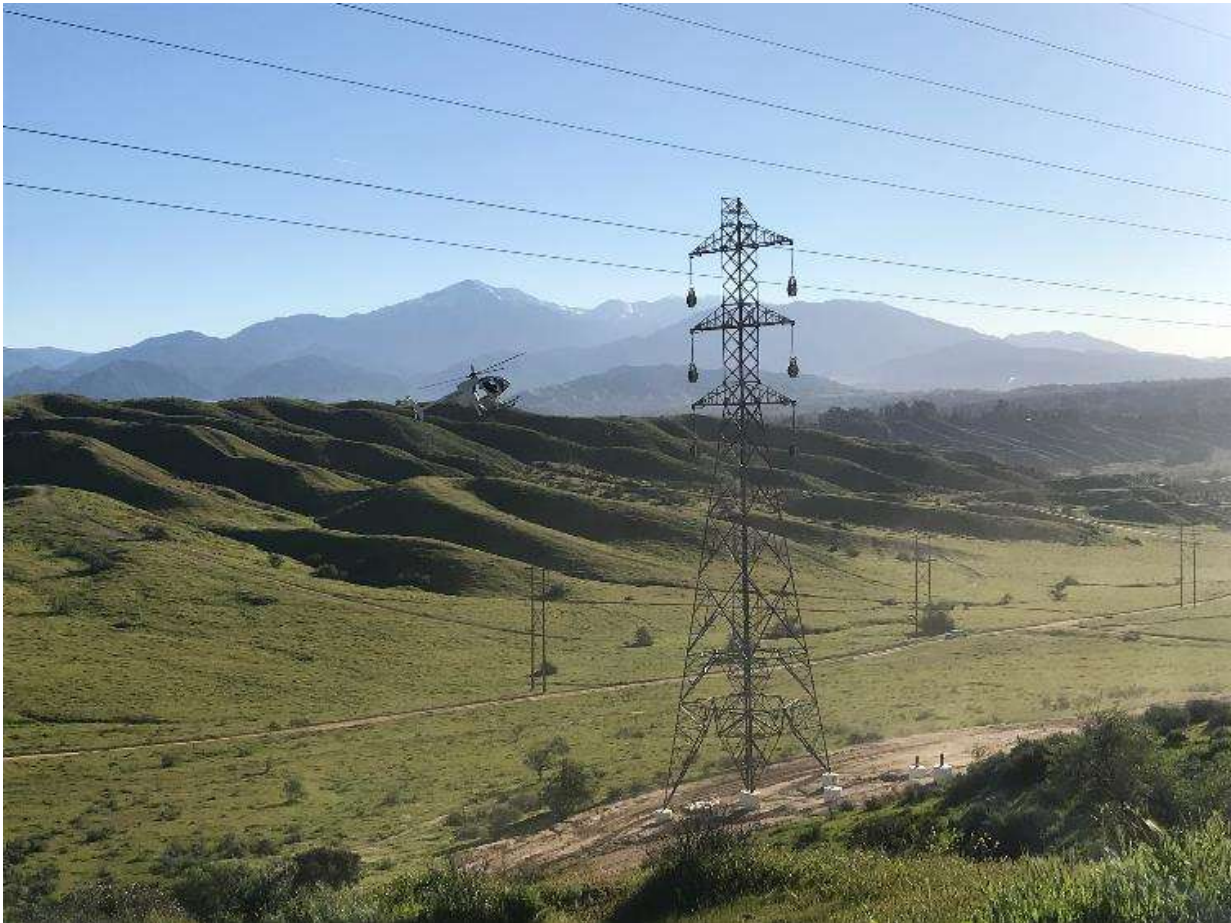
2. On March 14, the CPUC EMs observed a helicopter working less than 300-feet of red-tailed hawk nest #192 without being monitored by a biologist. The nest buffer reduction that had been proposed indicated that nest monitoring would take place while work was occurring close to the nest in order to determine if the nesting birds were disturbed by construction activity.

Photo 4 – Helicopter along flight path identified in Photo 3 (March 14, 2019).

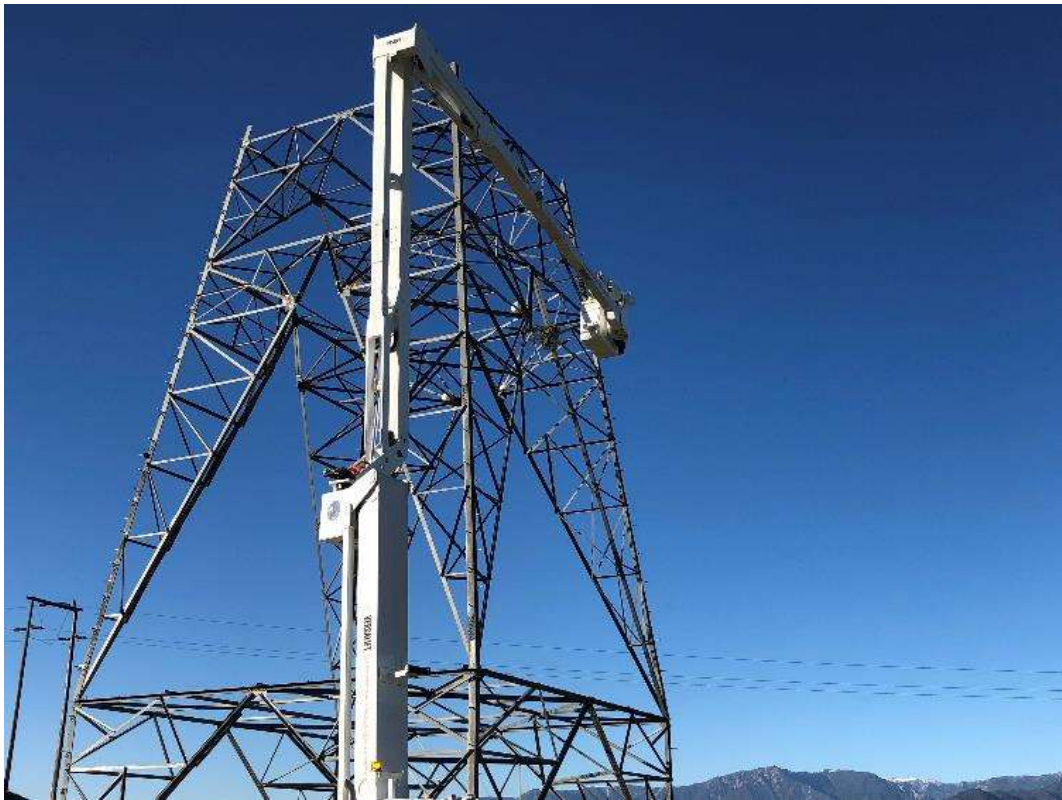
4. On March 13, construction crews removed a partially constructed red-tailed hawk nest from Tower 3N07 and relocated the nesting material to a newly constructed nest platform (see Photos 5 and 6).

Photo 5 – Relocating active red-tailed hawk nest from tower at Site 3X06-3X07 (March 13, 2019).

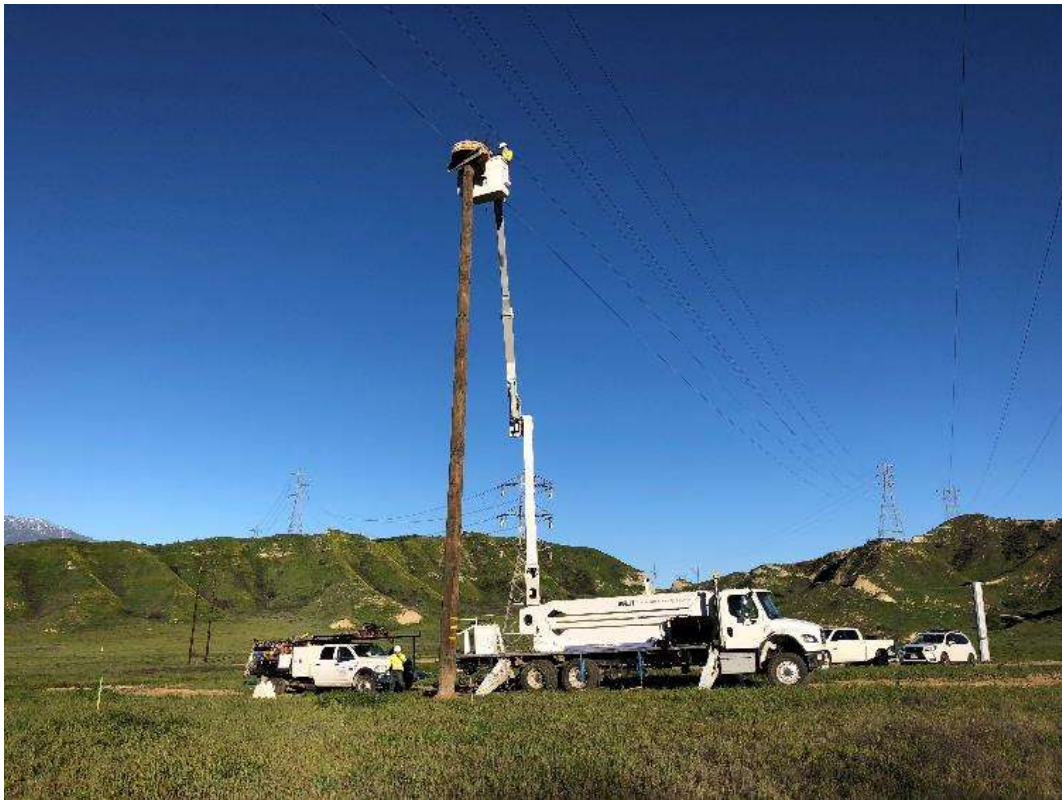
Photo 6 – Active red-tailed hawk nest relocated to installed nesting platform at Site 3X06-3X07 (March 13, 2019).
