**PROJECT MEMORANDUM**  
**SCE WEST OF DEVERS UPGRADE PROJECT**

**To:** John Forsythe, Project Manager, CPUC  
**From:** Vida Strong, Aspen Project Manager  
**Date:** June 6, 2019  
**Subject:** Monitoring Report #66: May 26 to June 1, 2019

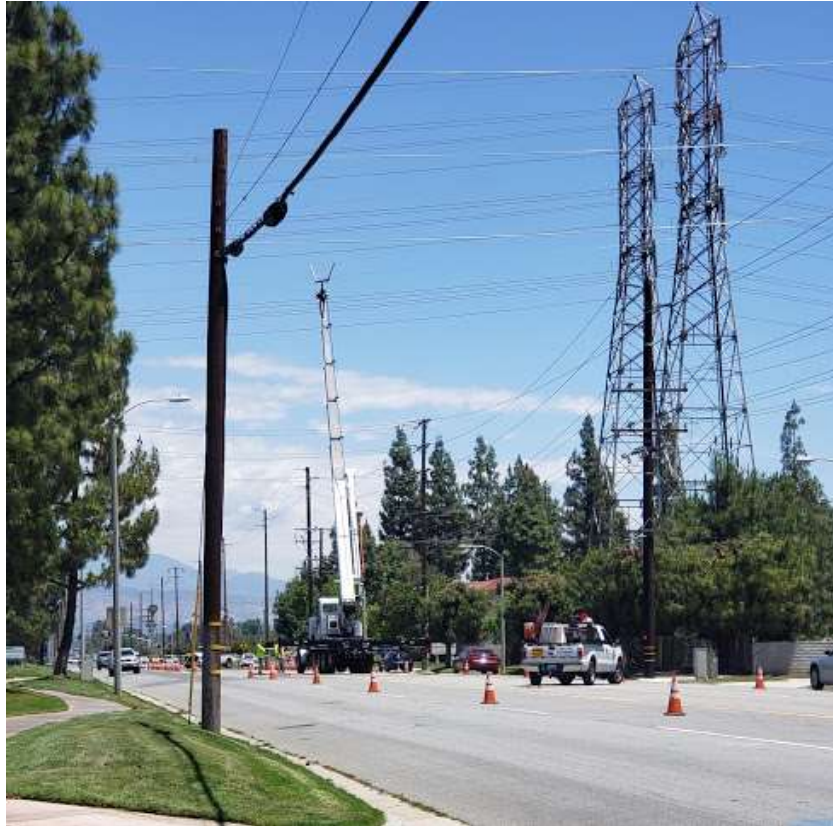
Photo 1 – Wire removal activities on Segment 1 with proper traffic control (May 29, 2019).

6. For the currently approved transmission components, Power Grade Incorporated is conducting access road maintenance/stabilization, BMP installation, vegetation removal, and site grading. CJ/Aldridge Drilling is performing foundation work. Abercrombie Services is assembling and erecting new towers, and conducting wire operations with support from Summit Helicopters. Cunningham Davis Corporation is removing existing towers and foundations. Work associated with Segment 1 during the monitoring period included: Tower assembly at Construction Areas 1X05, 1X06, 1X08, 1X11, 1X12, and 1X13, ; BMP installation and maintenance at Construction Areas 1X03 and 1X20; foundation work at Construction Areas 1X03, 1X04, and 1X05; tower wreck-out at Construction Areas 1X08, 1X12, 1X13, 1X15, 1X18, and 1X20 through 1X26; and wire removal activities occurred from Construction Areas 1X15 through 1X26 (see Photo 1).

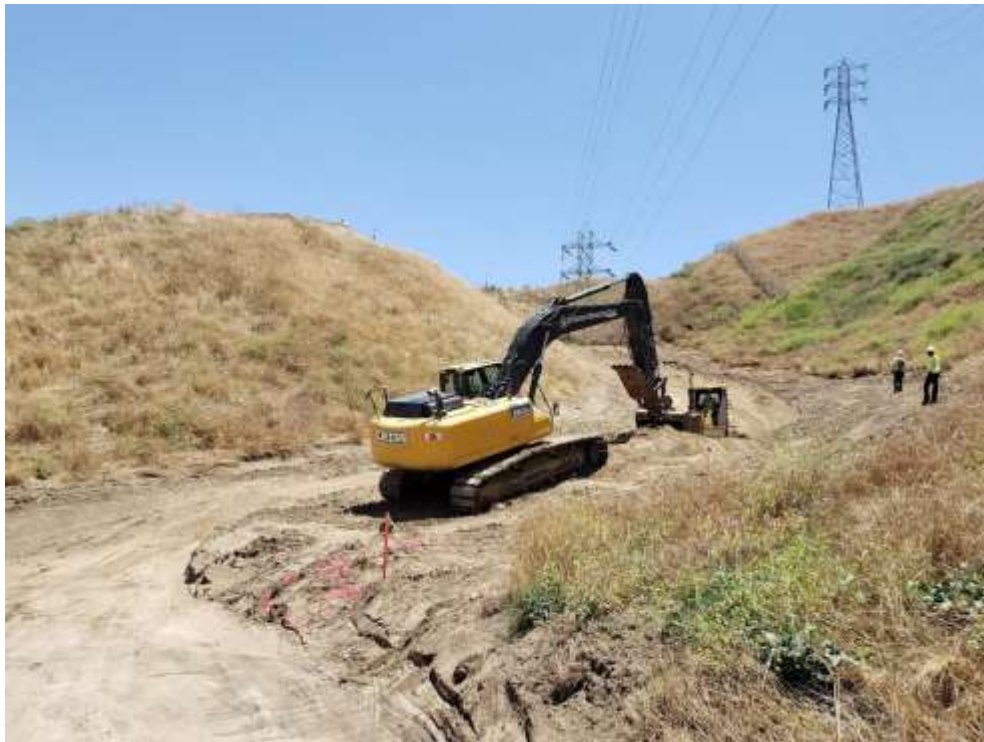
Photo 2 – Grading activities on Segment 2 (May 28, 2019).

7. Work associated with Segment 2 included: Clearing, grubbing, and soil export at Construction Areas 2X18, 2X22, 2X25, 2X31, and 2X32 (see Photo 2); grading, soil import, and Hilfiker wall installation at Construction Areas 2X08, 2X11, 2N22, 2X31, and 2X32; and BMP installation and maintenance at Construction Area 2N31.

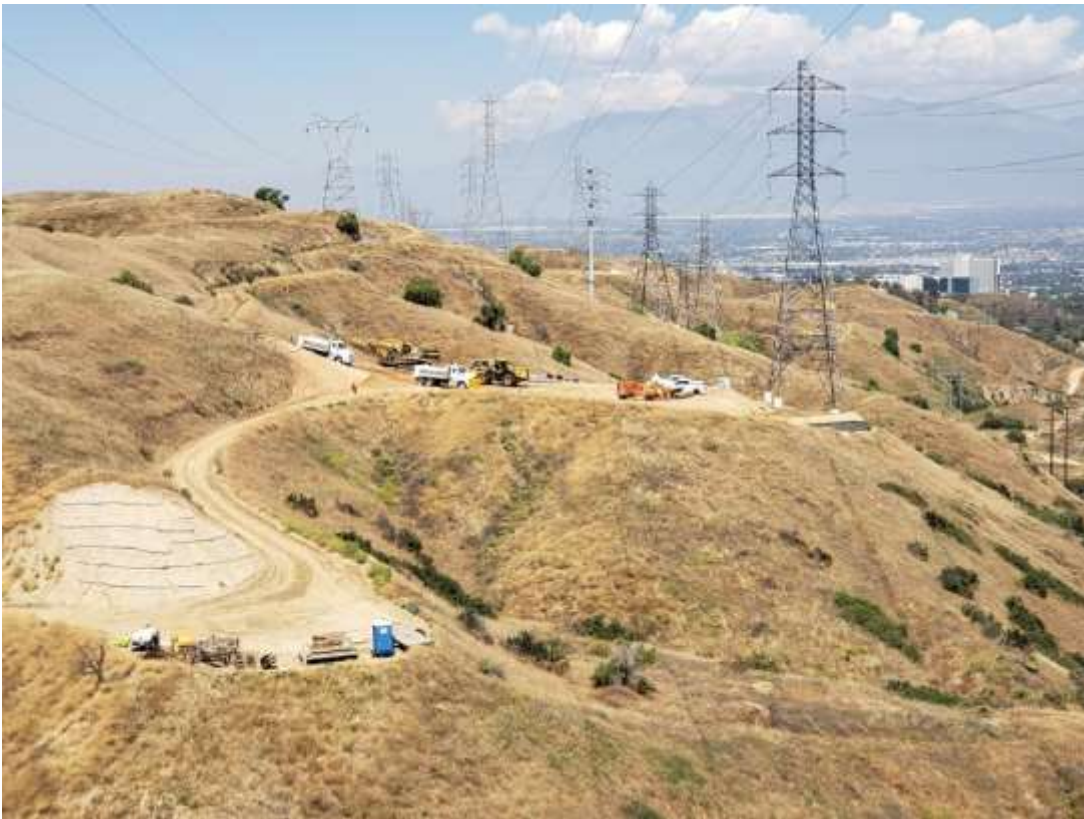
Photo 3 – Grading and soil export activities on Segment 3 (May 28, 2019).

8. Work associated with Segment 3 included: Tower assembly at Construction Areas 3X14, 3X24, 3X42, and 3X43; grading and soil exporting at Construction Area 3X64 (see Photo 3); foundations at Construction Area 3X64; and BMP installation and maintenance at Construction Areas 3X13, 3X15, 3X19, and 3X22.

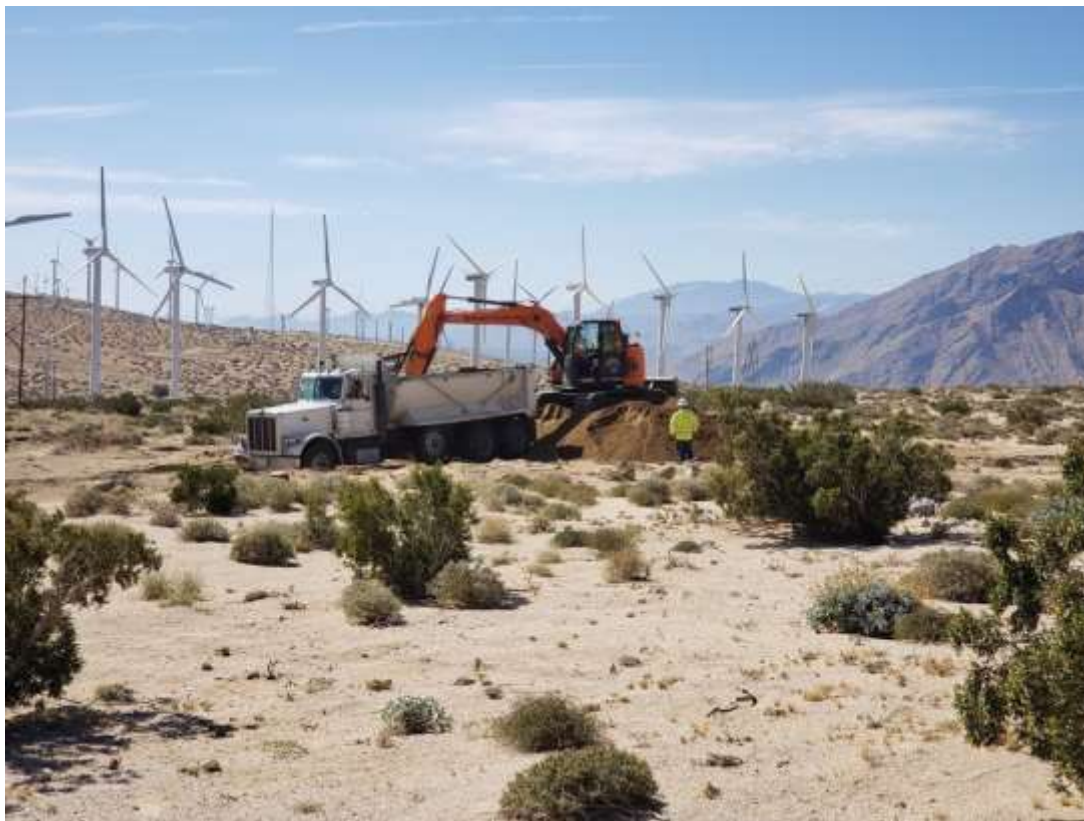
Photo 4 – Clearing, grubbing, and soil export activities on Segment 6 (May 28, 2019)

11. Work associated with Segment 6 (non-BLM lands) included: Vegetation clearing and grubbing at Construction Areas 6N16, 6N26, 6S26, and 6S27; grading and soil export at Construction Areas 6N25,

6N26, 6N27, 6S26, and 6S27 (see Photo 4); foundation work at Construction Areas 6X14, 6S15, 6S15, 6N16, and 6N17; BMP installation at Construction Areas 6N34 and 6N35; and access road maintenance between Construction Areas 6N25 and 6N26.

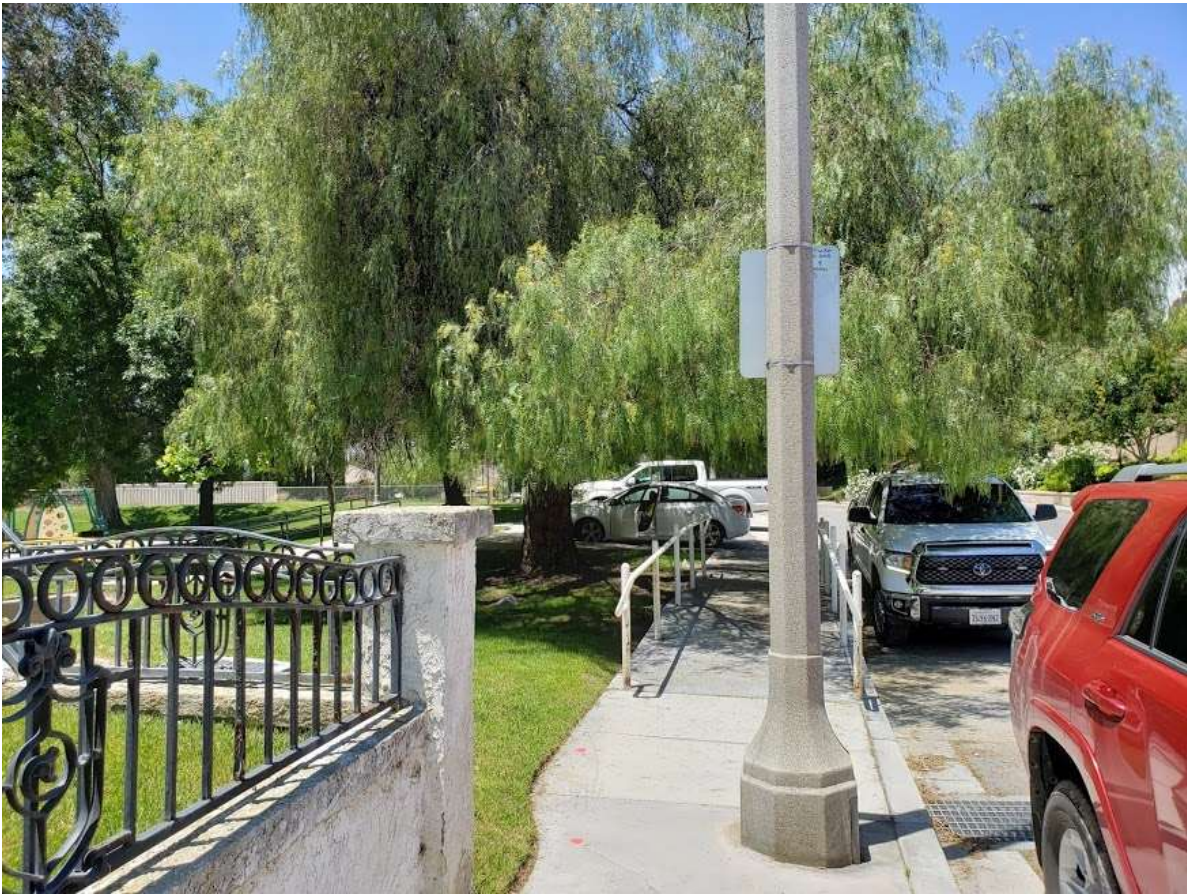
1. On May 28, CPUC EM observed construction personnel parked within active nest buffers near Construction Area 2N18 at a public park (see Photo 5). The CPUC EM notified the onsite Biological Monitor and the SCE Lead Avian Biologist. The crew vehicles were moved and notified there would be no parking allowed within the active nest buffers.

Photo 5 – Construction personnel vehicles within active nest buffers on Segment 2 (May 28, 2019)
