PROJECT MEMORANDUM
SCE WEST OF DEVERS UPGRADE PROJECT

To: John Forsythe, Project Manager, CPUC
From: Vida Strong, Aspen Project Manager
Date: June 13, 2019
Subject: Monitoring Report #67: June 2 to June 8, 2019

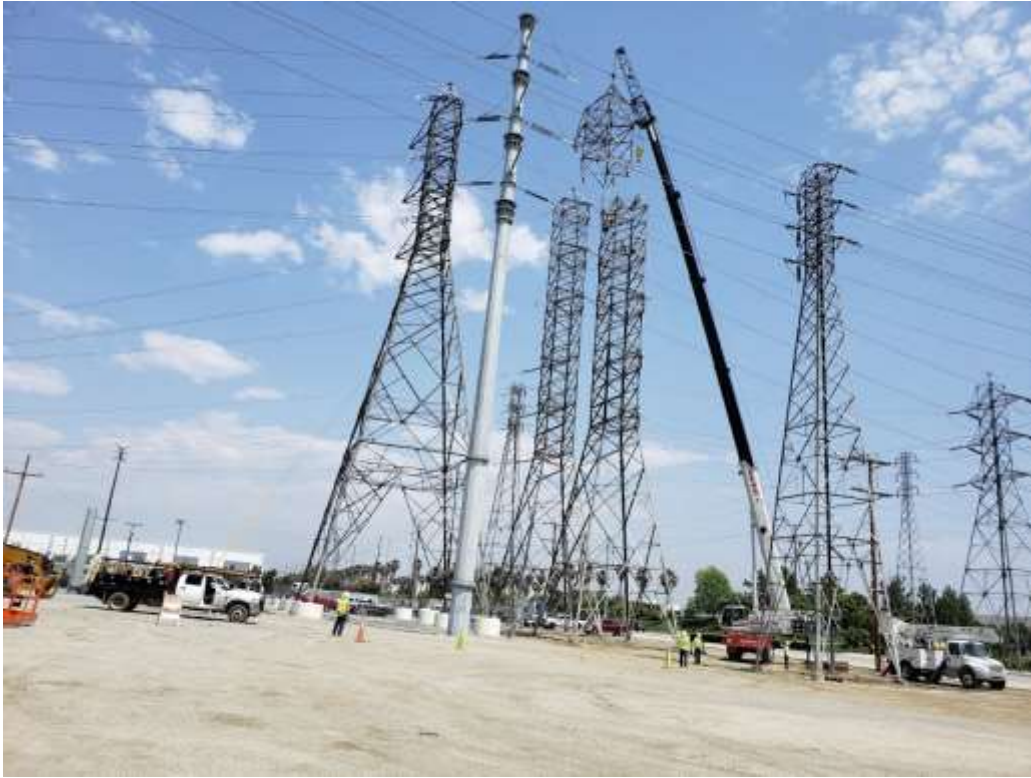
Photo 1 – Tower wreck-out activities on Segment 1 (June 3, 2019).

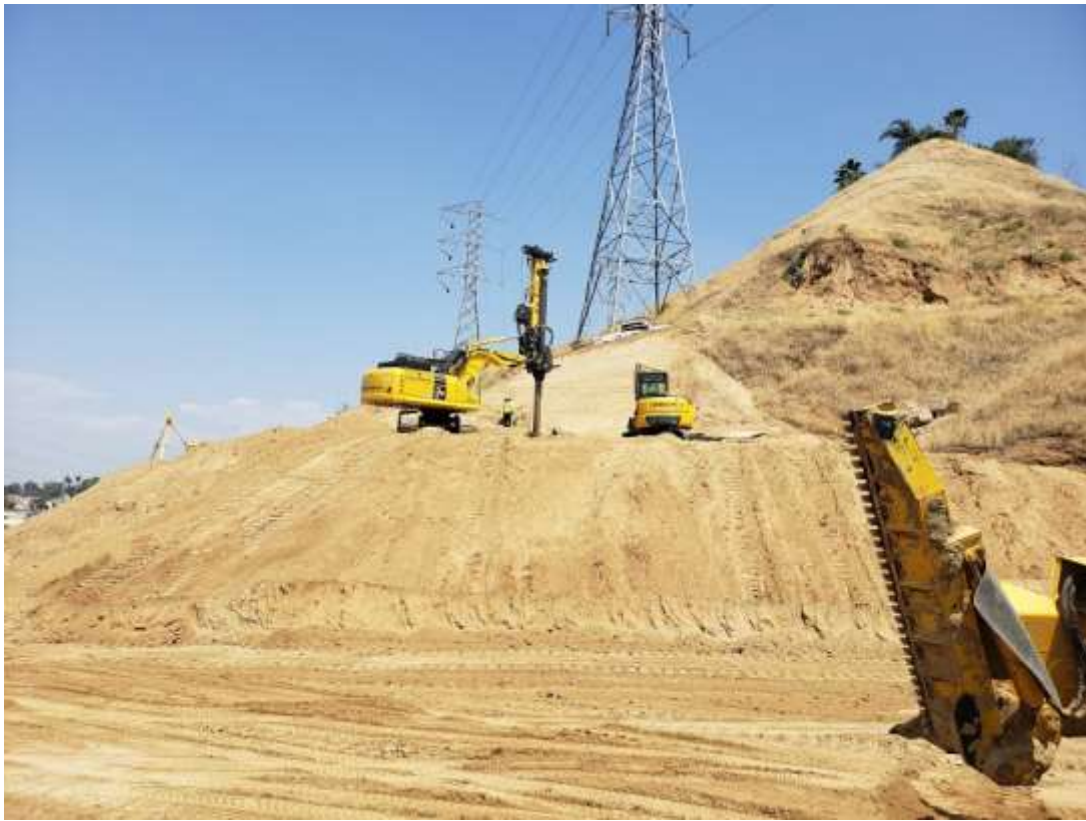
3. Work associated with Segment 2 included: Clearing, grubbing, and soil export at Construction Areas 2X18 and 2X25 (see Photo 2); grading, soil import, and soldier pile wall drilling at Construction Area 2X32 (see Photo 3); foundation work at Construction Area 2X07; guard structure installation at Construction Areas GS-2-E-2N21 and GS-2-2N26-2N29; access road maintenance from Construction Areas 2N01 to 2X32 and adjacent to WA-2-PradoLn-MPR26; and shaker plate installation where the project right-of-way meets Westwood Road, Hilltop Road, and Barton Road.

Photo 3 – Soldier pile wall drilling on Segment 2 (June 5, 2019).

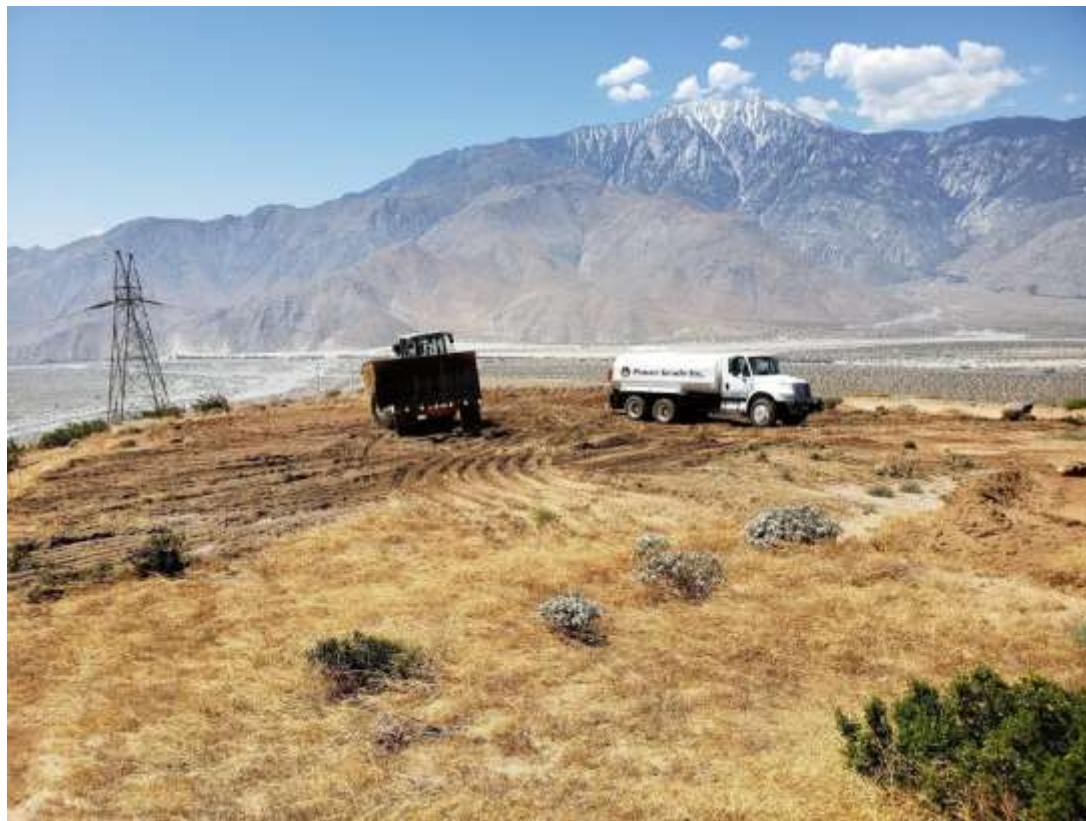
7. Work associated with Segment 6 (non-BLM lands) included: Vegetation clearing and grubbing at Construction Areas 6S28 and 6S28A (see Photo 4); grading at Construction Area 6S28; foundation work at Construction Areas 6X09, 6X14, 6S15, 6S15, 6N16, 6N18, 6S18, 6X19, 6N20, 6N21, and 6N22; BMP installation at Construction Areas 6S31, 6S33, 6S34, 6N35, 6S35, 6S36, 6N37, 6S37, 6S38, 6N39, 6S39, 6N40, 6S40, 6X41, 6S41E, 6X42, 6X43, T225, 6X44, 6X45, T223, M7-T3, 6X46, T238, T235, M6-T2, AND T232; and access road maintenance between Construction Areas 6S28 and 6S28A and from White Water Canyon Road to 6S29.

Photo 4 – Clearing, grubbing, and soil grading activities on Segment 6 (June 3, 2019)
