PROJECT MEMORANDUM
SCE WEST OF DEVERS UPGRADE PROJECT

To: John Forsythe, Project Manager, CPUC
From: Vida Strong, Aspen Project Manager
Date: September 23, 2019
Subject: Monitoring Report #80: September 8 to September 15, 2019

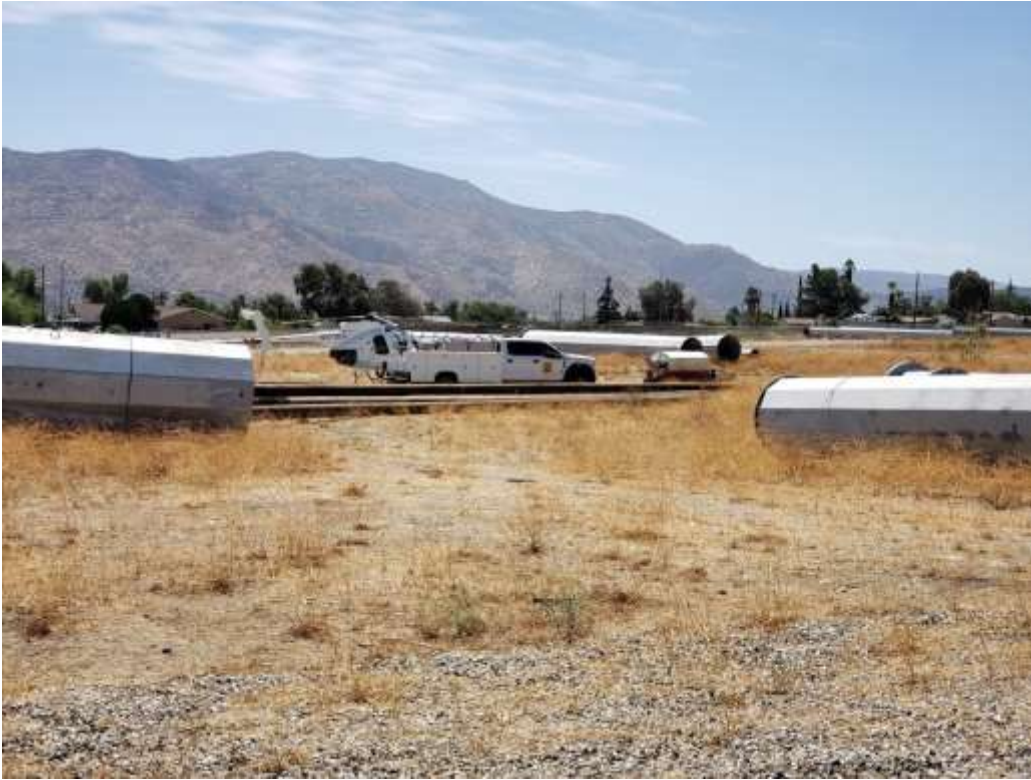
Photo 1 – Helicopter operations out of the Matich MY (September 9, 2019).

3. The Matich MY is being utilized by Barnard Construction primarily for tubular steel pole (TSP) storage. Work associated with the Matich MY included material/equipment deliveries throughout the monitoring period. Helicopter operations occurred out of the Matich Yard throughout the monitoring period (see Photo 1).

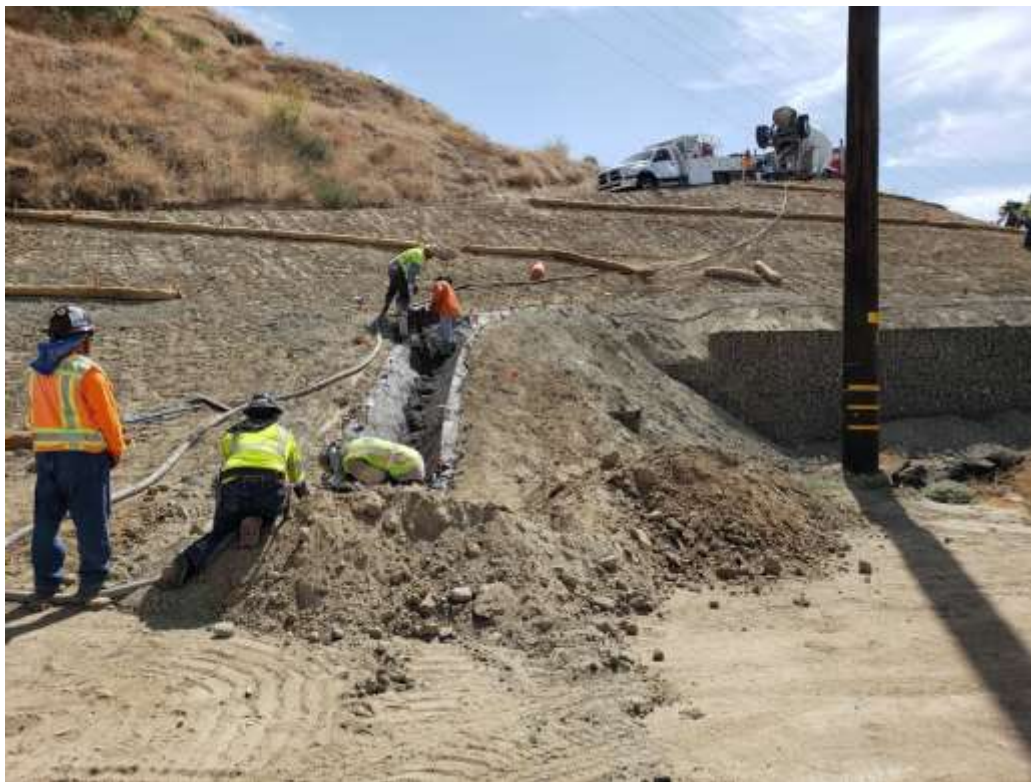
Photo 2 – Concrete pour for the v-ditch at Construction Area 2N32 on Segment 2 (September 9, 2019).

2. There were no work activities associated with Segment 1 during the monitoring period.
3. Work associated with Segment 2 included concrete pouring for the V-ditch at Construction Area 2N32 (see Photo 2).

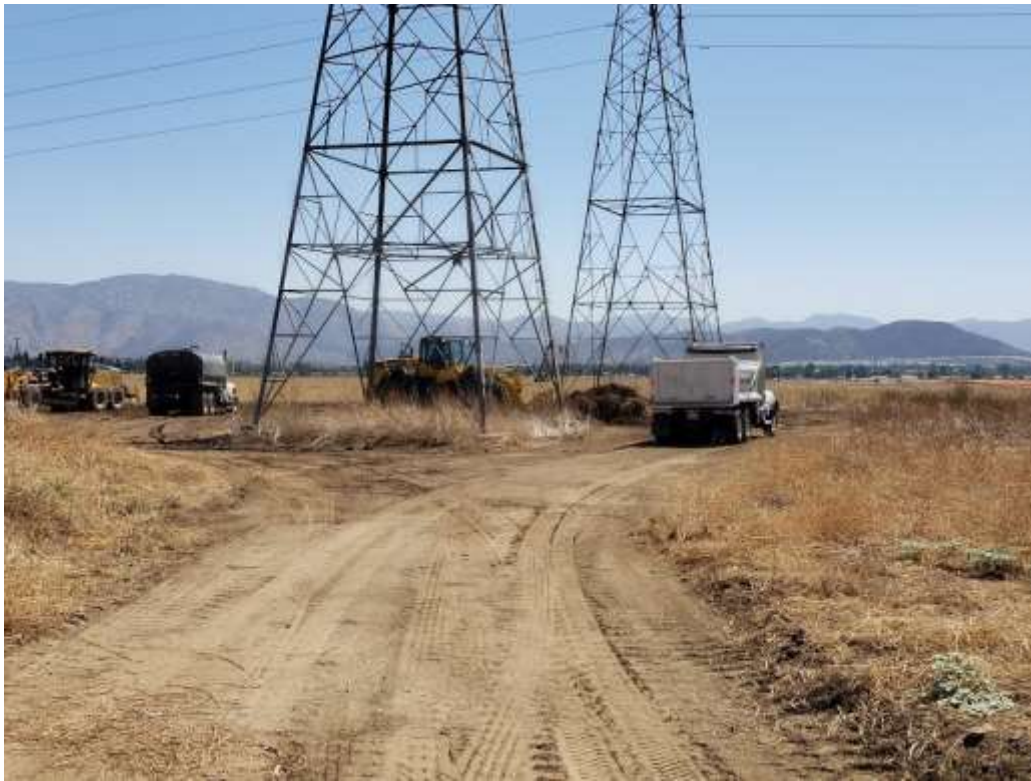
Photo 3 – Grading and soil export at Construction Area 4X20 on Segment 4 (September 11, 2019).

4. Work associated with Segment 3 included: hydroseed watering at Construction Areas 3X22, 3X40-E, 3X60-SE, and 3X65-SW.
5. Work associated with Segment 4 included: Grading at Construction Areas 4X20 through 4X31 (see Photo 3); grubbing at Construction Areas 4X19 and 4X20; material export at Construction Areas 4X19 through 4X26; BMP installation at Construction Areas 4X14 through 4X19; potholing at Construction Areas 4X03, 4X06, and 4X12; installing stabilized entrances to Construction Areas 4X22, 4X24, 4X26, 4X27, 4X30, and 4X32; access road maintenance from Construction Area 4X21 through 4X18 and 4X22 through Mountain Avenue; and hydroseed watering at Construction Areas 4N59, 4N60, 4N61, and 4N63.

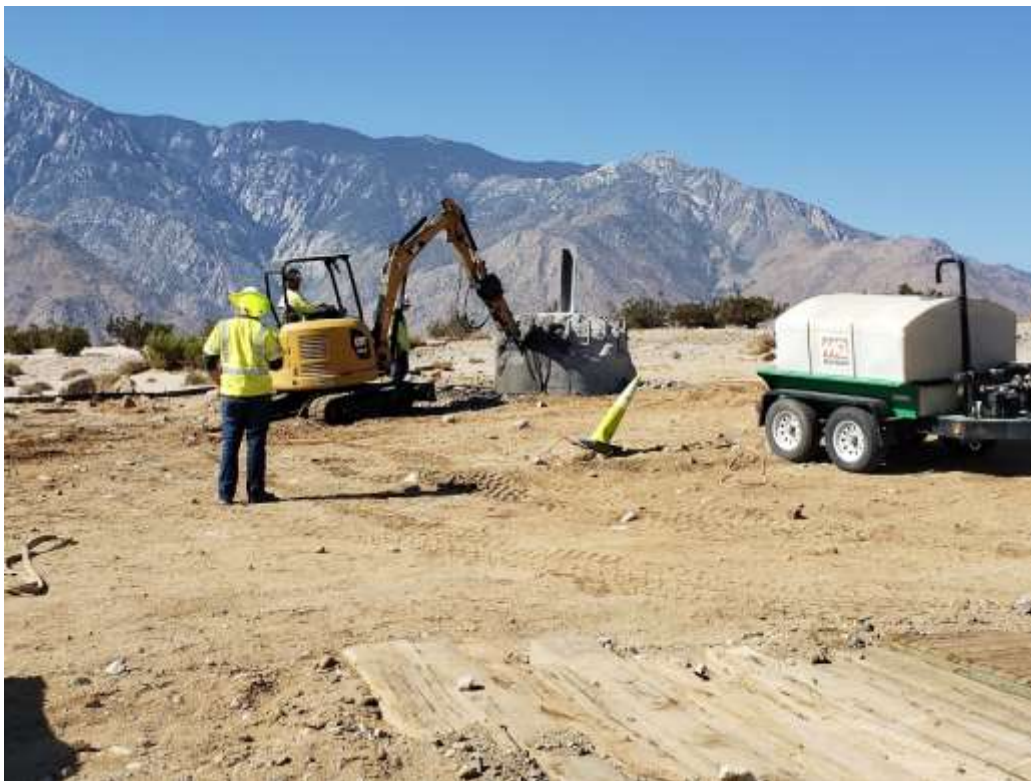
Photo 4 – Foundation wreck-out at Construction Area 6N27 on Segment 6 (September 9, 2019).

7. Work associated with Segment 6 (non-BLM lands) included: Foundation activities at Construction Areas 6X11 and 6S34 through 6S42; foundation removal at Construction Area 6N27 (see Photo 4); tower assembly at Construction Areas 6S11 through 6S14, 6N17, 6X20 through 6X23, and 6S26 (see

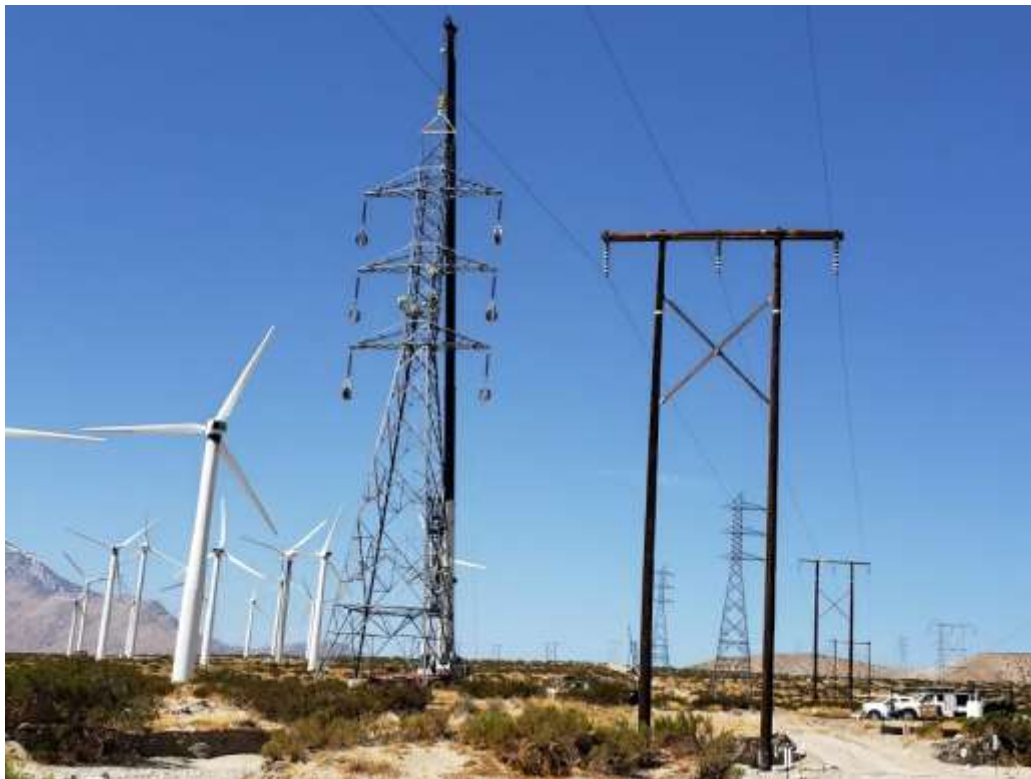
Photo 5 – Tower assembly at Construction Area 6S23 on Segment 6 (September 9, 2019).

Photo 5); BMP maintenance at Construction Areas 6X12, 6S25, 6S27, WSS-6- 6S26-6S27, T252, WSS-6-6S26-1-MPR-29, 6S26, and WSS-6-6S26-2-MPR-29; and tower wreck-out activities at Construction Areas T230, T232, T234 through T240, T248, T249, T252, and 6S34 (see Photo 6).

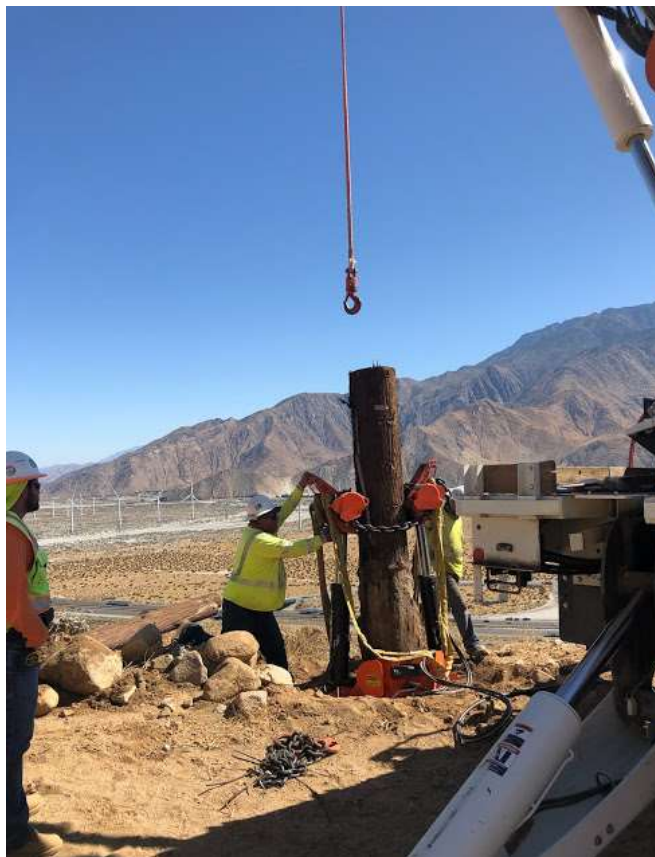
Photo 6 – H-frame removal at Construction Area T248 on Segment 6 (September 12, 2019).
