**PROJECT MEMORANDUM**  
**SCE WEST OF DEVERS UPGRADE PROJECT**

**To:** John Forsythe, Project Manager, CPUC  
**From:** Vida Strong, Aspen Project Manager  
**Date:** September 26, 2019  
**Subject:** Monitoring Report #81: September 16 to September 22, 2019

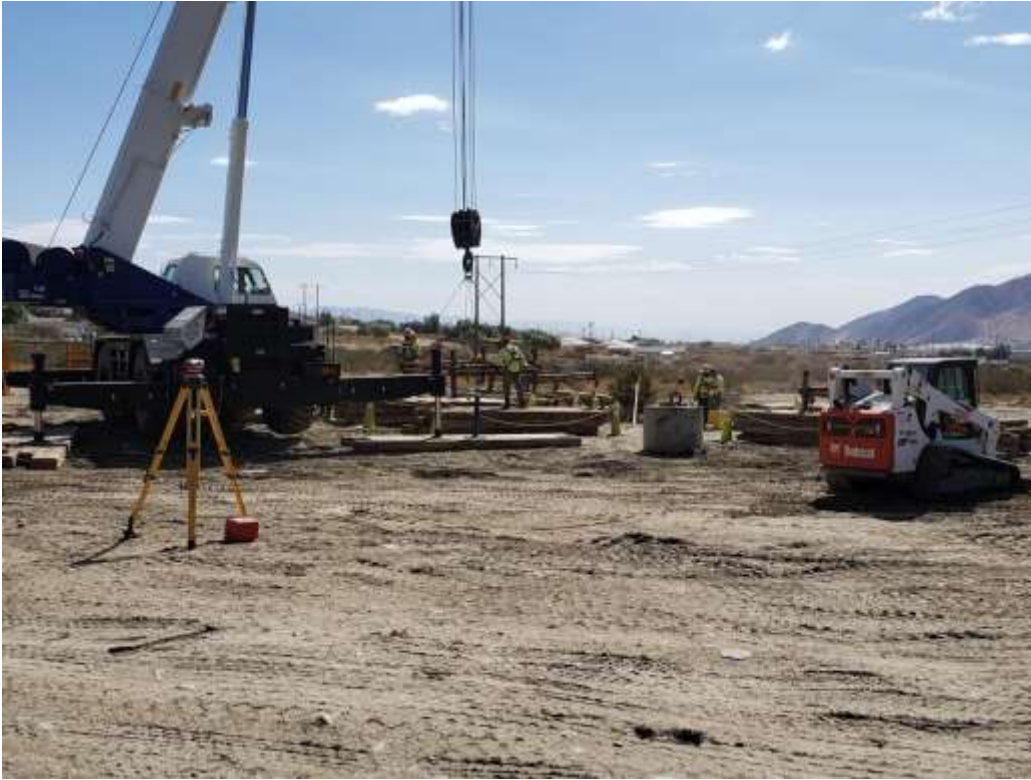
Photo 1 – Foundation activities at Construction Area 6X41 (September 16, 2019).

7. Work associated with Segment 6 (non-BLM lands) included: Foundation activities at Construction Areas 6X09 through 6X12, 6S37, and 6S39 through 6X45 (see Photo 1); foundation removal at Construction Area 6N27; tower assembly at Construction Areas 6X14, 6S15, and 6S18 through 6S22 (see Photo 2); BMP maintenance at Construction Areas 6N26 and 6S28; access road maintenance from Diablo Road to Construction Area 6X12; and tower wreck-out activities at Construction Areas T227, T230 through T241, T243, T248, and T256 through T271.

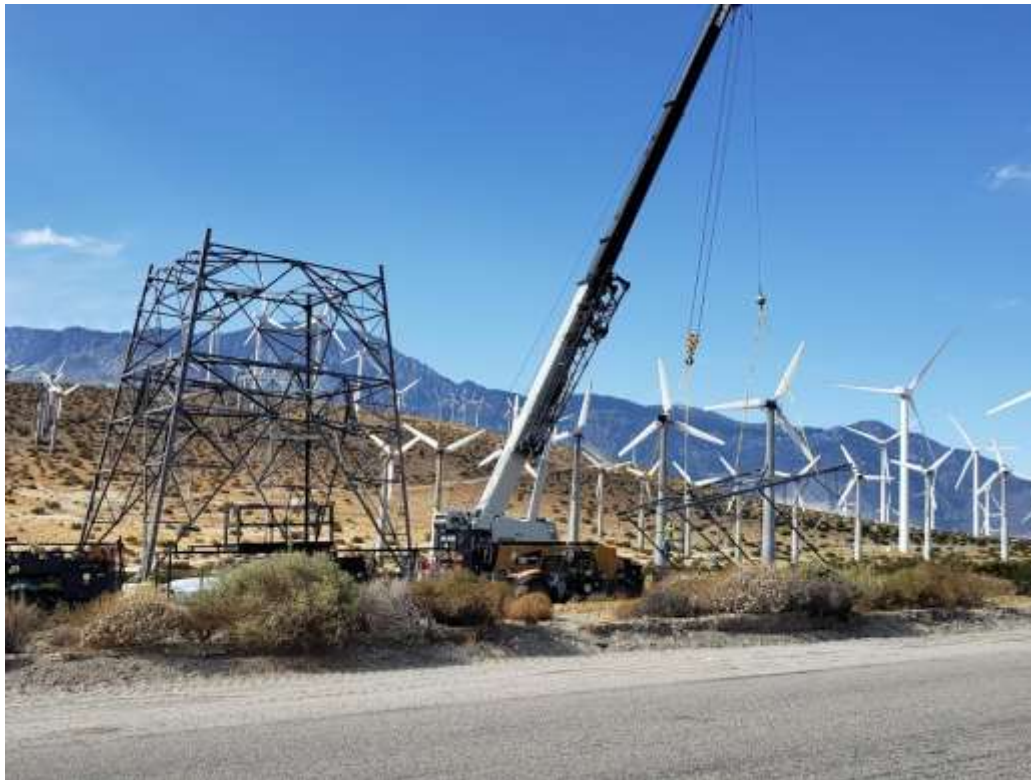
Photo 2 – Tower Assembly at Construction Area 6S20 (September 16, 2019).

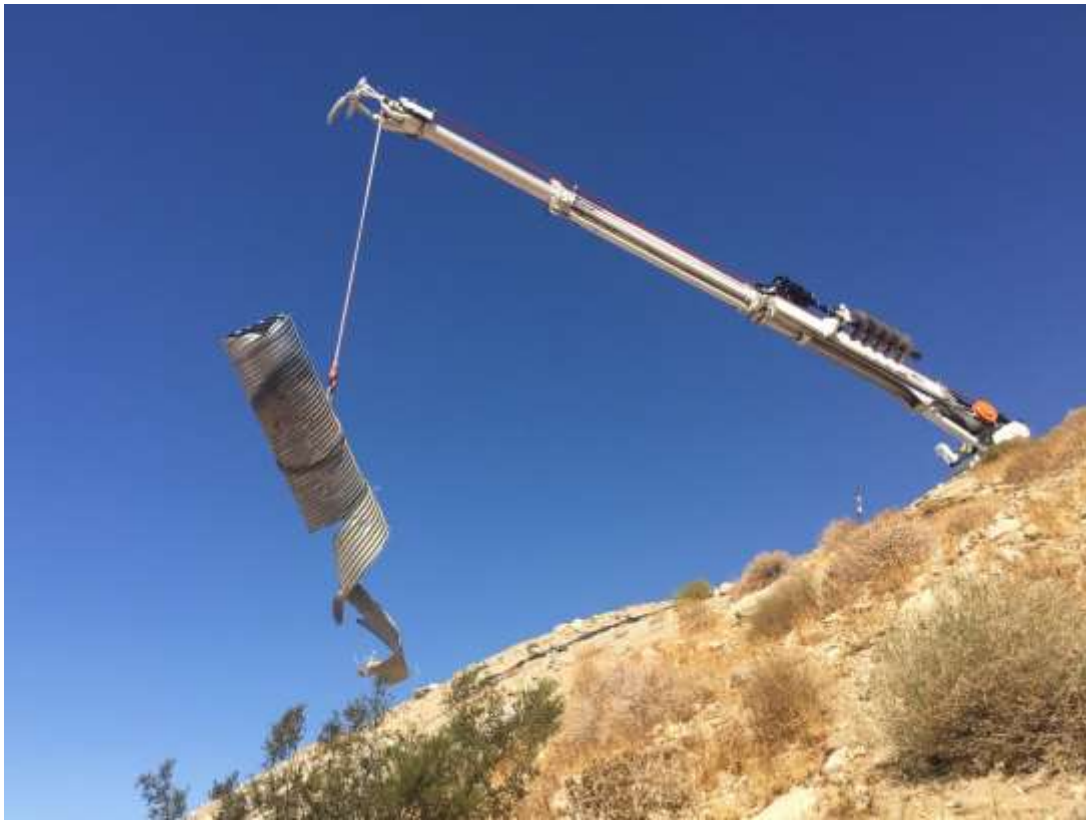
6. There was one SCE self-reported incident and one non-project related observation during the monitoring period. On September 20, a corrugated pipe casing that originally housed the in-ground pole butt at T248 was observed approximately forty feet down the side of a hill, outside of approved work limits, likely caused by a member of the public. The biologist surveyed the area between the pipe and area it likely tumbled along and no sensitive biological resources (e.g., suitable burrows) or dead or injured animals were observed. The pipe was dragged up the hill by a rope then lifted by a boom truck (see Photo 3). The disturbed area was raked to smooth over any disturbed soil. No vegetation aside from non-native grass was impacted. The non-project related observation was of dumped trash near Construction Area 6S28-A.

Photo 3 – Corrugated pipe retrieval at T248 (September 20, 2019) (Photo courtesy of SCE).

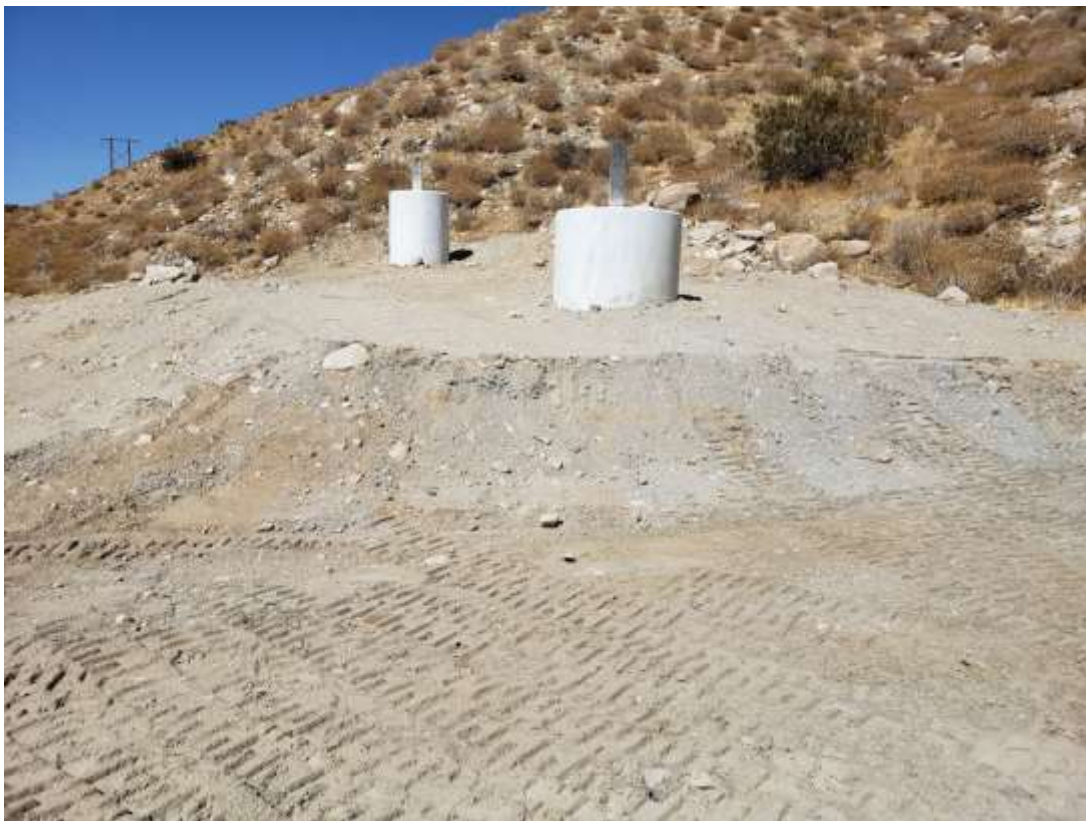
7. On September 24, the CPUC EM observed several Construction Areas within Segment 6 where concrete slurry was spread onsite instead of being disposed of offsite per requirements of the Project SWPPP (see Photo 4). A Level 1 incident was issued by the CPUC Lead EM on September 25, which included additional questions for SCE about potential future impacts at each site.

Photo 4 – Concrete slurry spreading level 1 incident on Segment 6 (September 24, 2019).
