PROJECT MEMORANDUM
SCE WEST OF DEVERS UPGRADE PROJECT

To: John Forsythe, Project Manager, CPUC
From: Vida Strong, Aspen Project Manager
Date: October 24, 2019
Subject: Monitoring Report #85: October 14 to October 20, 2019

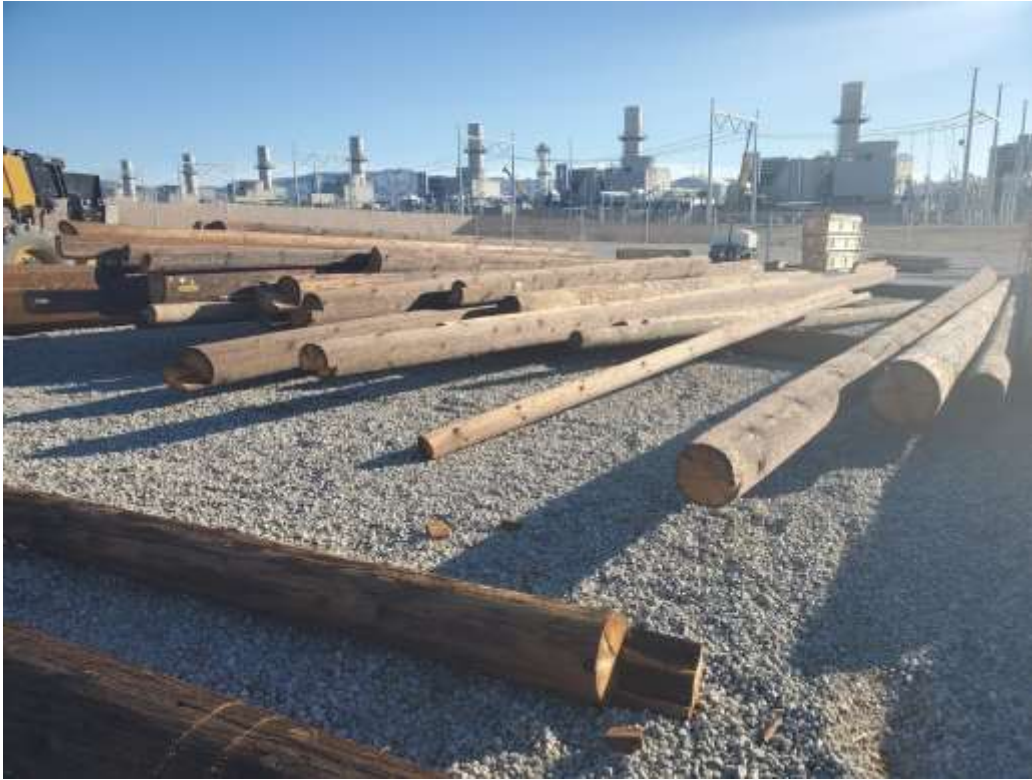
1. There were no SCE self-reported or CPUC incidents documented for construction activities associated with NTP #1 throughout the monitoring period.
2. On October 21, the CPUC EM observed treated wood poles improperly stored at the Devers, Matich, and Poultry MYs (Photo 1). Specifically, none of the treated poles were covered and poles were placed on cribbing at only one out of the three locations. Both the Inspectors and the contractor were aware of the issue at the Devers Yard; however, it had not been documented as a maintenance item or included in SWPPP inspection reports. A Level 1 Incident Report was issued to SCE on October 22 with additional questions to SCE regarding the reasoning for not including the wood pole storage issue in SWPPP inspection reports or maintenance logs and recommended repairs or design changes to the BMPs in place of covering over the poles. To date, SCE has not responded to the Incident Report.

Photo 1 –Treated wood poles stored improperly at the Devers MY (October 21, 2019).

Incident/ PM/NCR	Regulatory Requirement	Date Issued	Phase	Description
Level 1 Incident	SWPPP	09-25-19	Segment 6	The disposal of slurry at tower sites in Segment 6.
Level 1 Incident	SWPPP	10-22-19	Devers, Match, and Poultry MY	Improper storage of treated wood poles.

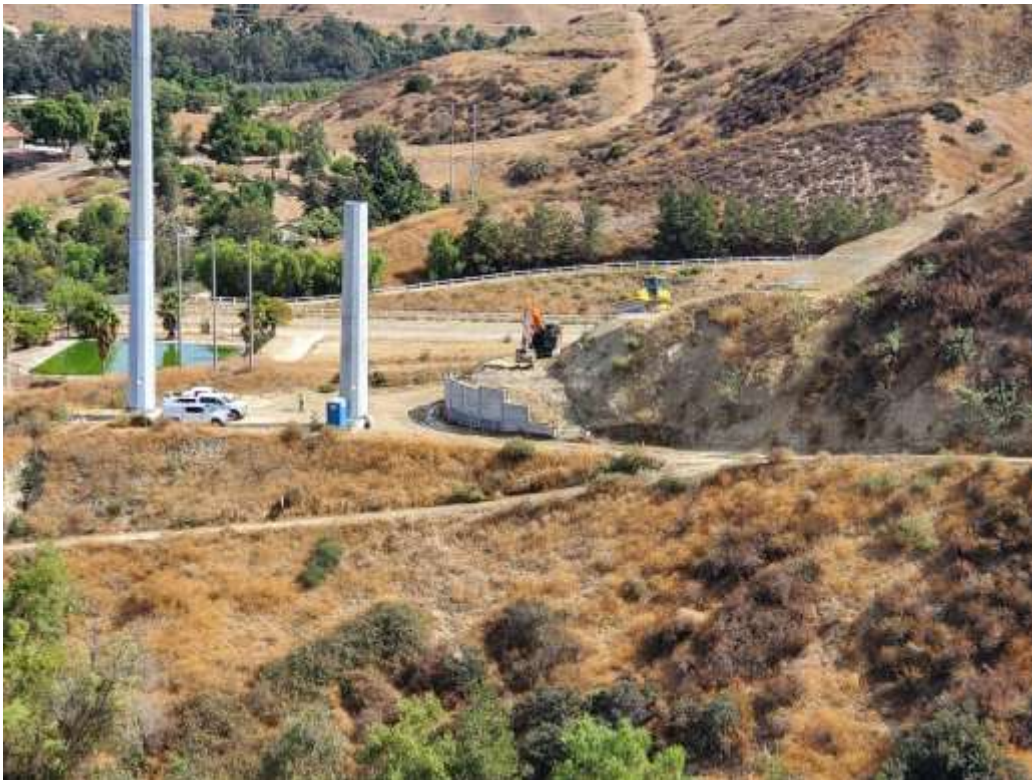
4. Work associated with Segment 3 included: Grading and material export at Construction Area 3X36 (see Photo 2); roadway maintenance from Redlands Boulevard to Live Oak Canyon Road; BMP maintenance at Construction Areas 3N04, 3X06, 3X08, 3X10, 3X19 through 3X25, 3X40 through 3X57, and 3X59 through 3X64; and hydroseed watering at Construction Areas 3X22, 3X40-E, 3X60-SE, and 3X65-SW.

Photo 2 – Grading activities at Construction Area 3X36, Segment 3 (October 16, 2019).

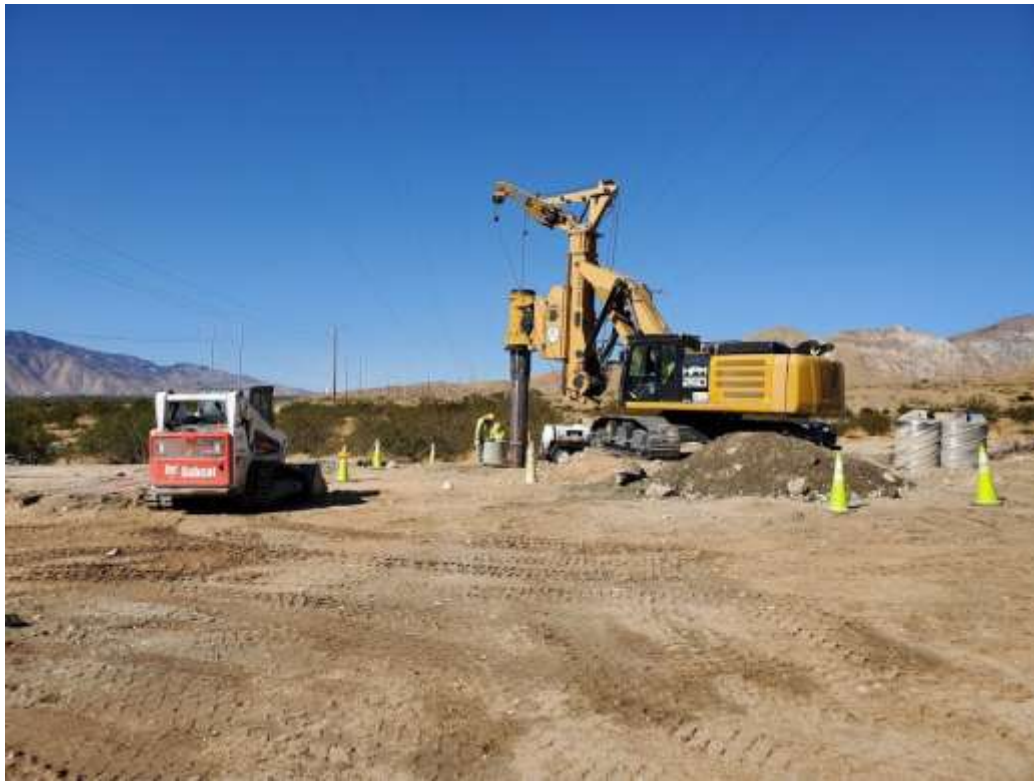
6. Work associated with Segment 5 (which includes sites within Morongo lands along Segment 5 as reported by SCE) included: foundation activities at Construction Areas 5X03 (see Photo 3) and 5X04.

Photo 3 – Foundation activities at Construction Area 5X03, Segment 5 (October 17, 2019).

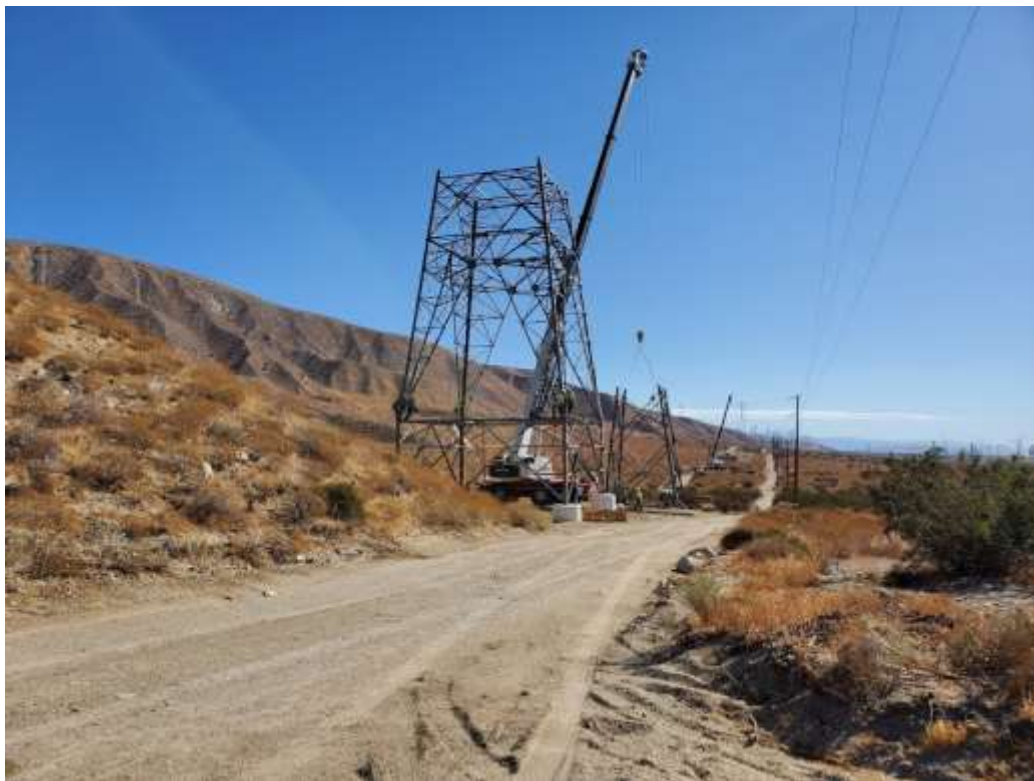
7. Work associated with Segment 6 (non-BLM lands) included: Foundation activities at Construction Areas 6X08 through 6X12, 6N16, 6N17, 6N19, 6N22, 6N25, 6N27, 6X40, 6X41, 6X47, and 6X48; BMP maintenance at Construction Areas 6X08 through 6N27 and 6S29 through 6S31; tower assembly at Construction Areas 6S29 through 6S37 (see Photo 4); and wire stringing activities from Construction Area 6S10 through 6S34 (see Photo 5).

Photo 4 – Tower assembly at Construction Area 6S36, Segment 6 (October 17, 2016).

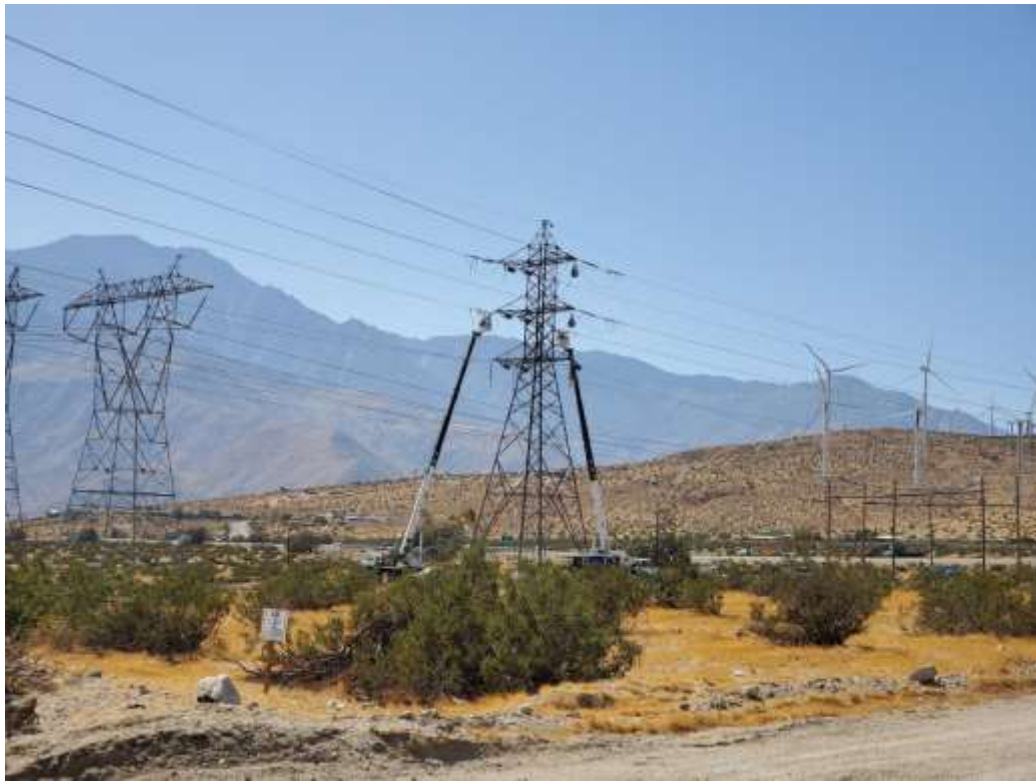
Photo 5 – Wire stringing activities on Segment 6 (October 14, 2019).
