PROJECT MEMORANDUM
SCE WEST OF DEVERS UPGRADE PROJECT

To: John Forsythe, Project Manager, CPUC
From: Vida Strong, Aspen Project Manager
Date: November 7, 2019
Subject: Monitoring Report #87: October 28 to November 3, 2019

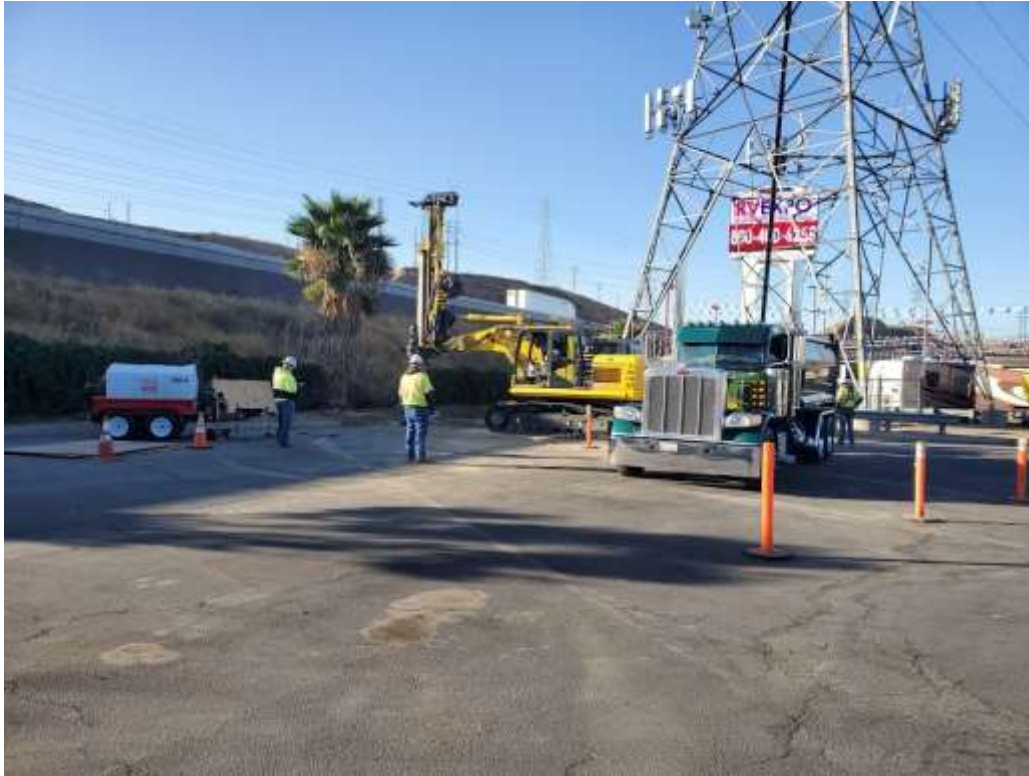
Photo 1 – Guard pole drilling at GS-2-W-2N32, Segment 2 (October 29, 2019).

2. There were no work activities associated with Segment 1 during the monitoring period.
3. Work associated with Segment 2 included: Tower assembly at Construction Area 2N12; vegetation clearing and grading at Construction Areas 2N01-WSS, 2N01, 2N12, WSS-2N12-MPR-31, WSS-2-2N26-2-MPR-28, 2X18, and 2X33-34; grading, roadway maintenance, and k-rail installation at Construction Area 2N32; and guard pole drilling and installation at GS-2-W-2N32 and GS-2-E-2N32 (see Photo 1).

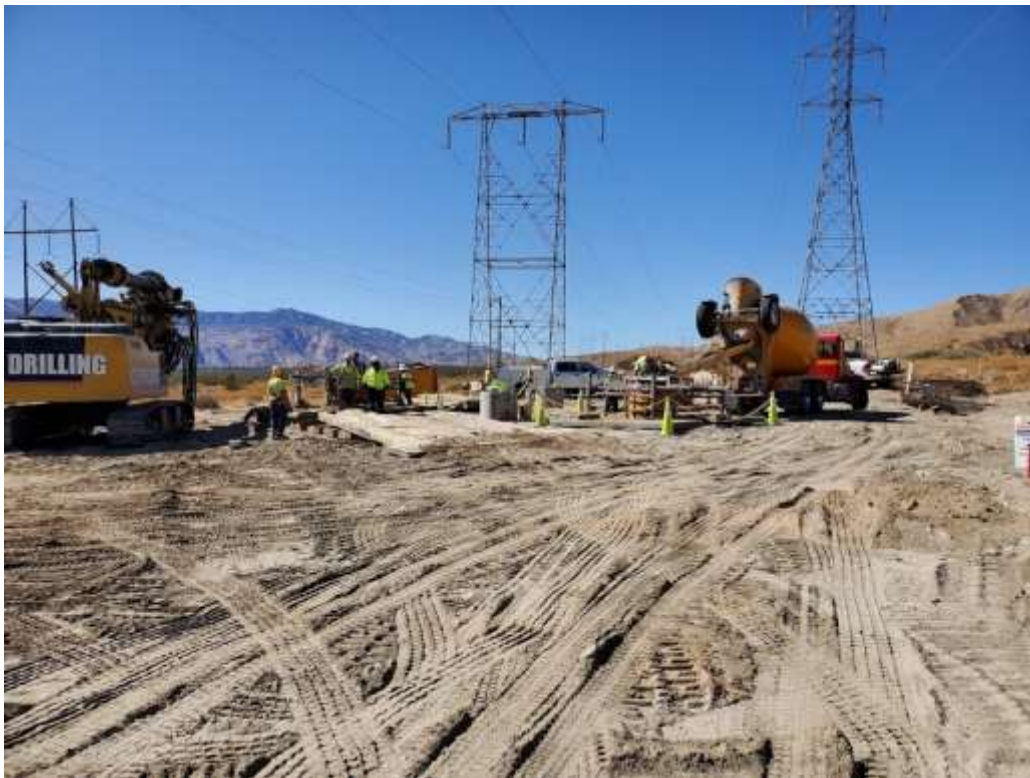
Photo 2 – Foundation activities at Construction Area 5X04, Segment 5 (October 28, 2019).

6. Work associated with Segment 5 (which includes sites within Morongo lands along Segment 5 as reported by SCE) included foundation activities at Construction Areas 5X03, 5X04, 5X09, and 5X10 (see Photo 2).

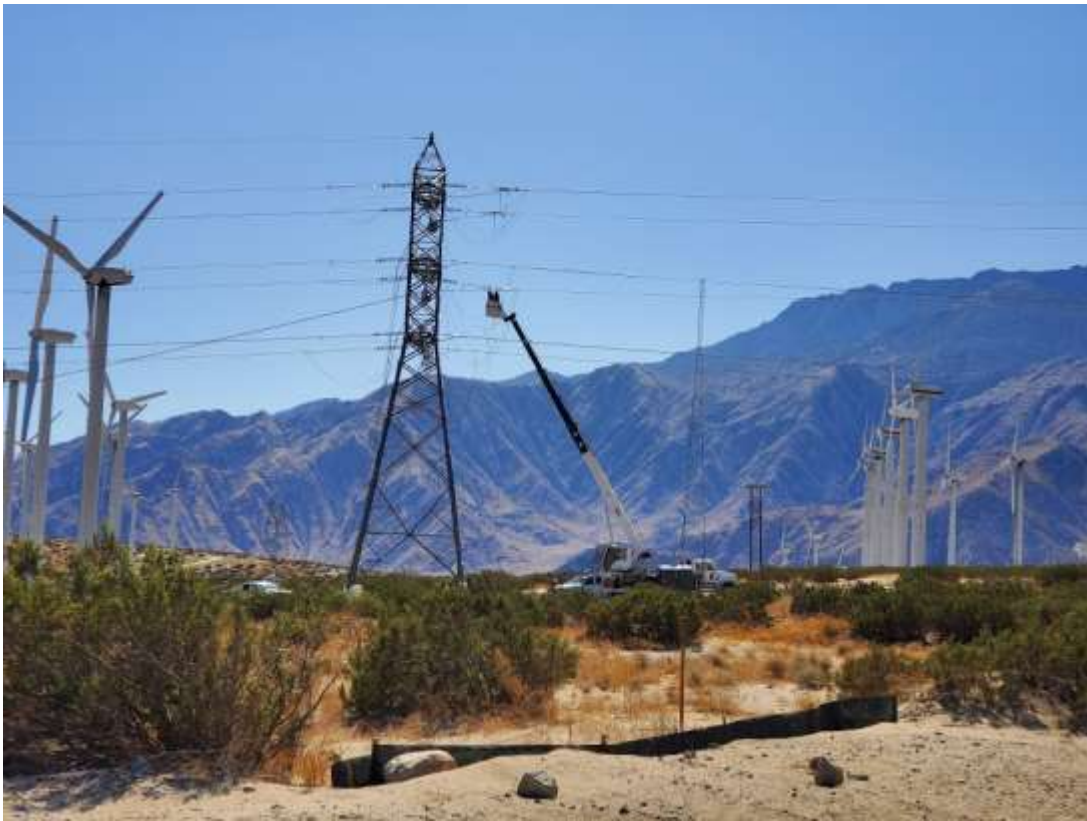
Photo 3 – Wire stringing activities at Construction Area 6S26, Segment 6 (October 28, 2019).

7. Work associated with Segment 6 (non-BLM lands) included: Foundation activities at Construction Areas 6X09, 6X10, 6N27, 6S31, and 6X48; tower assembly at Construction Areas 6X10, 6N26, and 6S38 through 6S41; BMP maintenance at Construction Areas 6N27 and 6S36; wire stringing punchlist items at Construction Areas 6S14 through 6S22; and wire stringing activities from Construction Area 6S26 through 6S34 (see Photo 3).

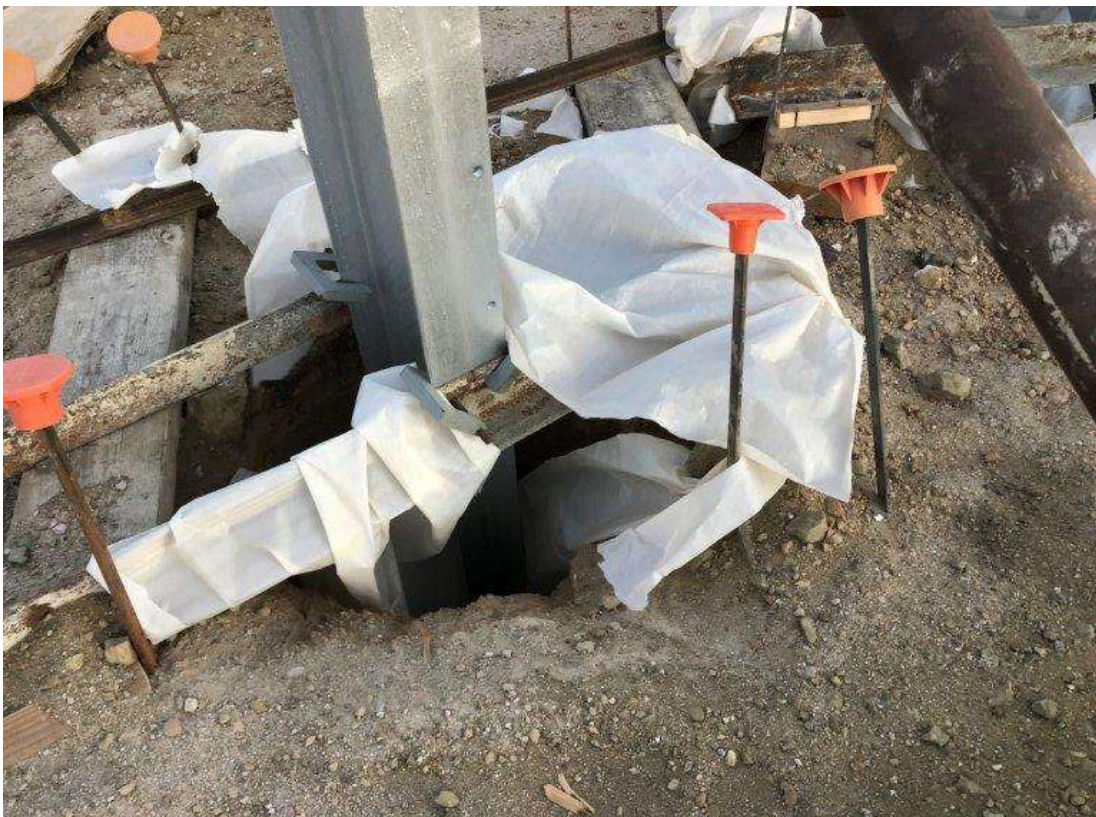
1. There were two SCE self-reported incidents and four non-project related observations during the monitoring period. On October 30, the onsite biologist observed one drill hole fully uncovered and other drill holes with large rips in the plastic covering at Construction Area 4X13 on Segment 4, resulting in SCE issuing a Level 1 Incident (see Photo 4). Plastic was present over the holes and secured around the edges; however, due to high winds overnight, the plastic was ripped open. On November 3, a rigging failure during wire stringing operations on Segment 6 occurred resulting in the conductor and a traveler touching the ground outside of the approved work area north of Construction Area 6S30. The onsite biological monitor assessed the area after the conductor was secure, the remaining sagging activities of the day were completed, and a Level 1 Incident was issued. The non-project related observations were for trash dumped along the right-of-way and non-project related construction activities in Segments 1 and 6.

Photo 4 – Uncovered drill hole at Construction Area 4X13, Segment 4 (October 30, 2019).
