PROJECT MEMORANDUM
SCE WEST OF DEVERS UPGRADE PROJECT

To: John Forsythe, Project Manager, CPUC
From: Vida Strong, Aspen Project Manager
Date: February 13, 2020
Subject: Monitoring Report #98: February 3 to February 9, 2020

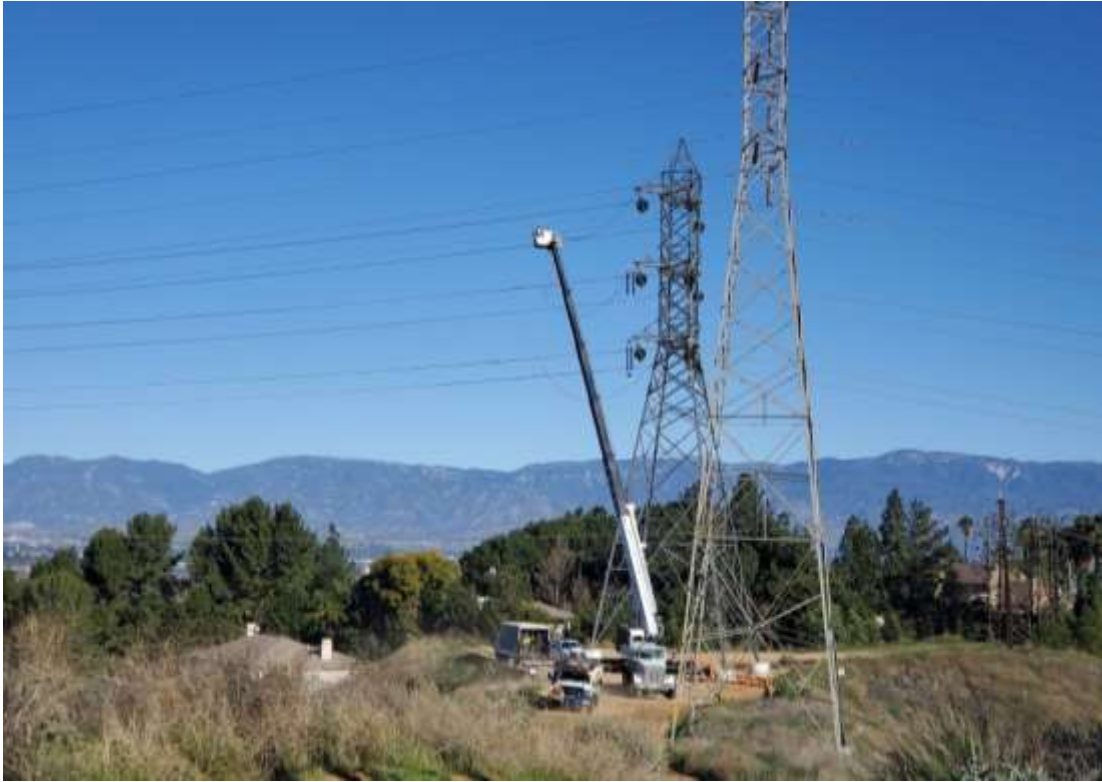
Photo 1 – Wire stringing activities at Construction Area 2N22, Segment 2 (February 4, 2020).

3. Work activities associated with Segment 2 included: Wire stringing activities (helicopter and ground) at Construction Areas 2N01 through 2N35 (see Photo 1); BMP maintenance at Construction Area 2N35; and overnight netting repair over the I-215 freeway between Construction Areas 2N32 and 2N33.

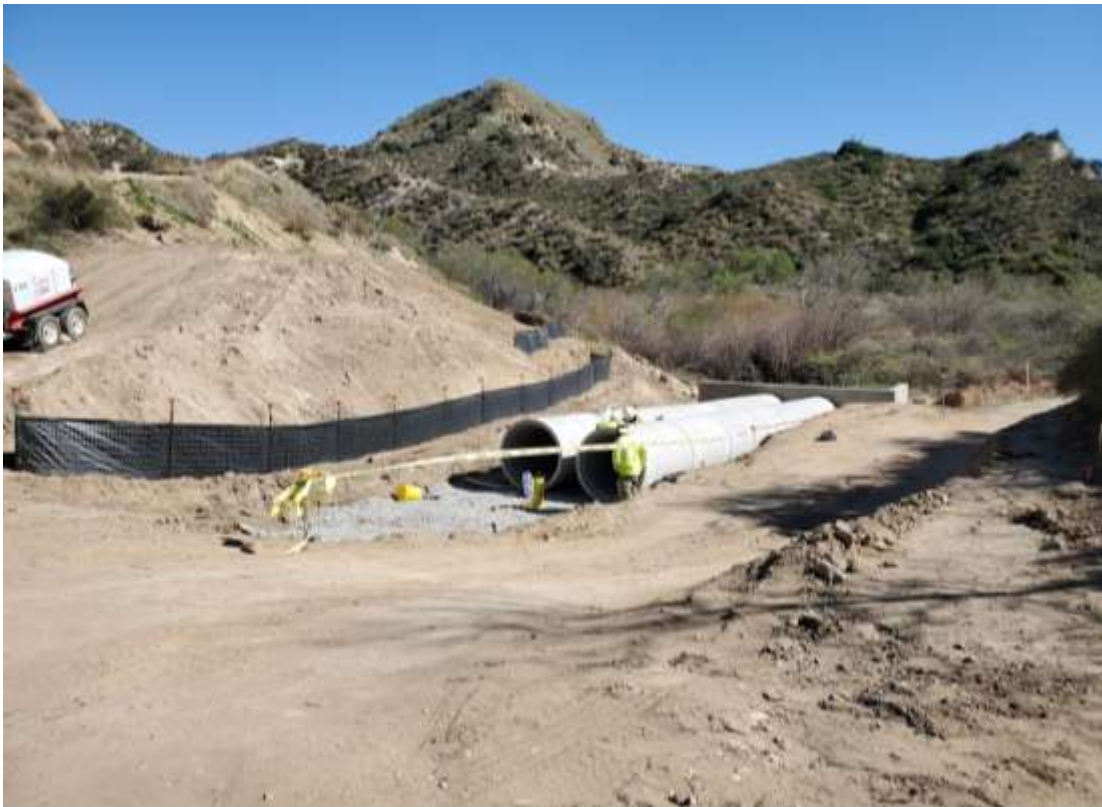
Photo 2 – Concrete crossing activities at Construction Area 4X04, Segment 4 (February 4, 2020).

5. Work associated with Segment 4 included: Sacking and patching the culvert drain on the access road to Construction Area 4X04 (see Photo 2); foundation activities at Construction Areas 4X36, and 4X39 through 4X44; tower assembly at Construction Areas 4X14 through 4X18; erecting Shoofly SF421 and conductor transfer at Construction Area 4X15; hydroseed watering at Construction Areas 4N59, 4N62, and 4N63; and BMP maintenance at Construction Areas 4X38 through 4X41.

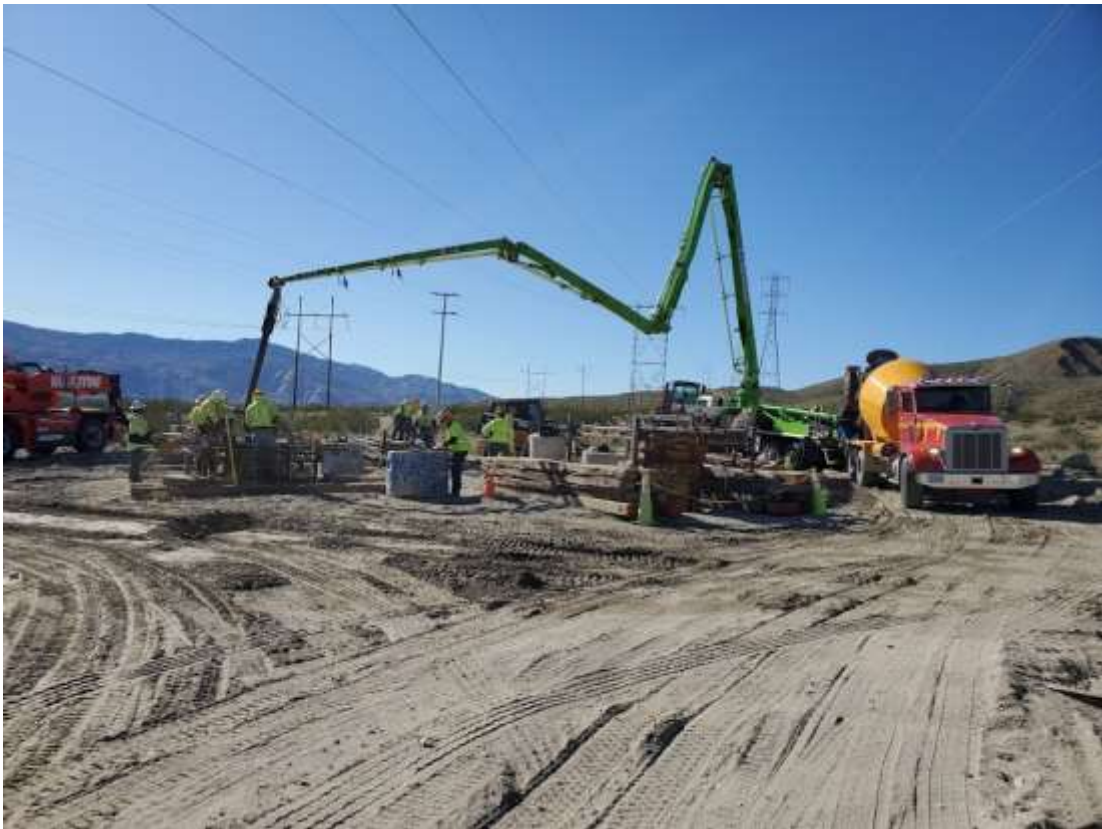
Photo 3 – Foundation activities at Construction Area 5X05, Segment 5 (February 4, 2020).

6. Work associated with Segment 5 (which includes sites within Morongo lands along Segment 5 as reported by SCE) included: Foundation activities at Construction Areas 5X04 through 5X06, 5X23, and 5X30 (see Photo 3); removing slurry at Construction Area 5X22; stockpile removal at Construction Area 5X20; importing rock material to Construction Area Stockpile-Morongos-MPR-3; removing the bolt template from Construction Area 5X54; and tower assembly at Construction Areas 5X16 through 5X19.

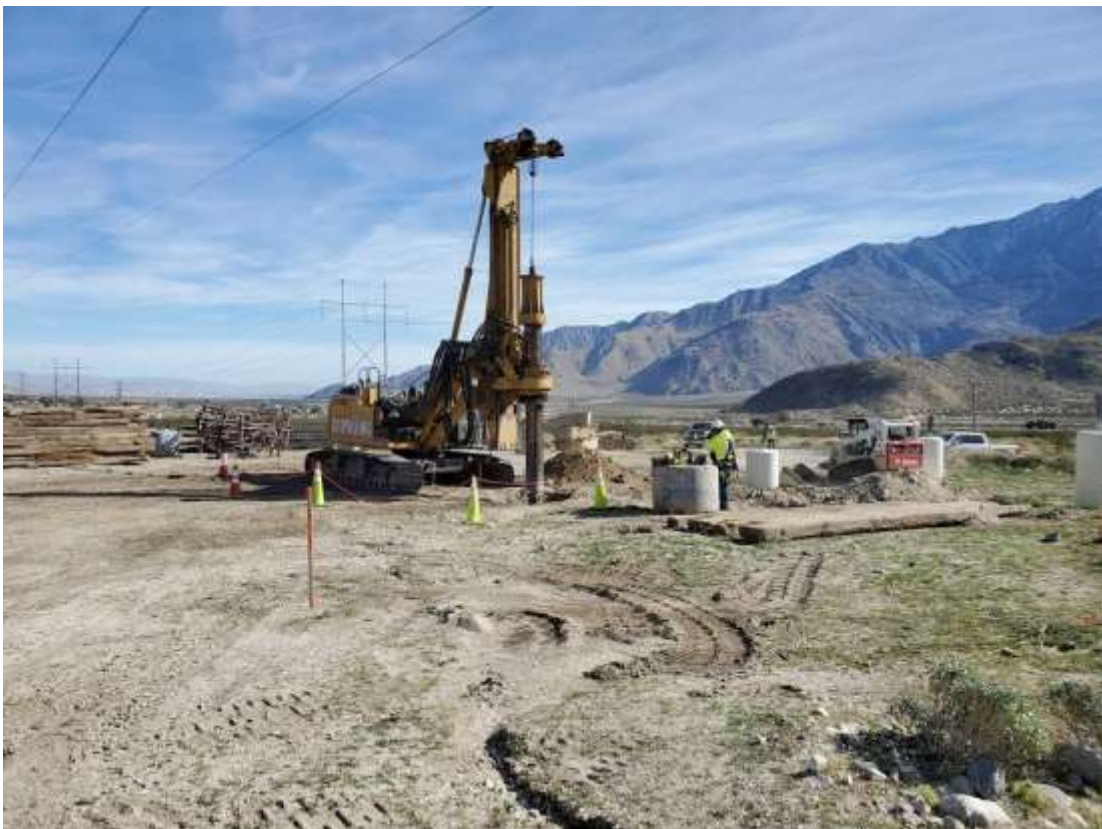
Photo 4 – Foundation activities at Construction Area 6X45, Segment 6 (February 5, 2020).

7. Work associated with Segment 6 (non-BLM lands) included: Drilling, placing lagging, pouring concrete, and setting cages and I-beams for soldier pile wall construction at Construction Area 6N30; and foundation activities at Construction Areas 6X42 and 6X45 (see Photo 4).
