PROJECT MEMORANDUM
SCE WEST OF DEVERS UPGRADE PROJECT

To: John Forsythe, Project Manager, CPUC
From: Vida Strong, Aspen Project Manager
Date: February 27, 2020
Subject: Monitoring Report #100: February 17 to February 23, 2020

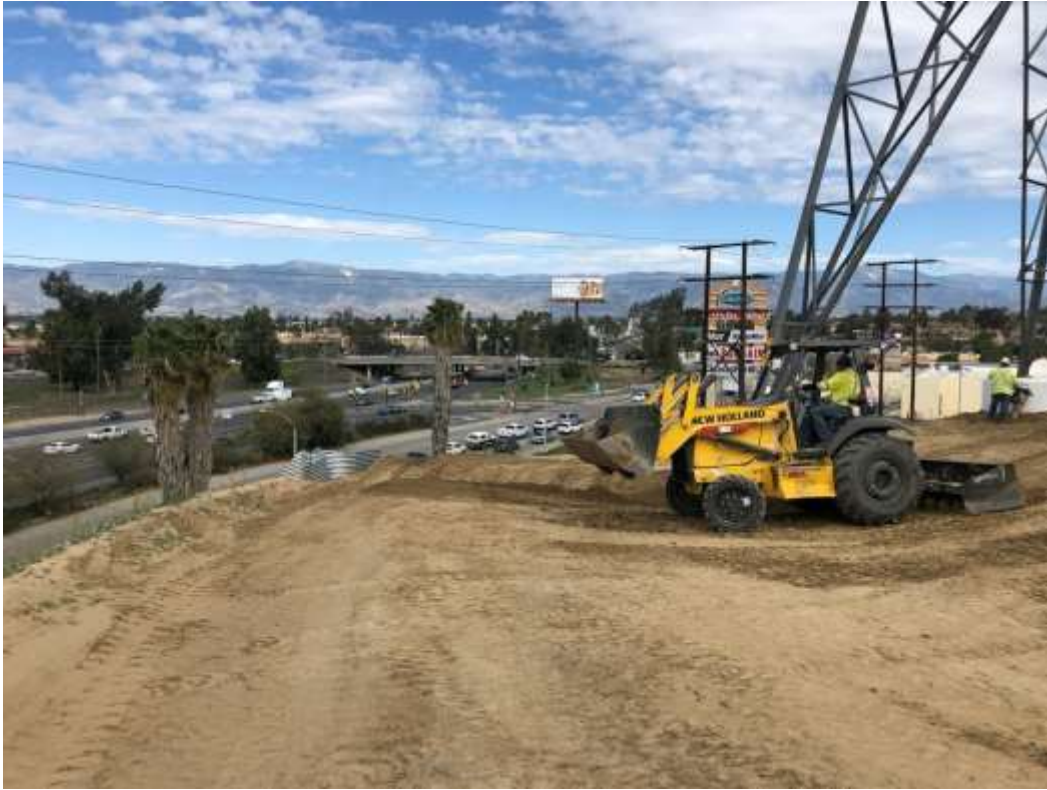
Photo 1 – Restoration grading at Construction Area 2N32 (February 21, 2020).

2. There were no work activities associated with Segment 1 during the subject monitoring period.
3. Work activities associated with Segment 2 included: Wire stringing punch-list items at Construction Areas 2N12, 2N31, and 3N32; site clean-up activities at Construction Areas 2N01 through 2N36; BMP maintenance at Construction Area 2N32; and restoration grading at Construction Area 2N32 (see Photo 1).

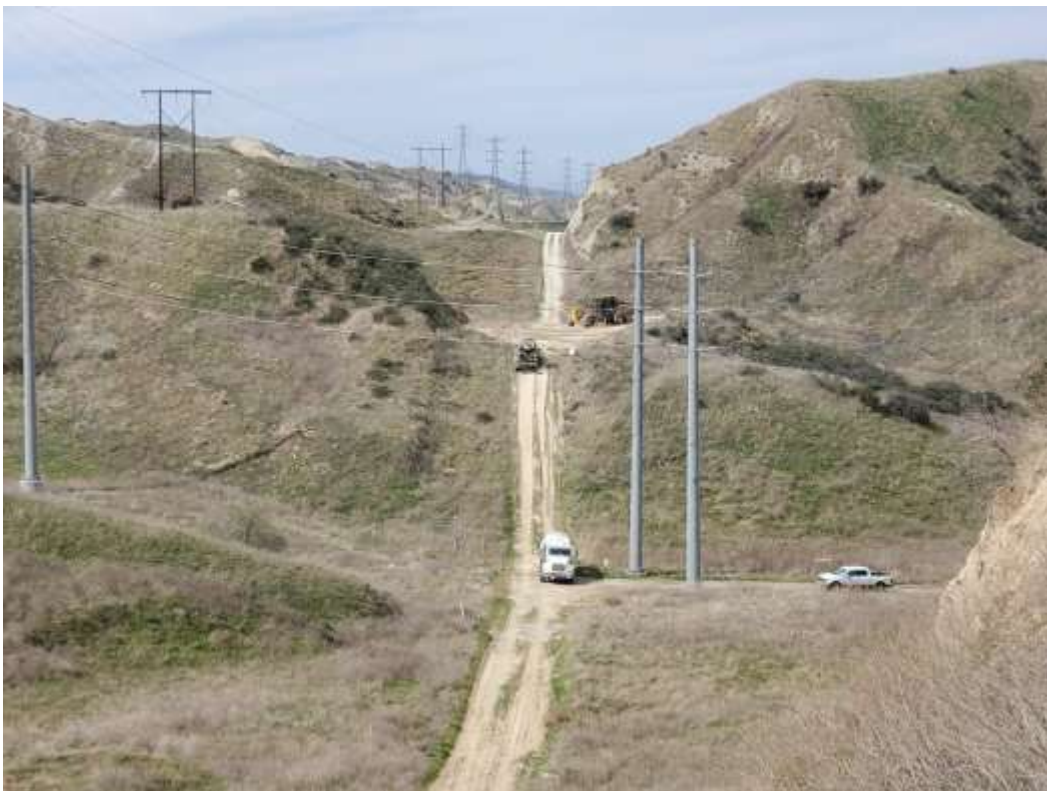
Photo 2 – Grading at Construction Area 3S03, Segment 3 (February 17, 2020).

4. Work activities associated with Segment 3 included: Vegetation removal and grading at Construction Areas 3S02 and 3S03 (see Photo 2); material export from Construction Area 3S02; foundation compaction and final grade at Construction Areas 3X37, 3X40, 3X43, and 3X46; MAC drain installation at Construction Areas 3X33, 3X42, 3X43, 3X60, and 3X62 (see Photo 3); hydroseed watering at Construction Areas 3N03, 3N04, 3X10, 3X12, and 3X14; permanent BMP installation activities at Construction Area 3X33; and roadway and spur road maintenance from Construction Area 3S04 through 3X07.

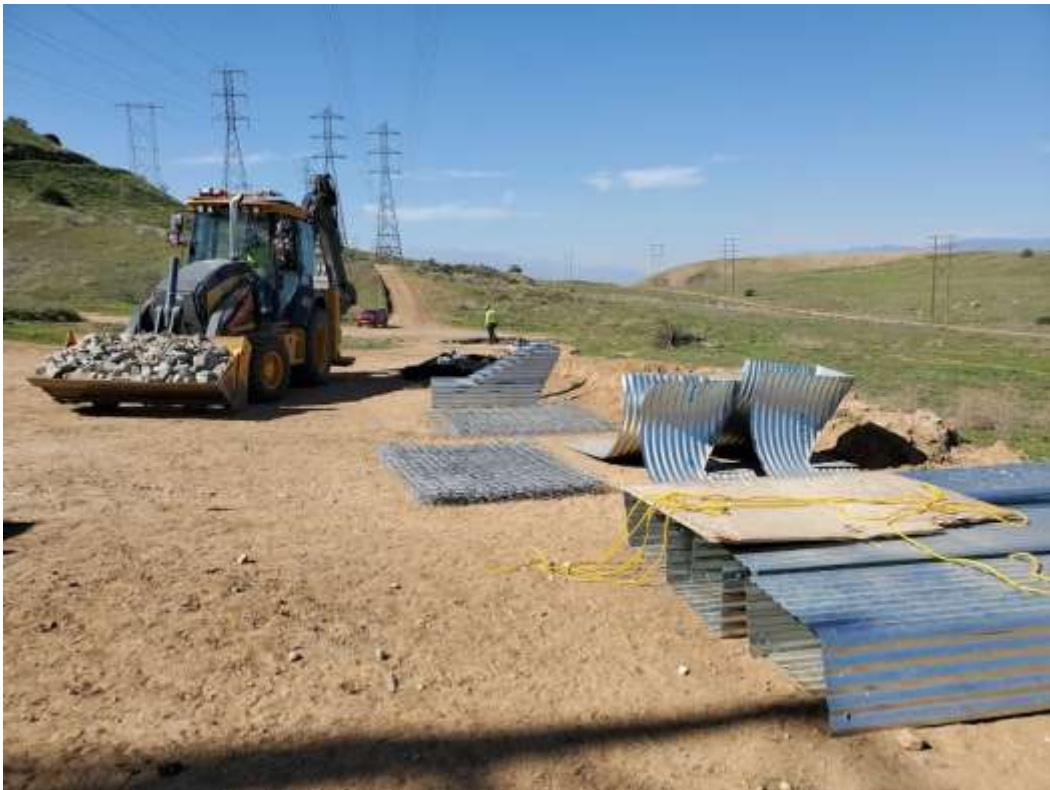
Photo 3 – MAC drain installation at Construction Area 3X60, Segment 3 (February 17, 2020).

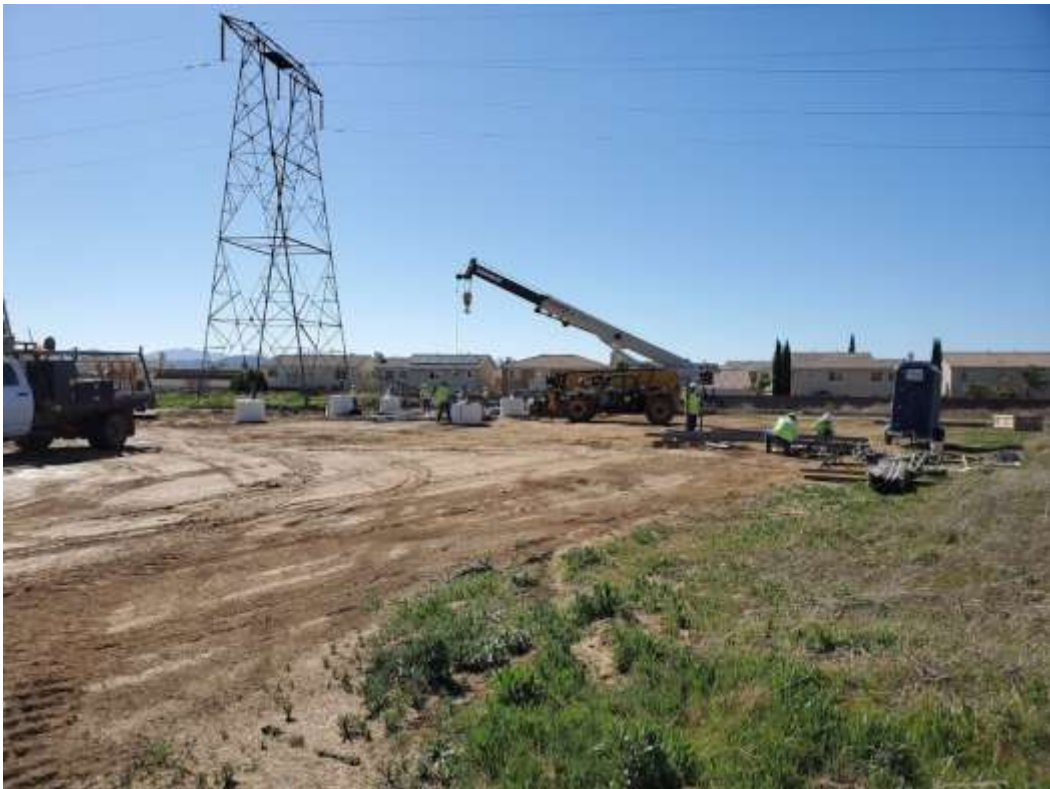
Photo 4 – Tower assembly at Construction Area 4X24, Segment 4 (February 17, 2020).

5. Work associated with Segment 4 included: Foundation activities at Construction Areas 4X42 through 4X45, 4X47, 4X51, and 4X53; tower assembly at Construction Areas 4X21 through 4X22 and 4X24 through 4X27 (see Photo 4); mowing vegetation at Construction Area 4S60; excavation, backfilling, and maintenance, including BMPs, on the access road to Construction Area 4X04; and hydroseed watering at Construction Areas 4N59, 4N62, and 4N63.

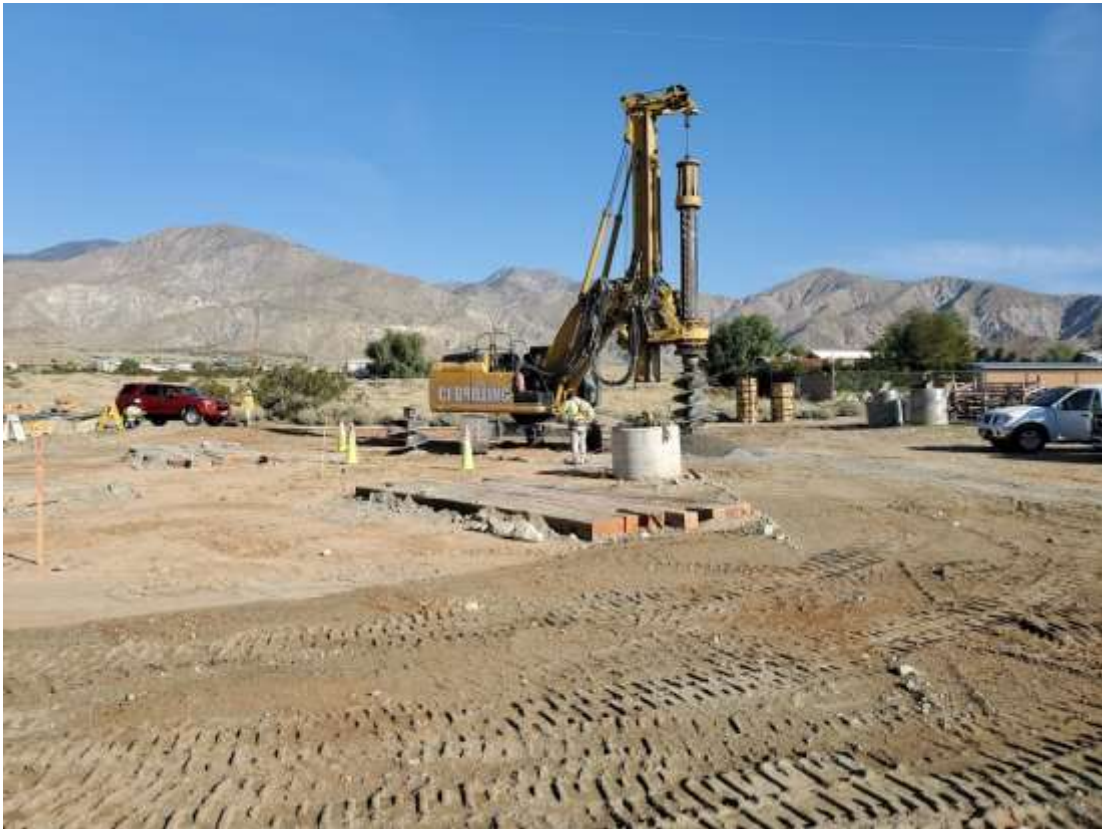
Photo 5 – Foundation activities at Construction Area 6X40, Segment 6 (February 17, 2020).

7. Work associated with Segment 6 (non-BLM lands) included: Drilling, placing lagging, pouring concrete, and setting cages and I-beams for soldier pile wall construction at Construction Area 6N30 and foundation activities at Construction Areas 6S27, 6N37 through 6X42, and 6X45 (see Photo 5).
