PROJECT MEMORANDUM
SCE WEST OF DEVERS UPGRADE PROJECT

To: John Forsythe, Project Manager, CPUC
From: Vida Strong, Aspen Project Manager
Date: November 12, 2020
Subject: Monitoring Report #137: November 2 to 8, 2020

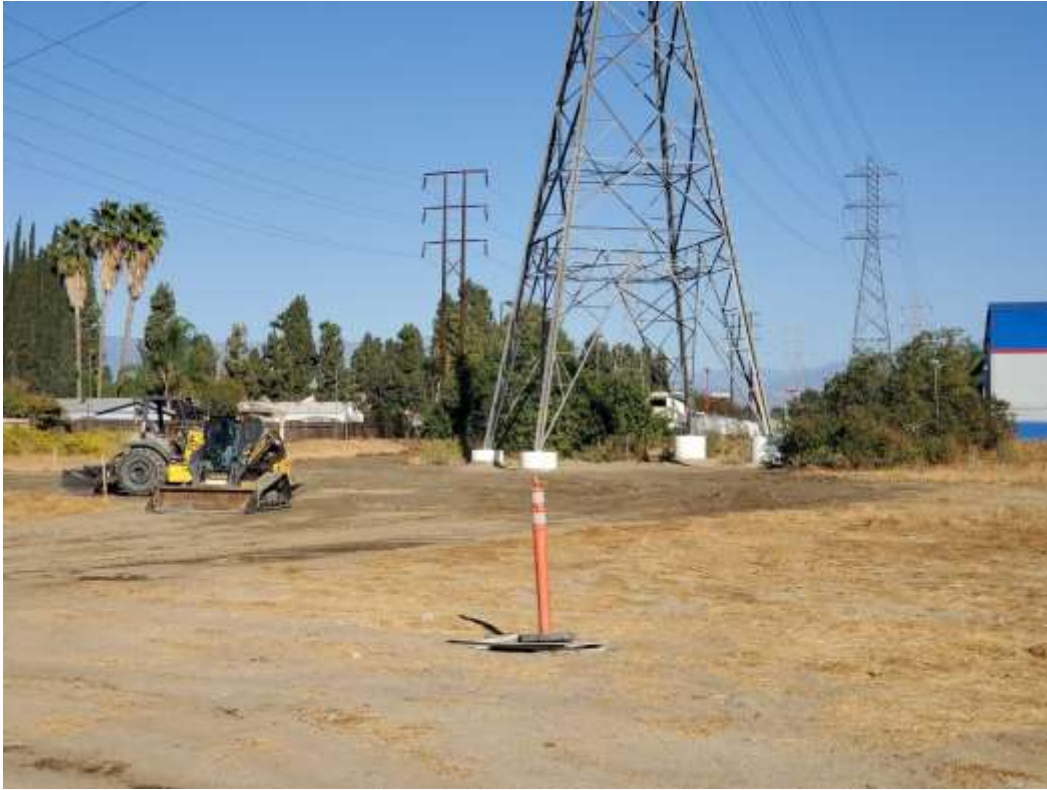
Photo 1 – Site restoration activities at Construction Area 2N35, Segment 2 (November 4, 2020).

2. No work activities associated with Segment 1 occurred during the monitoring period.
3. Work activities associated with Segment 2 included: Berm installation and light grading activities at Construction Areas 2N15, 2N18, and 2N23; site restoration grading at Construction Areas 2N18 and 2N35 (see Photo 1); loose material removal at Construction Areas 2N31 and 2N32; BMP installation at Construction Areas 2N04, 2N07, 2N08, 2N12, 2N18, and 2N32; and access road maintenance between Construction Areas 2N25 and 2N26.

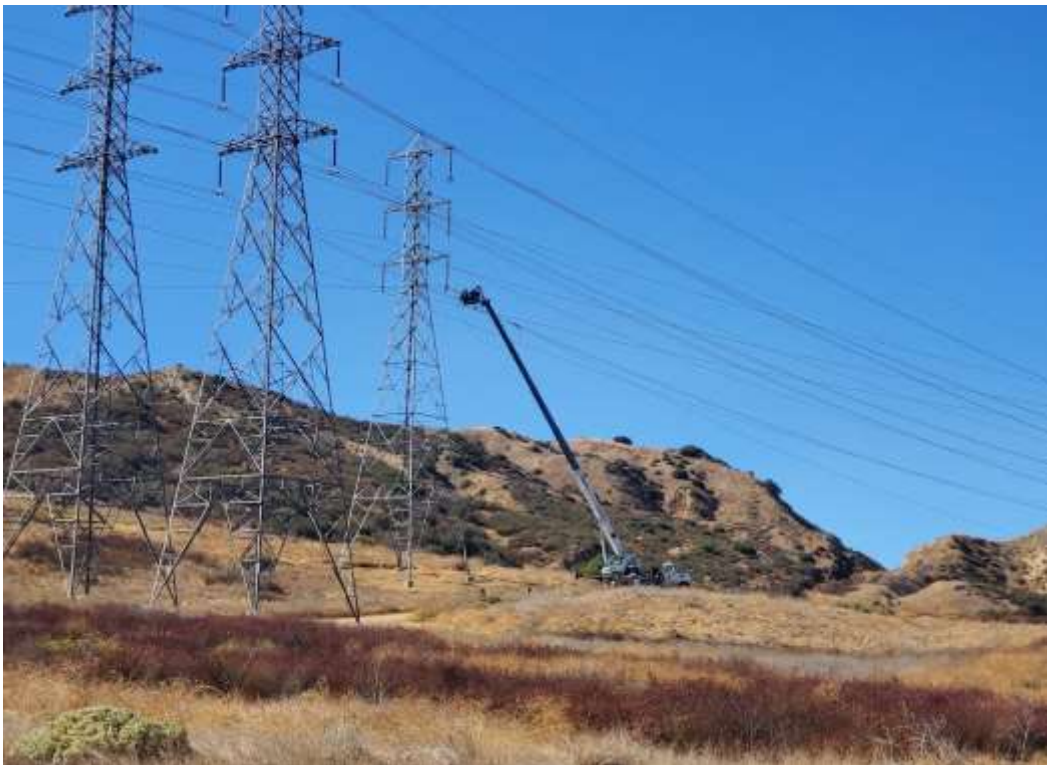
Photo 2 – Wire wreck-out activities at Construction Area 3X14, Segment 3 (November 2, 2020).

4. Work activities associated with Segment 3 included: Wire wreck-out activities (ground and helicopter) at Construction Areas 3X06 through 3X29 (see Photo 2); tower assembly at Construction Areas 3S03, 3S04, 3X06-07, 3X31, 3X32, 3X36, 3X39, 3X41, and 3X44; OPGW traveler installation at Construction Areas 3S01 through 3S06; MAC drain installation at Construction Areas 3X64 and 3X65 (see Photo 3), access road maintenance of access road south of Construction Area 3S02; asbestos testing at Construction Areas 3S02, 3X21 through 3X25, 3X28, 3X31, 3X32, 3X33, 3X37, 3X38, 3X40, 3X46, 3X48, 3X51, M36-T1, and M90-T2; hydroseed watering at Construction Area 3X21 through 3X27, 3X33, 3X37, 3X40, 3X43; and BMP installation at Construction Area 3X06-07.

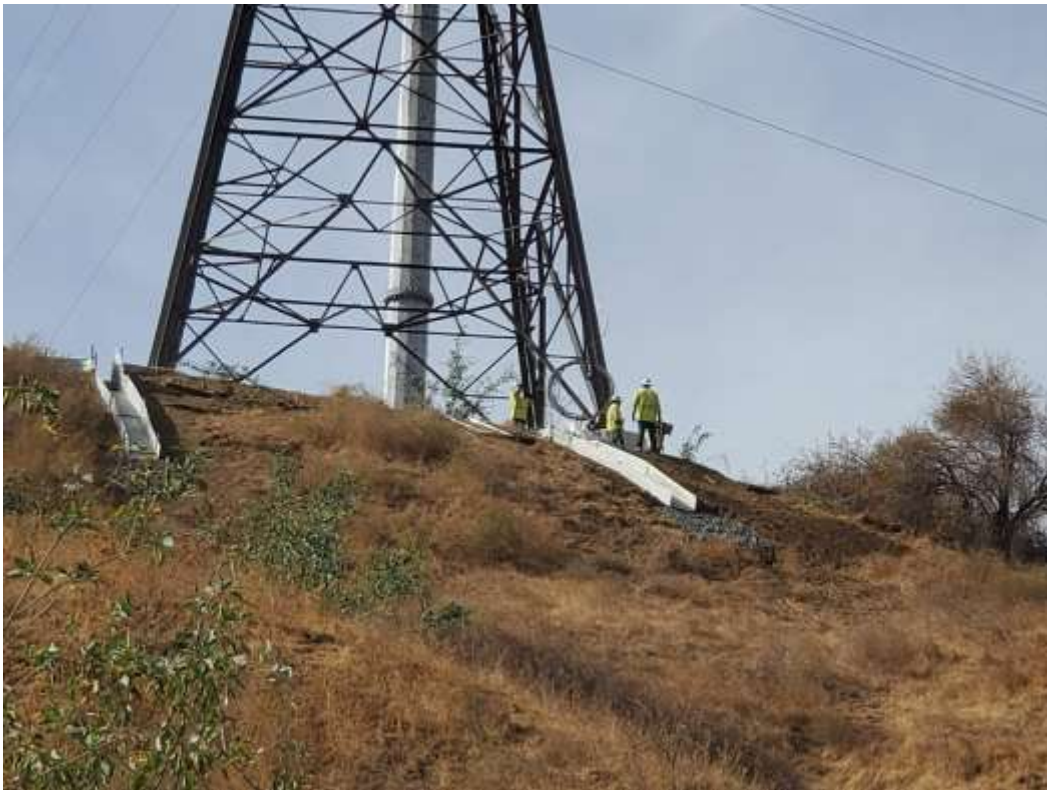
Photo 3 – MAC drain installation at Construction Area 3X65, Segment 3 (November 3, 2020).

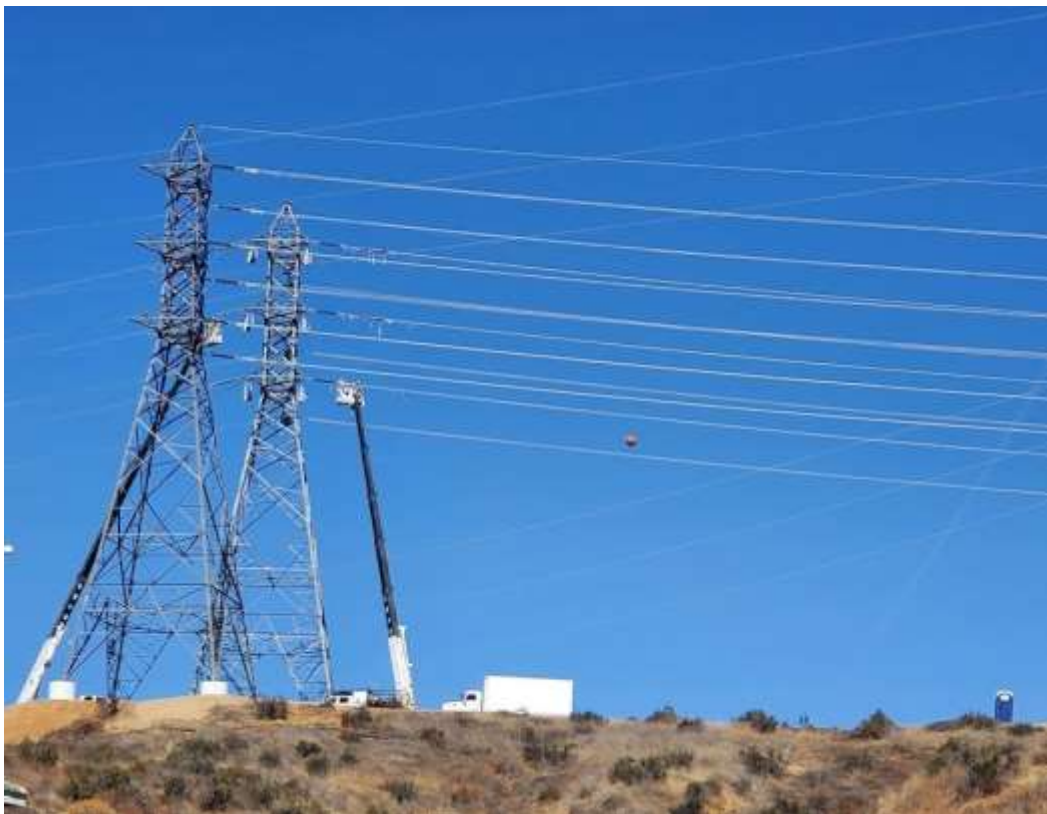
Photo 4 – Wire stringing activities at Construction Area 4X56, Segment 4 (November 2, 2020).

5. Work associated with Segment 4 (including Construction Areas 4X12 and 4X13 within Morongo Lands as reported by SCE) included: Tower wreck-out at Construction Areas 4X01 through 4X04, 4X06, and 4X08; wire stringing activities (ground and helicopter) at Construction Areas 4X27 through 4X57 (see Photo 4); traveler installation at Construction Areas 4X58 through 4S60; asbestos testing at Construction Area 4X21; and BMP maintenance at Construction Area 4X04-3-SE, 4X45, 4X47, and 4X52.

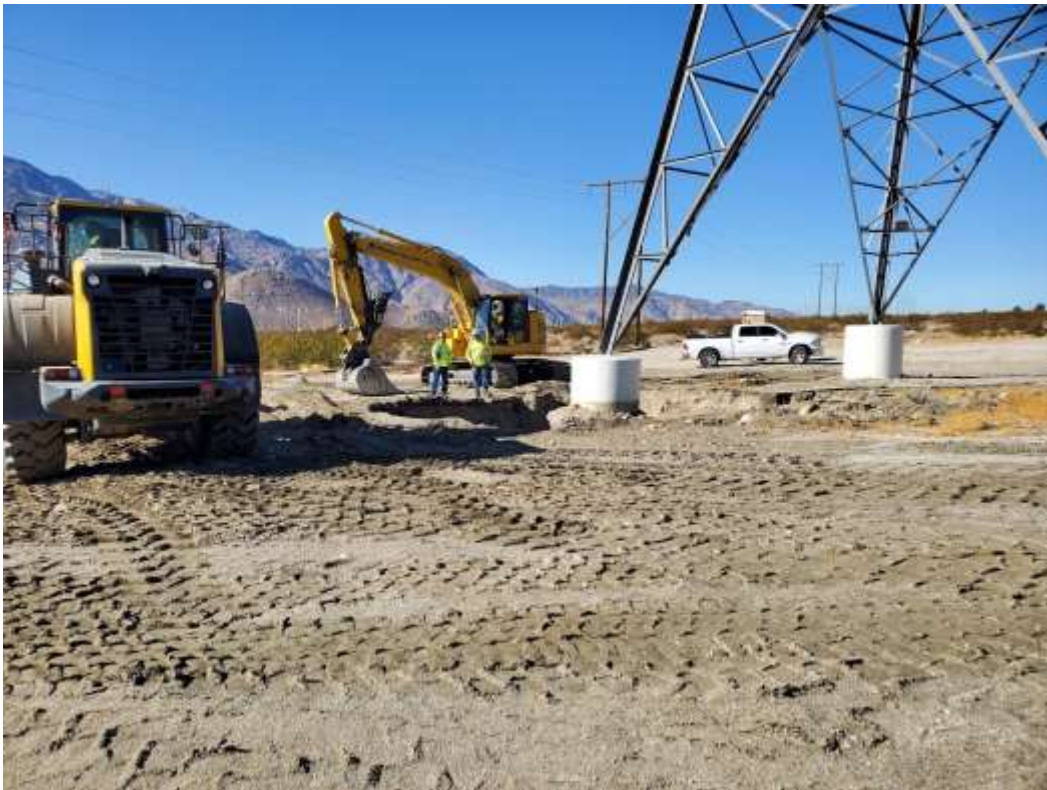
Photo 5 – Scour prevention activities at Construction Area 6X41, Segment 6 (November 4, 2020).

7. Work associated with Segment 6 (non-BLM lands) included: Scour prevention activities (importing material, excavation, riprap installation, grading, sifting material, back-filling, and compaction) at Construction Areas 6X41 and 6X42 (see Photo 5); wire punch-list construction activities at Construction Area 6S27, 6N38, and 6X41; light grading at Construction Area 6X11; wire stringing activities (ground and helicopter) at Construction Areas 6X08 through 6X11 (see Photo 6); guard pole pick-up at Construction Area GS-6X15-6N16-1; and BMP maintenance at Construction Area 6N42.

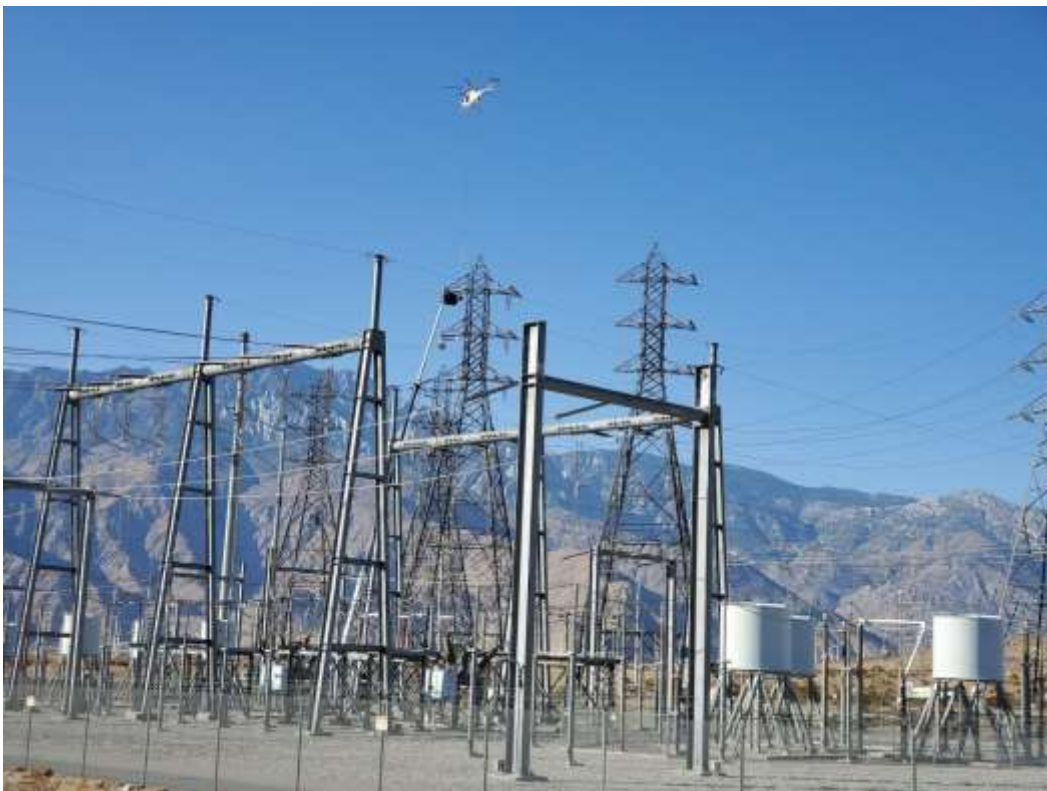
Photo 6 – Wire stringing activities at Construction Area 6X09, Segment 6 (November 4, 2020).
