PROJECT MEMORANDUM
SCE WEST OF DEVERS UPGRADE PROJECT

To: John Forsythe, Project Manager, CPUC
From: Vida Strong, Aspen Project Manager
Date: November 19, 2020
Subject: Monitoring Report #138: November 9 to 15, 2020

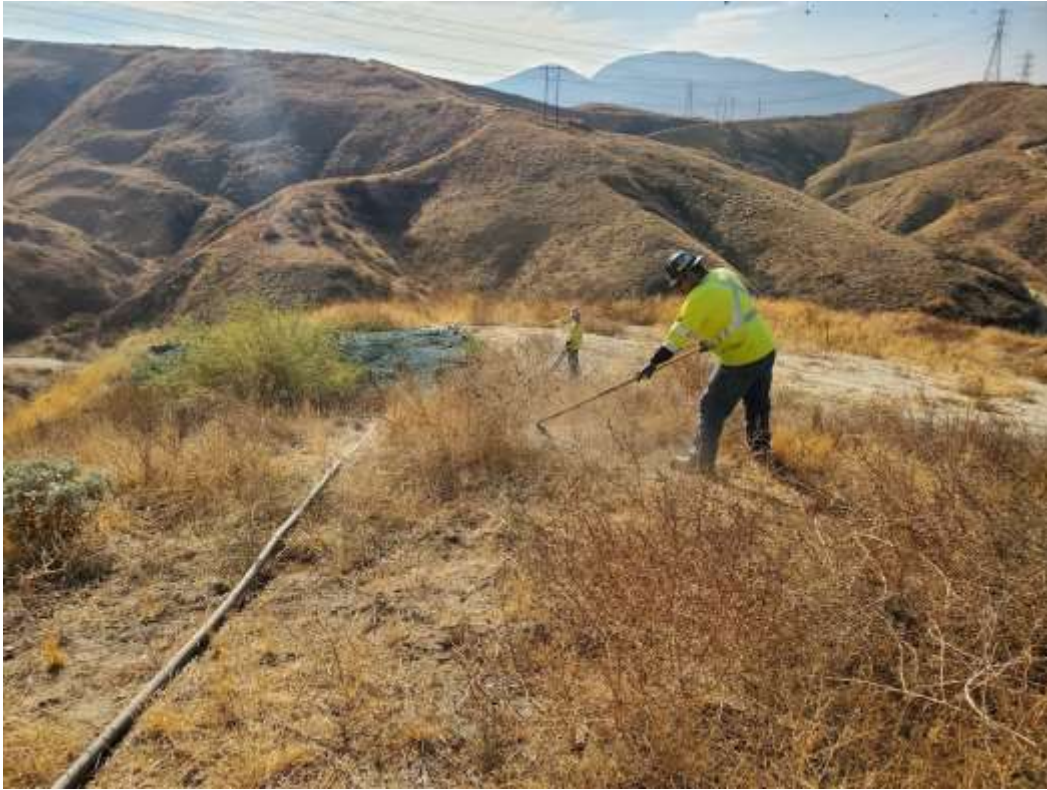
Photo 1 – Scarification and hydroseed activities at Construction Area 2N08, Segment 2 (November 12, 2020).

2. No work activities associated with Segment 1 occurred during the monitoring period.
3. Work activities associated with Segment 2 included: MAC drain installation at Construction Area 2N11; scarification for hydroseed at Construction Areas 2N06 through 2N08 and 2N10; hydroseed application at Construction Areas 2N08 and 2N10 (see Photo 1); and BMP installation at Construction Area 2N10.

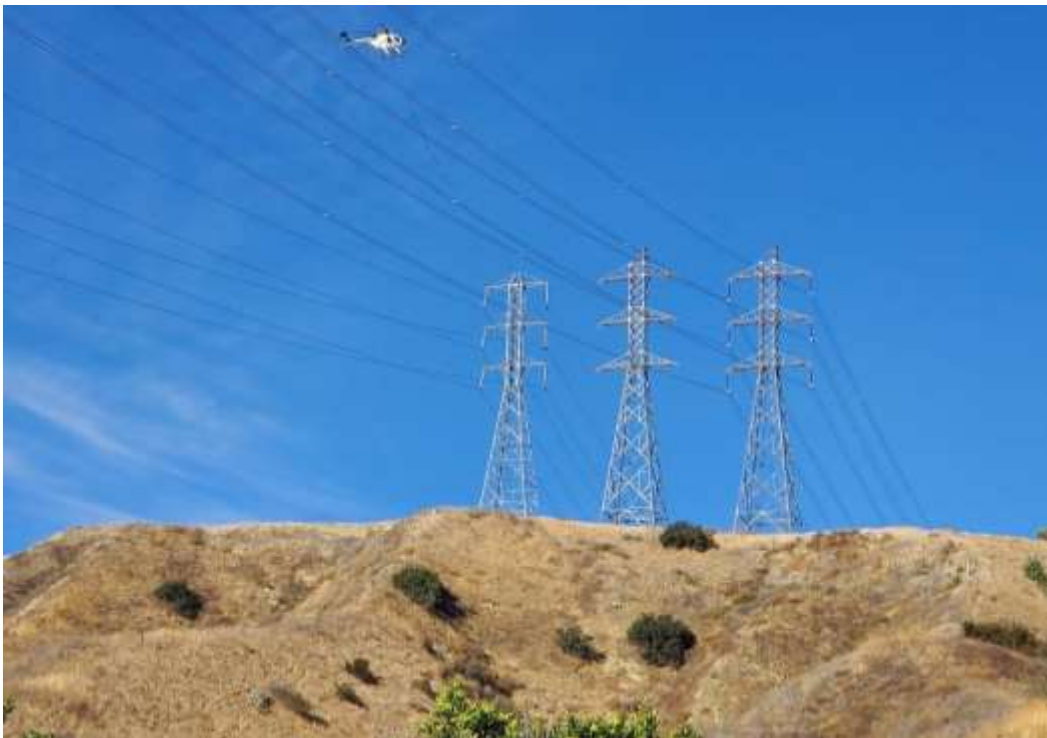
Photo 2 – Helicopter wire wreck-out activities at Construction Area 3X40, Segment 3 (November 11, 2020).

4. Work activities associated with Segment 3 included: Wire wreck-out activities (ground and helicopter) at Construction Areas 3X29 through 3X59 (see Photo 2); tower assembly at Construction Areas 3X06-07, 3X39, 3X41, 3X44, 3X55, 3X56, 3S60, and 3X64; wire stringing activities (ground and helicopter) at Construction Areas 3S01 through 3X06-07; traveler installation at Construction Areas 3X06 through 3X23; snub installation activities at Construction Area 3X29; master grounds installation at Construction Area 3X61; conductor bridling at Construction Areas 3X59 and 3X60; OPGW traveler installation at Construction Areas 3S01 through 3S29; MAC drain installation at Construction Area 3X64; hydroseed application at Construction Area 3X64 (see Photo 3); and construction entrance maintenance at Construction Area 3X55.

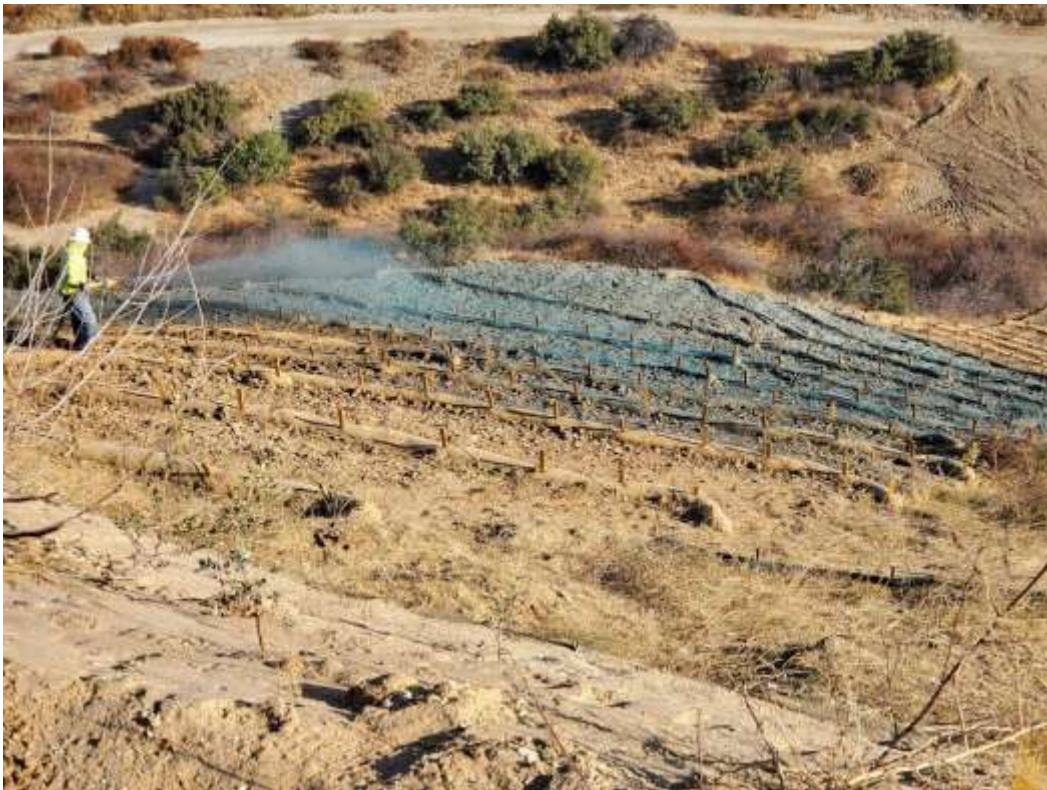
Photo 3 – Hydroseed application at Construction Area 3X64, Segment 3 (November 13, 2020).

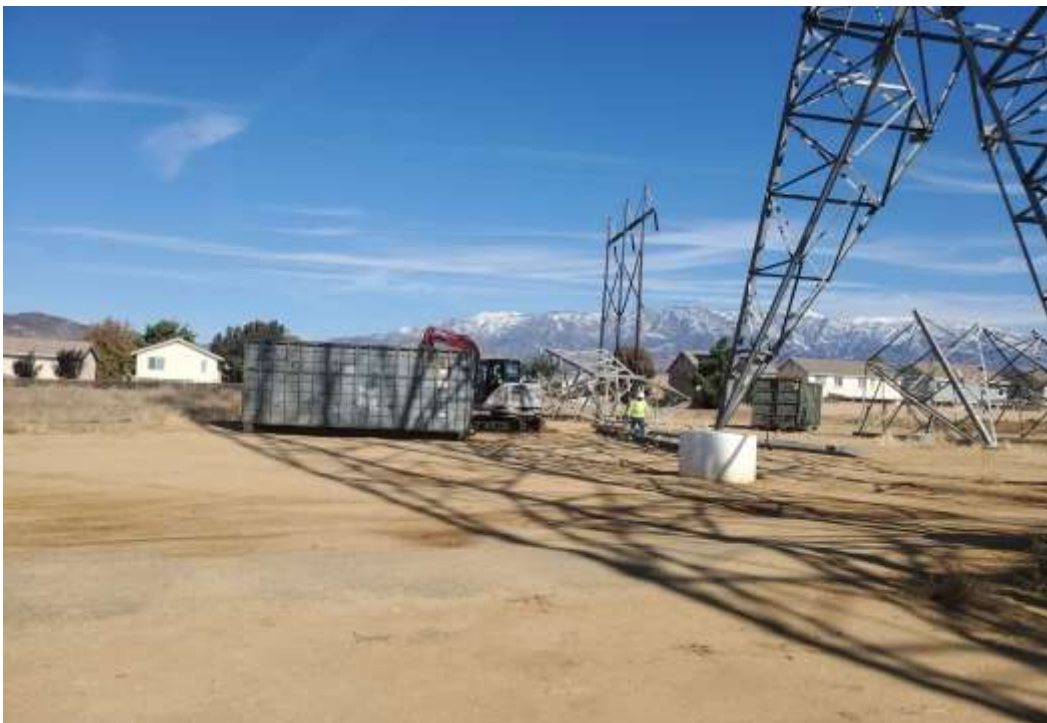
Photo 4 – Tower wreck-out activities at Construction Area 4X30, Segment 4 (November 11, 2020).

5. Work associated with Segment 4 (including Construction Areas 4X12 and 4X13 within Morongo Lands as reported by SCE) included: Tower wreck-out at Construction Areas 4X01, 4X29, 4X30, and 4X36 (see Photo 4); tower pad grading at Construction Area 4S57; wire stringing activities (ground and helicopter) at Construction Areas 4X29 through 4S60; traveler installation at Construction Areas 4X56 through 4S60; conductor spacer installation at Construction Areas 4X50 through 4X57 (see Photo 5); guard structure removal activities at Construction Areas 4X38, WSS-4-4X44-1-MPR-32, WSS-4-4X44-2-MPR-32, M25-T4, 4X45-4X46, GS-4X46-4X47-1, and WSS-4-4X47-4X48; wire clean-up activities at Construction Areas 4X38, 4X39, and 4X44 through 4X47; climbing deterrent installation at Construction Area 4X20; asbestos testing at Construction Areas 4X46 through 4X50; and BMP maintenance at Construction Area 4X10.

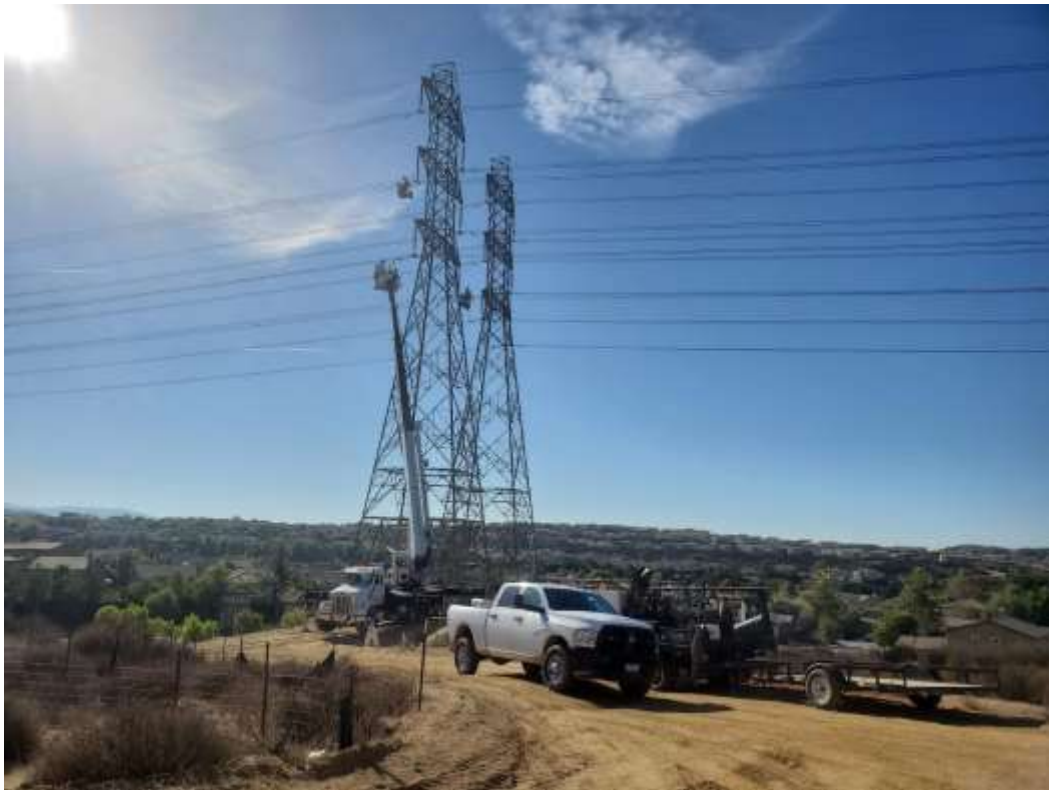
Photo 5 – Spacer installation at Construction Area 4X51, Segment 4 (November 11, 2020).

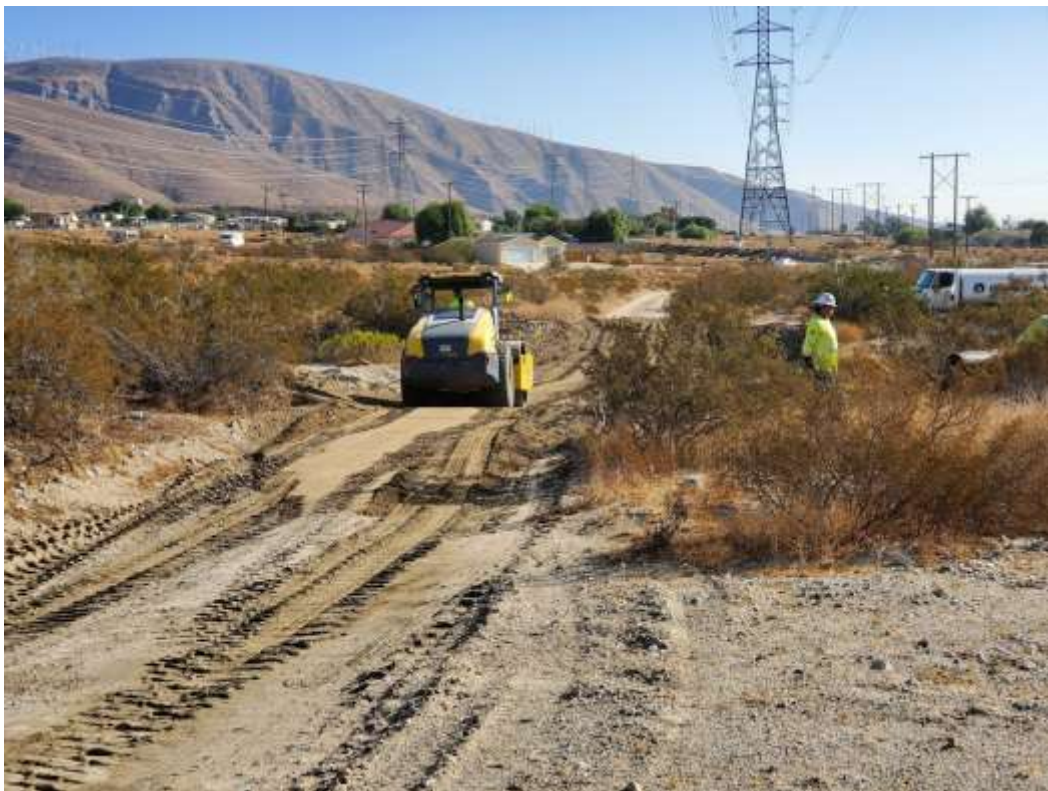
Photo 6 – Wet crossing grading on access road to Construction Area 6X41, Segment 6 (November 12, 2020).
