PROJECT MEMORANDUM
SCE WEST OF DEVERS UPGRADE PROJECT

To: John Forsythe, Project Manager, CPUC
From: Vida Strong, Aspen Project Manager
Date: February 11, 2021
Subject: Monitoring Report #147: February 1 to 7, 2021

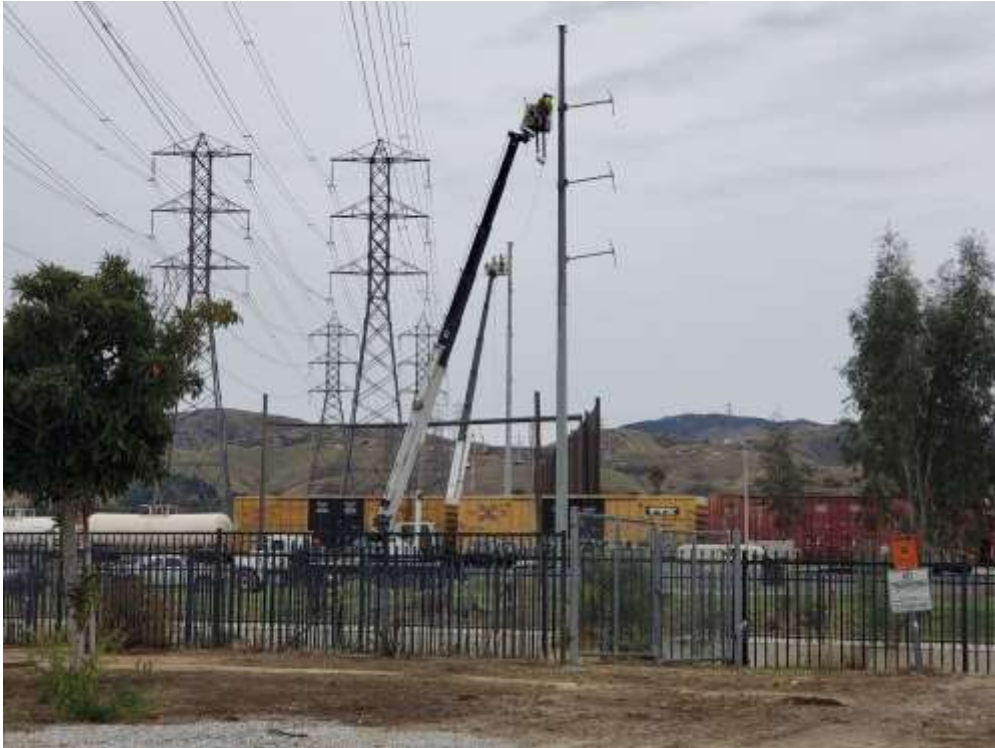
Photo 1 – Shoofly wire wreck-out activities at Construction Areas 1X10 through 1X11 (SF110 through SF111), Segment 1 (February 1, 2021).

2. Work activities associated with Segment 1 included: Wire wreck-out activities (ground) at Construction Areas 1X04-1X05 (SF104), 1X10 through 1X13 (SF110 through SF112), and 1X15 through 1X19 (SF116 through SF122) (see Photo 1); wire stringing activities (ground and helicopter) at Construction Areas 1W00 through 1X03 (see Photo 2); grading activities at Construction Area 1X03; shoofly foundation removal at Construction Areas SF104, SF105, SF110, and SF111; shoofly tower wreck-out at Construction Areas SF102, SF110, and SF111; and guard pole removal between Construction Areas 1X05 and 1X06.

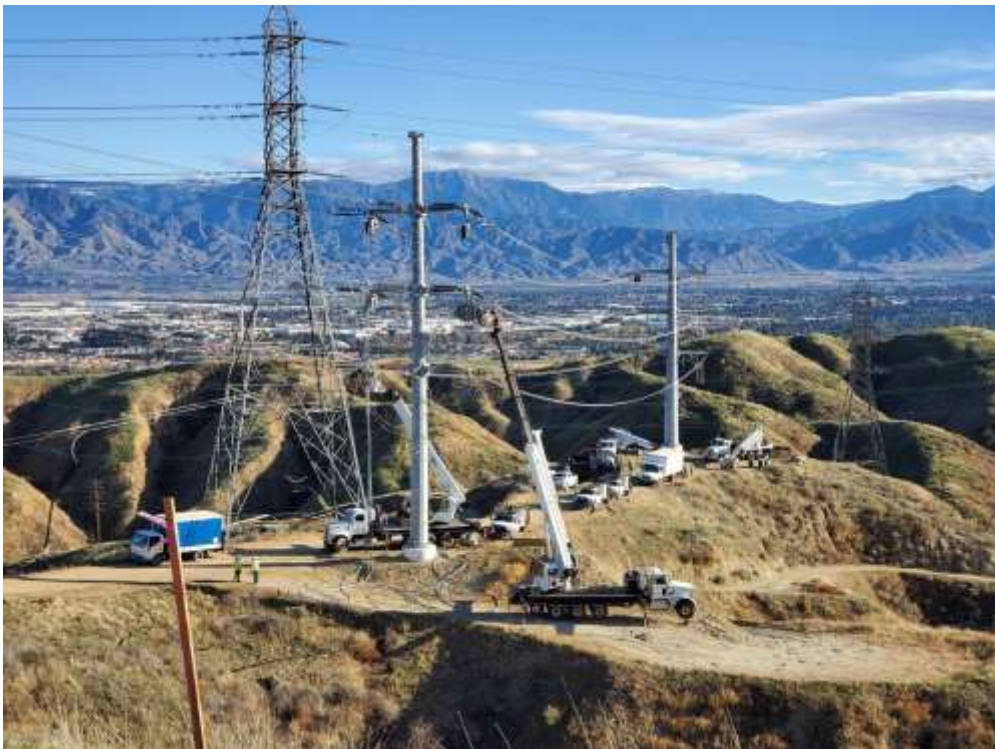
Photo 2 – Wire stringing activities at Construction Areas 1W01 through 1W02, Segment 1 (February 2, 2021).

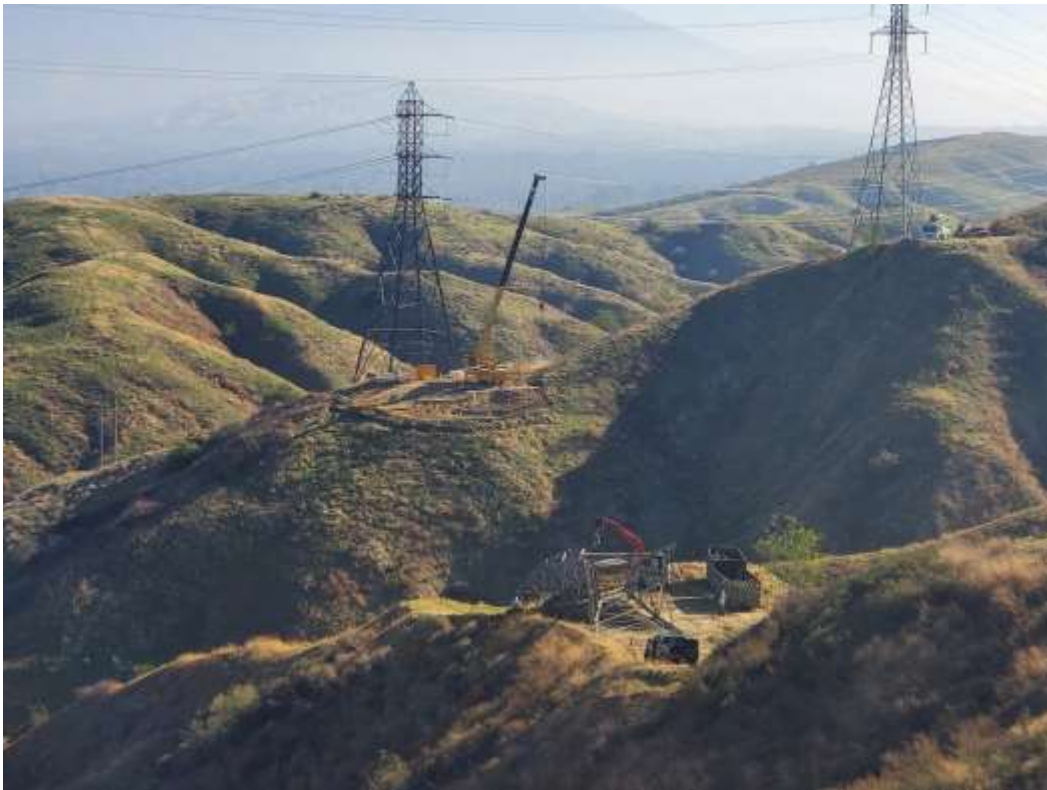
Photo 3 – Foundation installation activities at Construction Area 3X65 and tower wreck-out at Construction Area M3-T1, Segment 3 (February 4, 2021).

4. Work activities associated with Segment 3 included: Foundation installation at Construction Area 3X65 (see Photo 3); tower wreck-out at Construction Area M3-T1 (also see Photo 3); bird deterrent adjustments at Construction Areas 3X10, 3X33, 3X52, and M37-T3; wire stringing block installation at Construction Areas 3X60 through 3X64; and anchor removal at Construction Area 3X65.

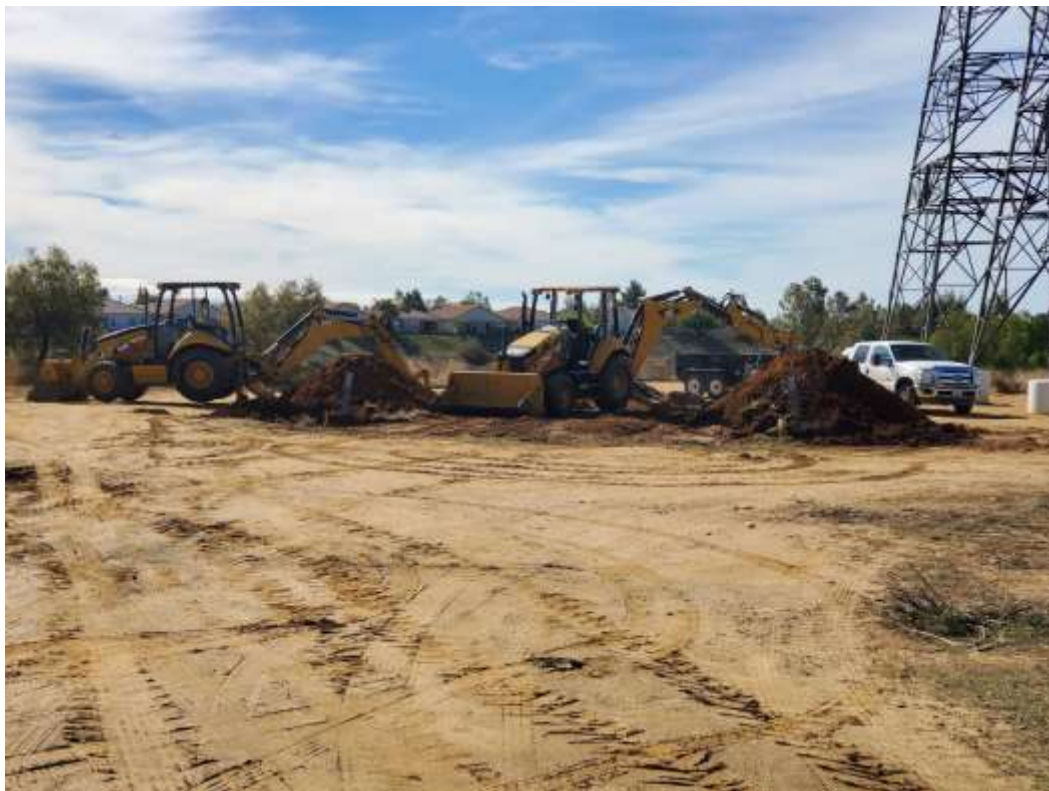
Photo 4 – Foundation wreck-out activities at Construction Area 4X39, Segment 4 (February 2, 2021).

5. Work associated with Segment 4 (including Construction Areas 4X12 and 4X13 within Morongo Lands as reported by SCE) included: MAC drain vegetation clearing and installation at Construction Areas 4X47, 4X48, 4X50, 4X54, and 4X57; foundation wreck-out at Construction Areas 4X37 through 4X39 (see Photo 4), 4X41 through 4X45, and 4X50; and BMP maintenance at Construction Areas 4X05, 4X06, 4X10, 4X36, and 4X37.

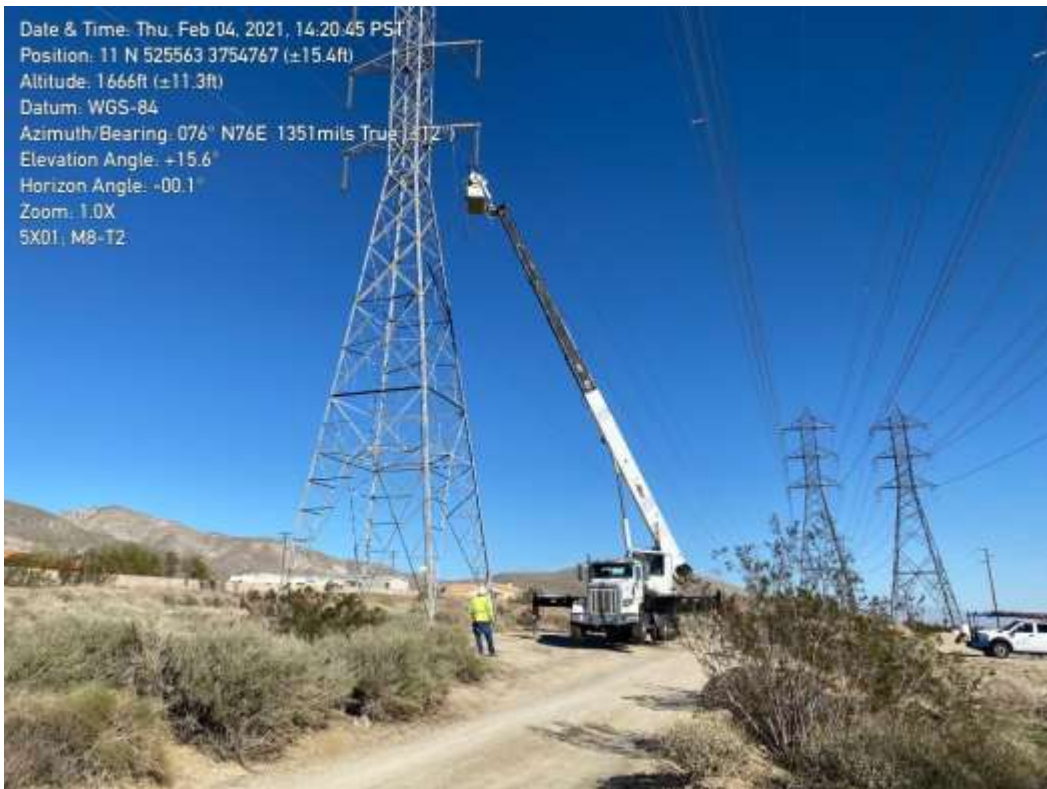
Photo 5 – Wire wreck-out activities at Construction Area 5X01, Segment 5 (Photo courtesy of SCE) (February 4, 2021).

6. Work associated with Segment 5 (including sites within Morongo lands as reported by SCE) included: BMP maintenance at Construction Area 5X08; MAC drain vegetation clearing and installation at Construction Areas 5X08 and 5X14; shoofly wreck-out at Construction Areas 5X29, 4175195E, and 4175196E; and wire wreck-out activities (ground) at Construction Areas 5X01, 5X46, 5X48, 5X49, and M15-T4 (see Photo 5).

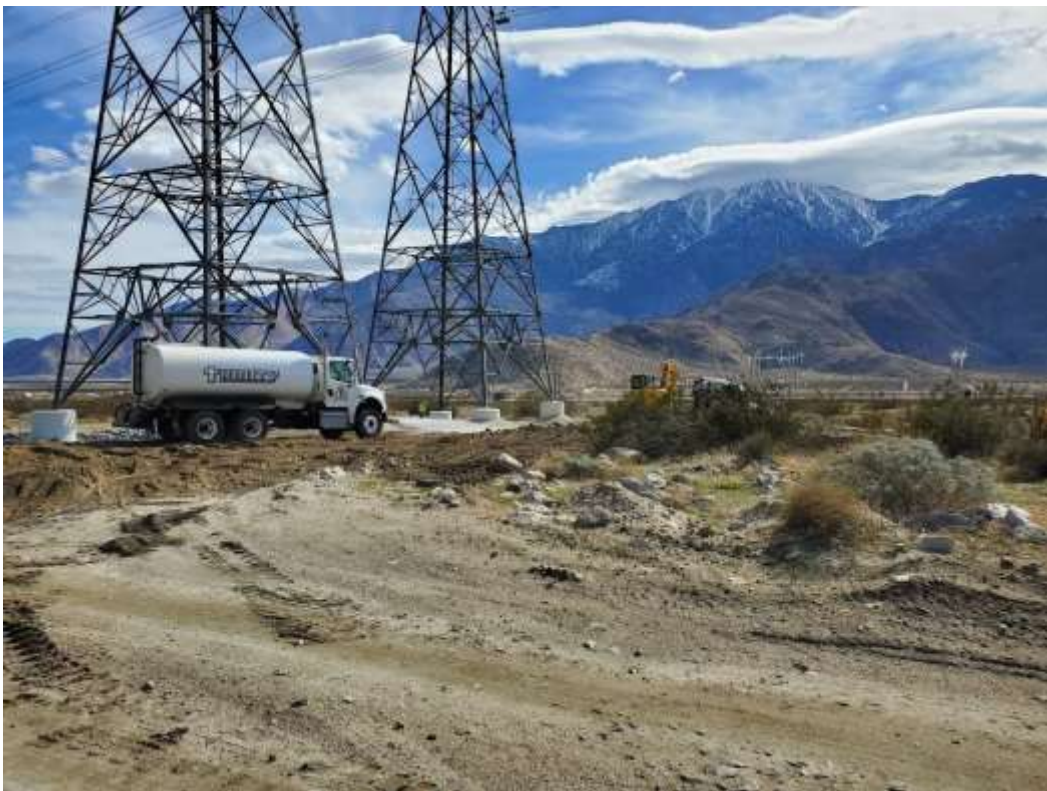
Photo 6 – Site restoration activities at Construction Area 6X44, Segment 6 (February 2, 2021).

7. Work associated with Segment 6 (non-BLM lands) included: Site restoration activities at Construction Areas 6X41 through 6X48 (see Photo 6); site scarification for hydroseed at Construction Areas 6S18, 6X22, 6X23, 6S30A, 6S31, and M62-T3; wire wreck-out activities (ground) at Construction Area 6N37; and pole butt removal at Construction Area T269.
