PROJECT MEMORANDUM
SCE WEST OF DEVERS UPGRADE PROJECT

To: John Forsythe, Project Manager, CPUC
From: Vida Strong, Aspen Project Manager
Date: February 25, 2021
Subject: Monitoring Report #149: February 15 to 21, 2021

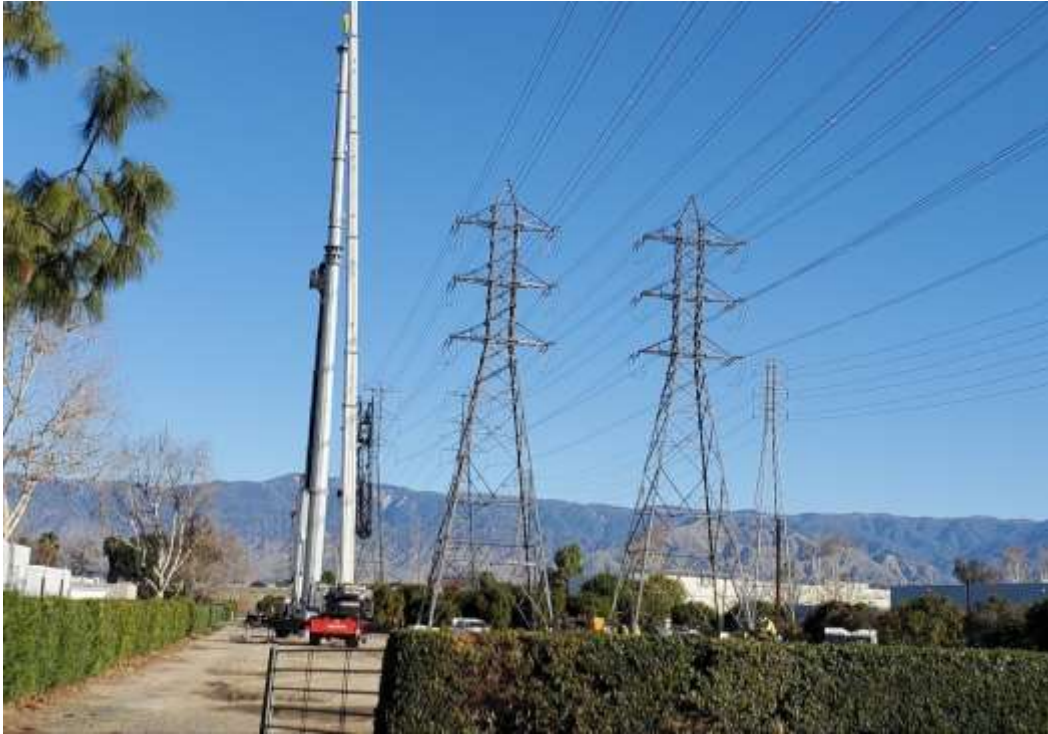
2. Work activities associated with Segment 1 included shoofly tower wreck-out activities at Construction Areas 1X15 through 1X20 (SF116 through SF122) (see Photo 1).

Photo 1 – Shoofly tower wreck-out at Construction 1X19 (SF121), Segment 1 (February 18, 2021).

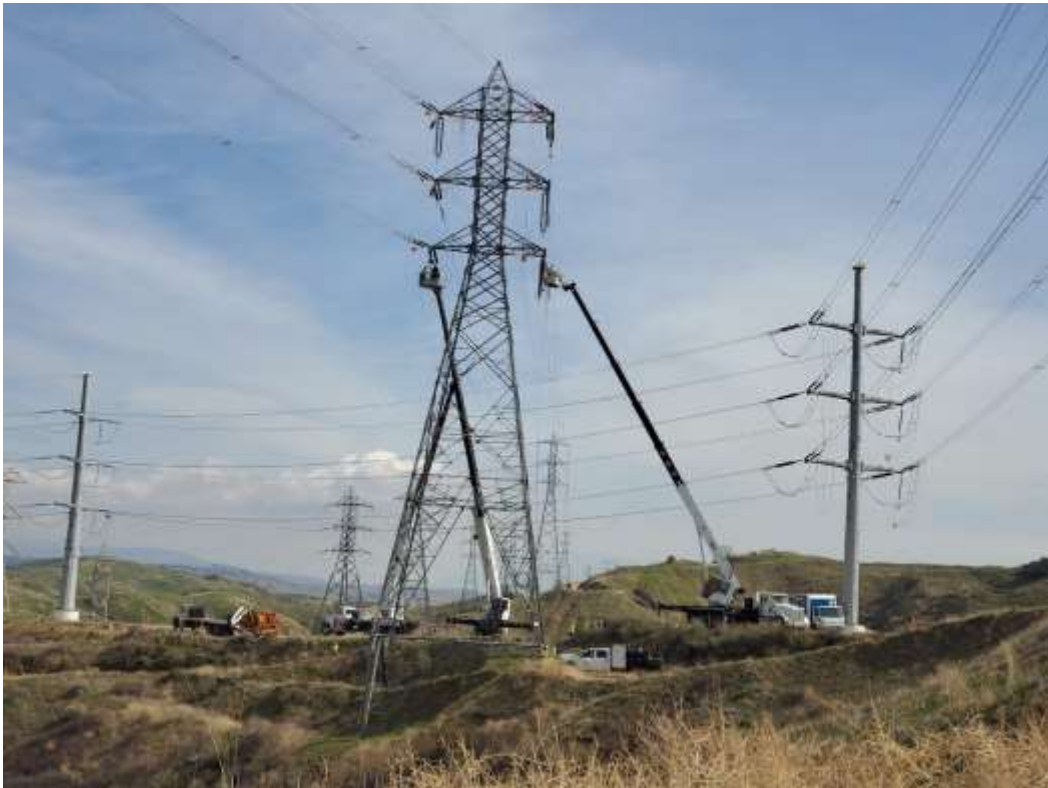
3. Work activities associated with Segment 2 included wire wreck-out activities (ground and helicopter) at Construction Areas 2N01-WSS through 2N02 (see Photo 2) and BMP maintenance activities at Construction Area 2N17.

Photo 2 – Wire stringing activities at Construction Area 2N02, Segment 2 (February 16, 2021).

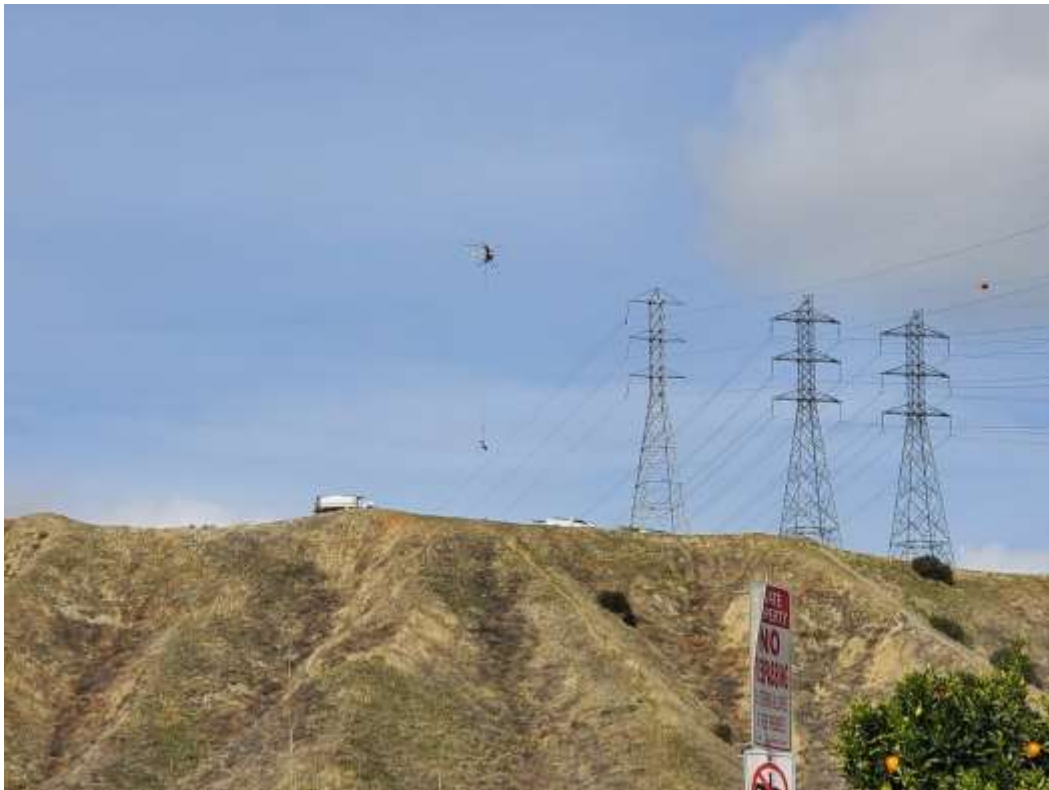
Photo 3 – Helicopter wire wreck-out activities at Construction Area 3X39, Segment 3 (February 16, 2021).

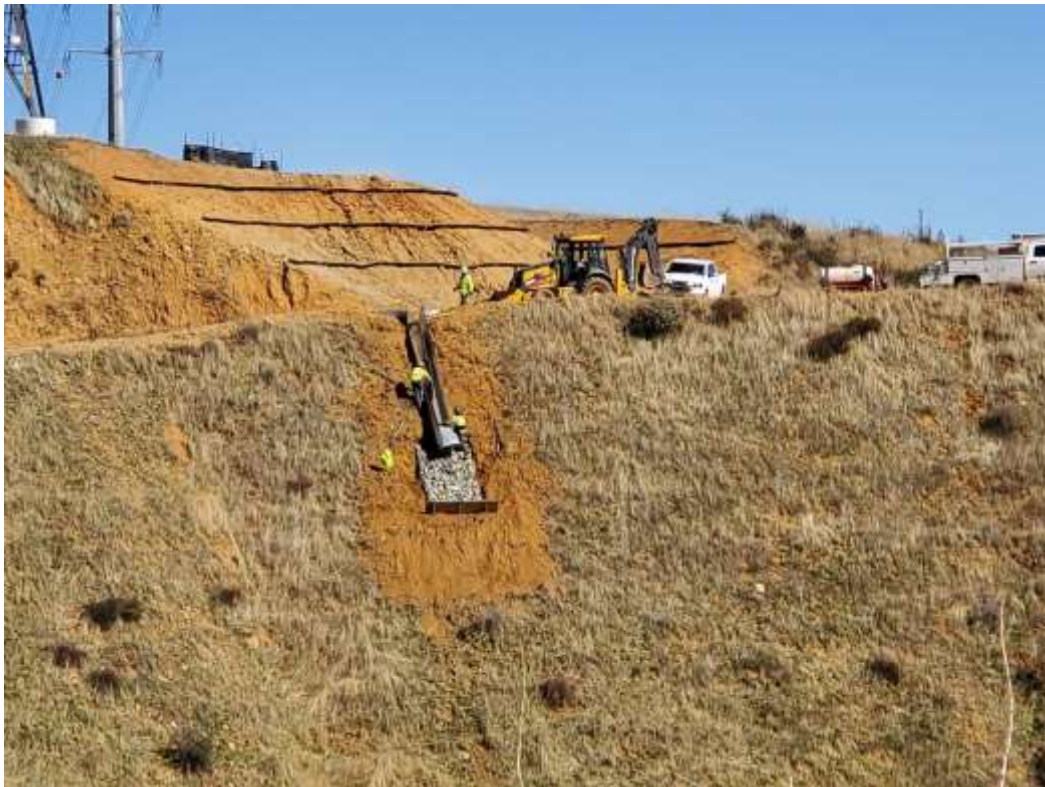
5. Work associated with Segment 4 (including Construction Areas 4X12 and 4X13 within Morongo Lands as reported by SCE) included: MAC drain vegetation clearing and installation at Construction Areas 4X04 through 4X07 and 4X12 (see Photo 4); foundation wreck-out at Construction Areas 4X05, 4X06, 4X08, 4X10, 4X24, and 4X25; wire wreck-out activities (ground) at Construction Area 4X55; BMP maintenance at Construction Areas 4X51, 4X52, and 4X55; and access road maintenance between Construction Areas 4X03 through 4X13.

Photo 4 – MAC drain installation at Construction Area 4X06, Segment 4 (February 18, 2021).

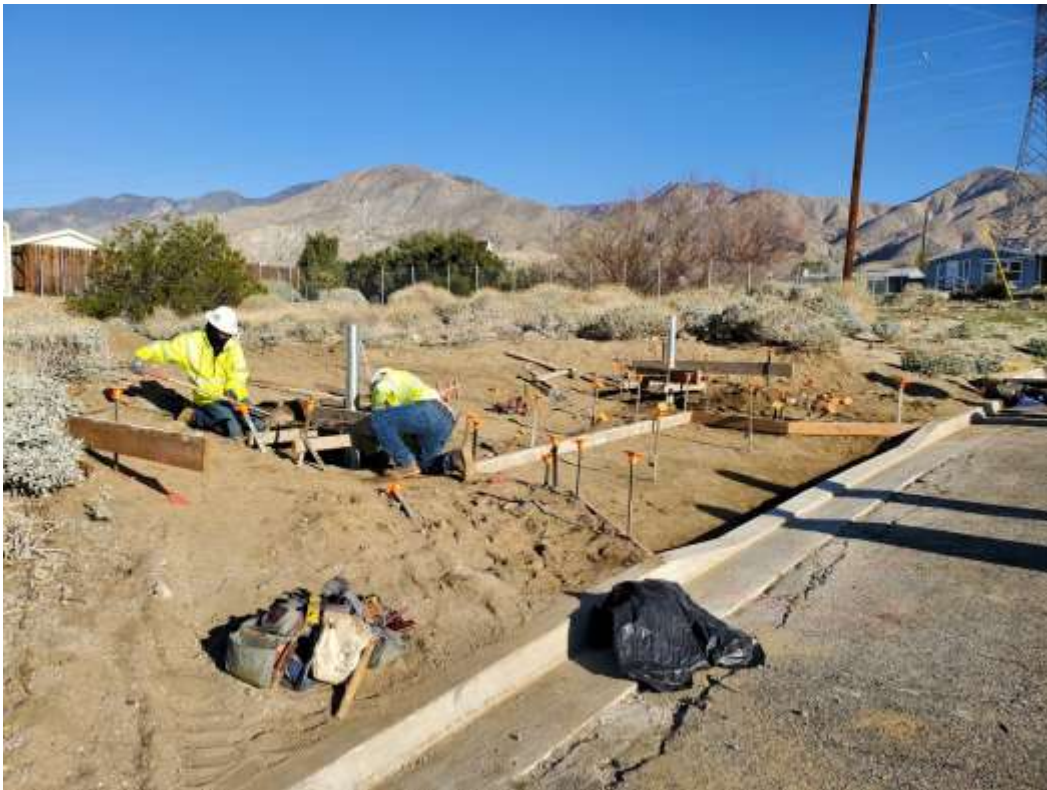
Photo 5 – Gate installation at Construction Area 6S39, Segment 6 (February 17, 2021).

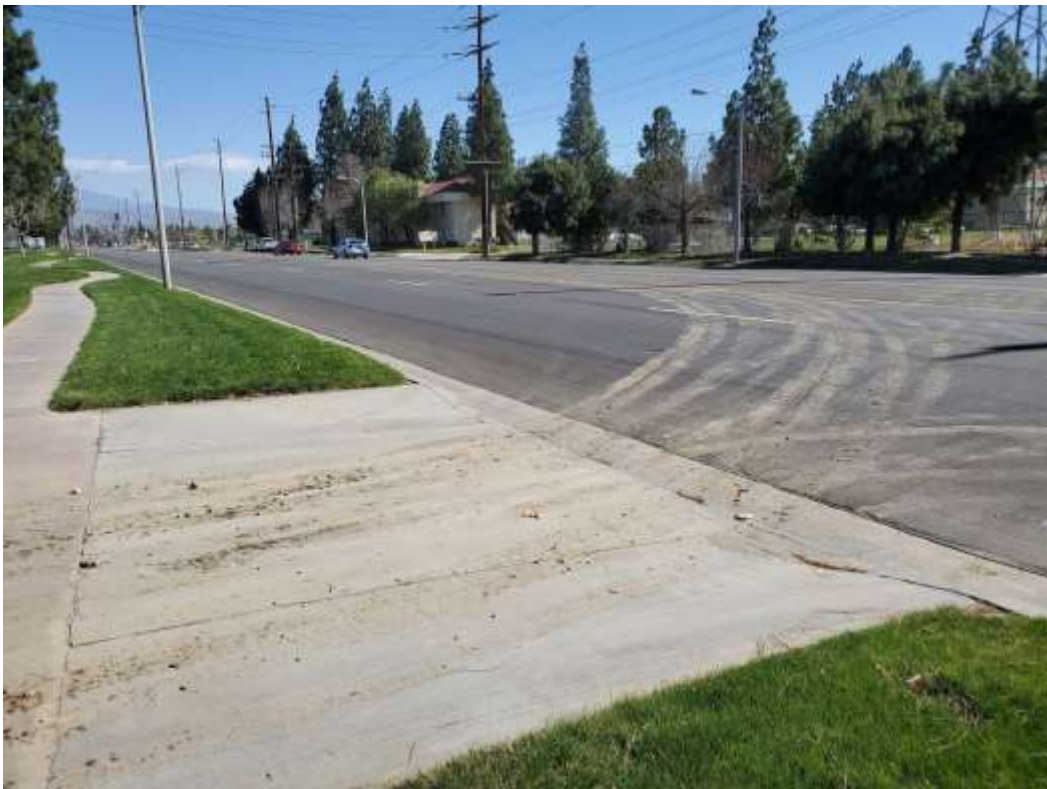
3. On February 17, the CPUC EM observed track-out onto Redlands Boulevard from the entrance to the right-of-way at Construction Area 1X19 on Segment 1 (see Photo 6). The FCR was notified of the observation. The FCR immediately called for a street sweeper to clean the track-out and all roads in the area.

Photo 6 – Track-out observed by CPUC EM at Construction Area 1X19, Segment 1 (February 17, 2021).
