PROJECT MEMORANDUM
SCE WEST OF DEVERS UPGRADE PROJECT

To: John Forsythe, Project Manager, CPUC
From: Vida Strong, Aspen Project Manager
Date: April 5, 2021
Subject: Monitoring Report #154: March 22 to 28, 2021

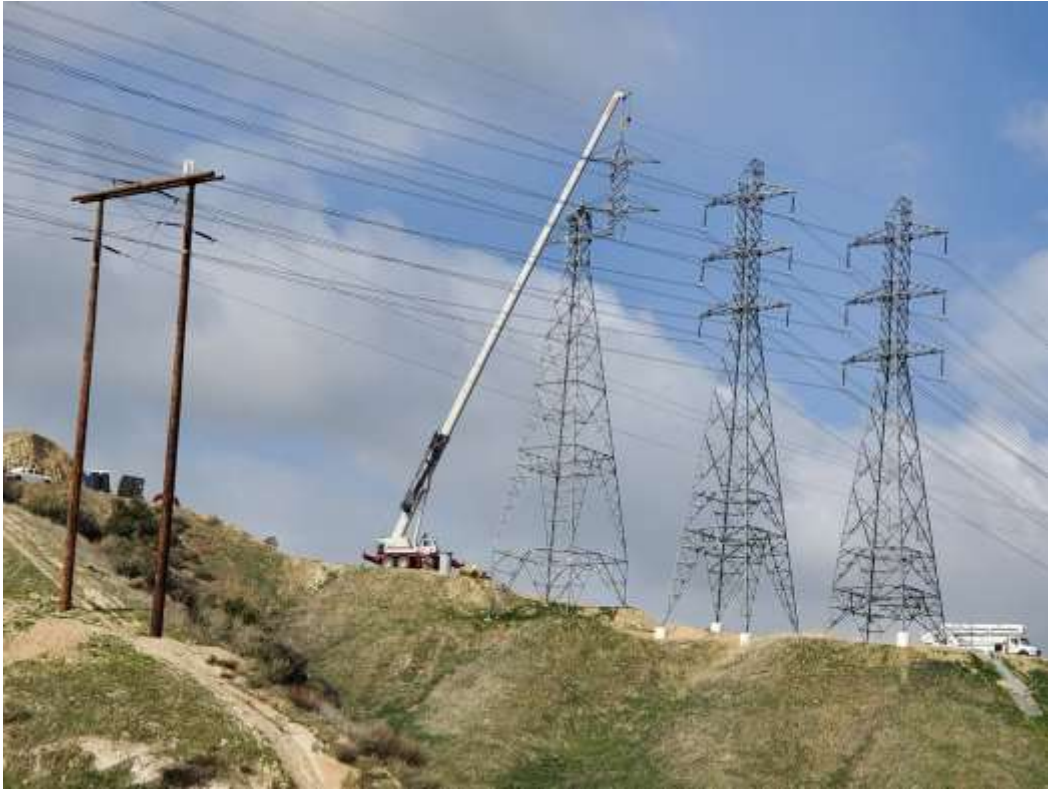
Photo 1 – Tower wreck-out at Construction Area 3X08, Segment 3 (March 23, 2021).

4. Work activities associated with Segment 3 included: Tower wreck-out activities at Construction Areas 3X04, 3X06-07, 3X08 (see Photo 1), 3X10, 3X12, 3X14, 3X16, 3X17, 3X20 through 3X23, 3X33, and 3X43; foundation wreck-out and tower shearing at Construction Areas 3S01, 3S02, 3S04, 3X06-07, 3X08, 3X10, M36-T1, 3X46, 3X48 (see Photo 2), 3X50, and 3X51; telecom testing and splicing at Construction Areas 3S02, 3X25, and 3X33; and MAC drain vegetation clearing and installation at Construction Area 3X21.

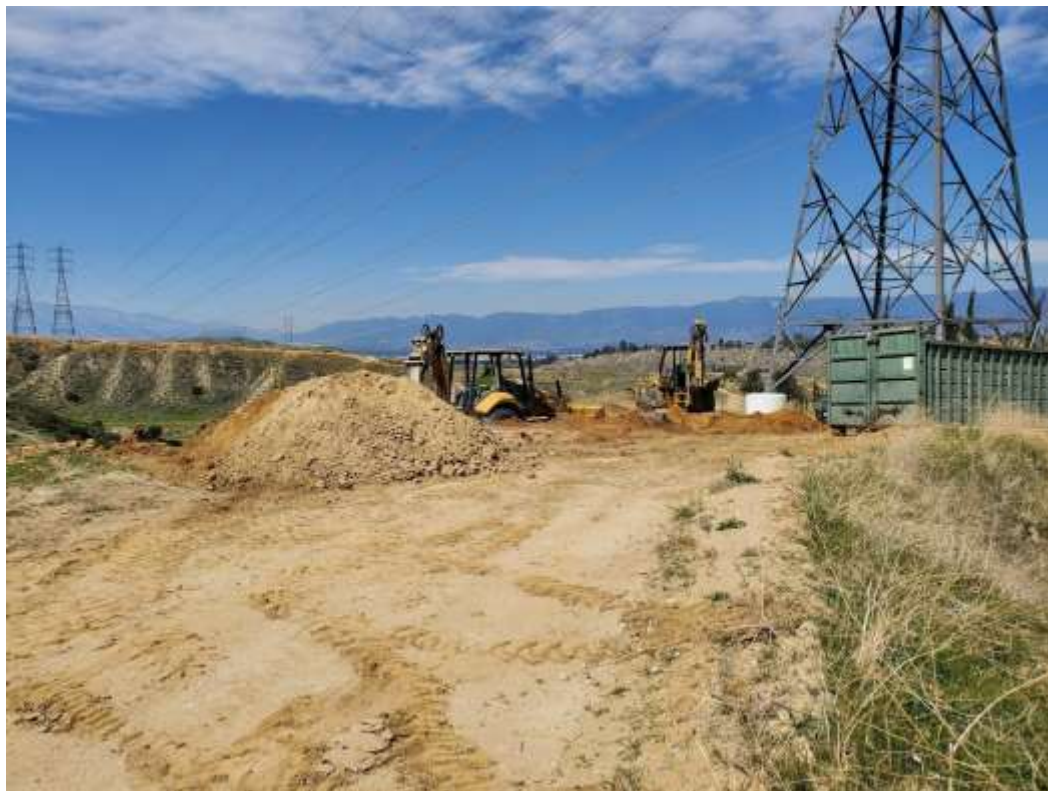
Photo 2 – Foundation wreck-out activities at Construction Area 3X48, Segment 3 (March 22, 2021).

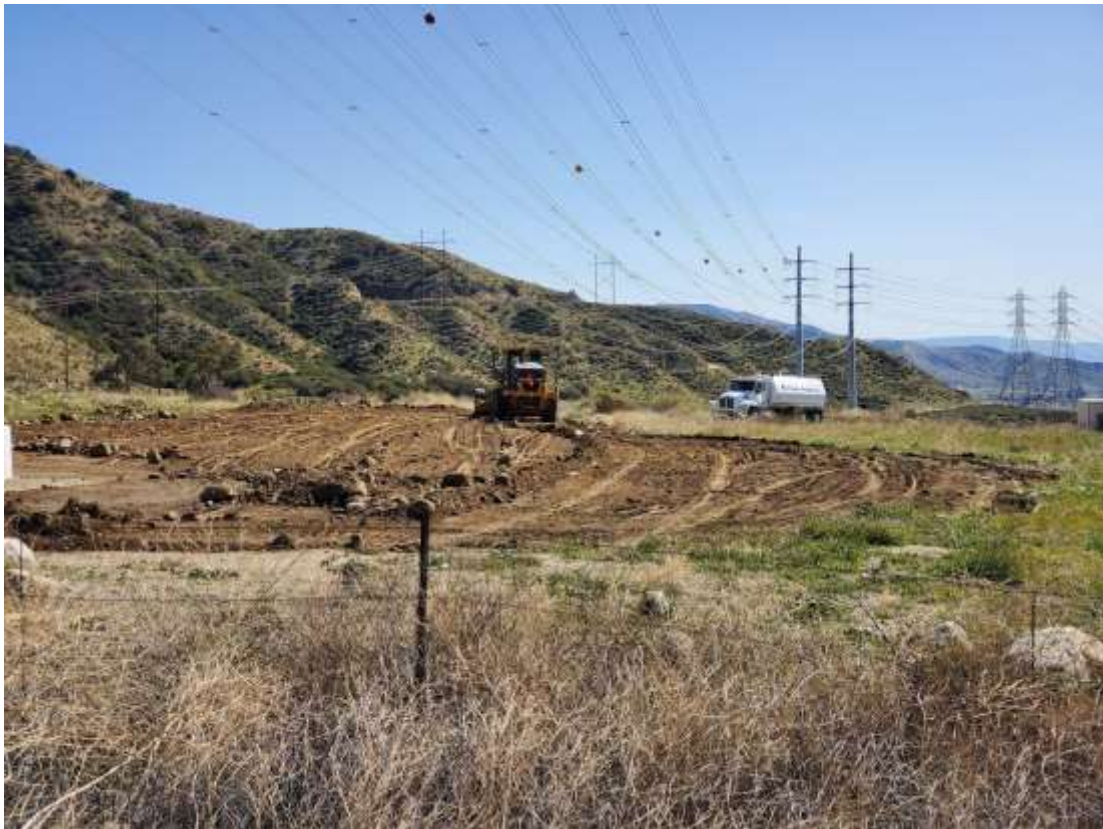
Photo 3 – Site restoration grading at Construction Area 4X01, Segment 4 (March 22, 2021).

5. Work associated with Segment 4 (including Construction Areas 4X12 and 4X13 within Morongo Lands as reported by SCE) included: Site restoration and foundation compaction at Construction Areas 4X01 (see Photo 3), 4X03, and 4X06 through 4X10; telecom testing and splicing at Construction Areas 4X01, 4X35 (see Photo 4), and 4X56; BMP maintenance at Construction Area 4X04; and access road maintenance from Construction Area 4X01 through 4X04.

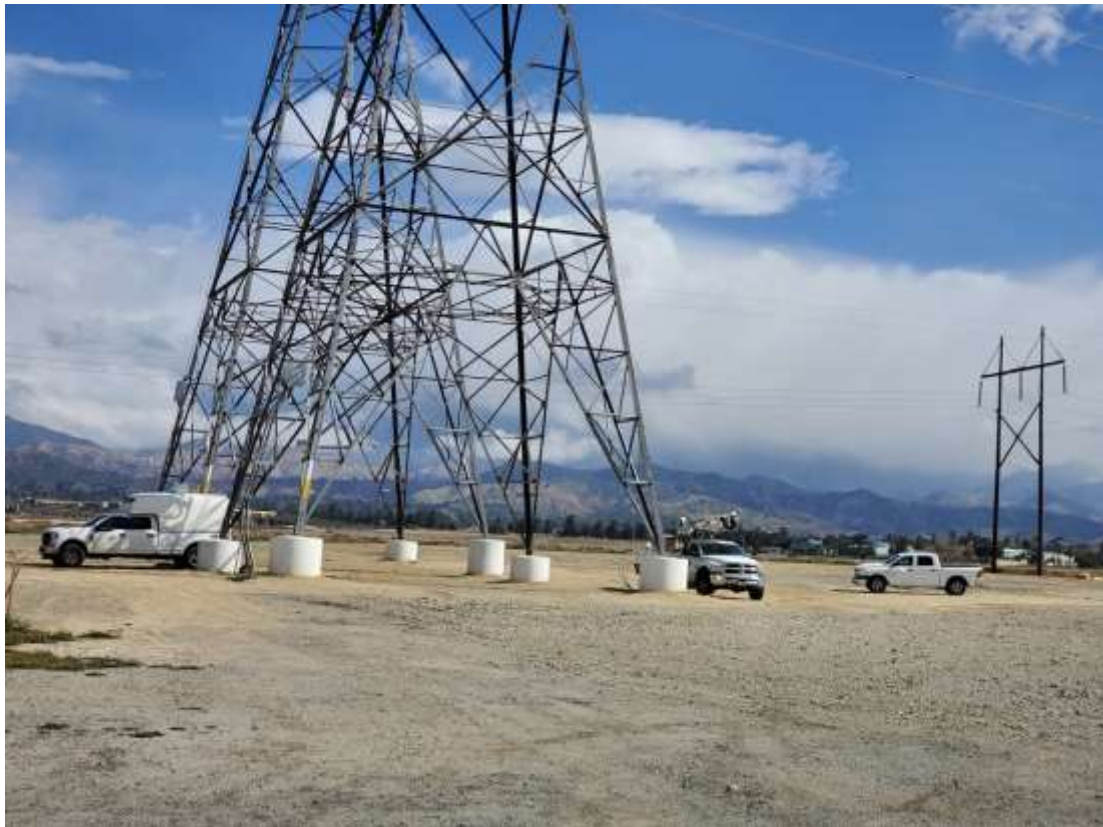
Photo 4 – Telecom testing and splicing at Construction Area 4X35, Segment 4 (March 23, 2021).

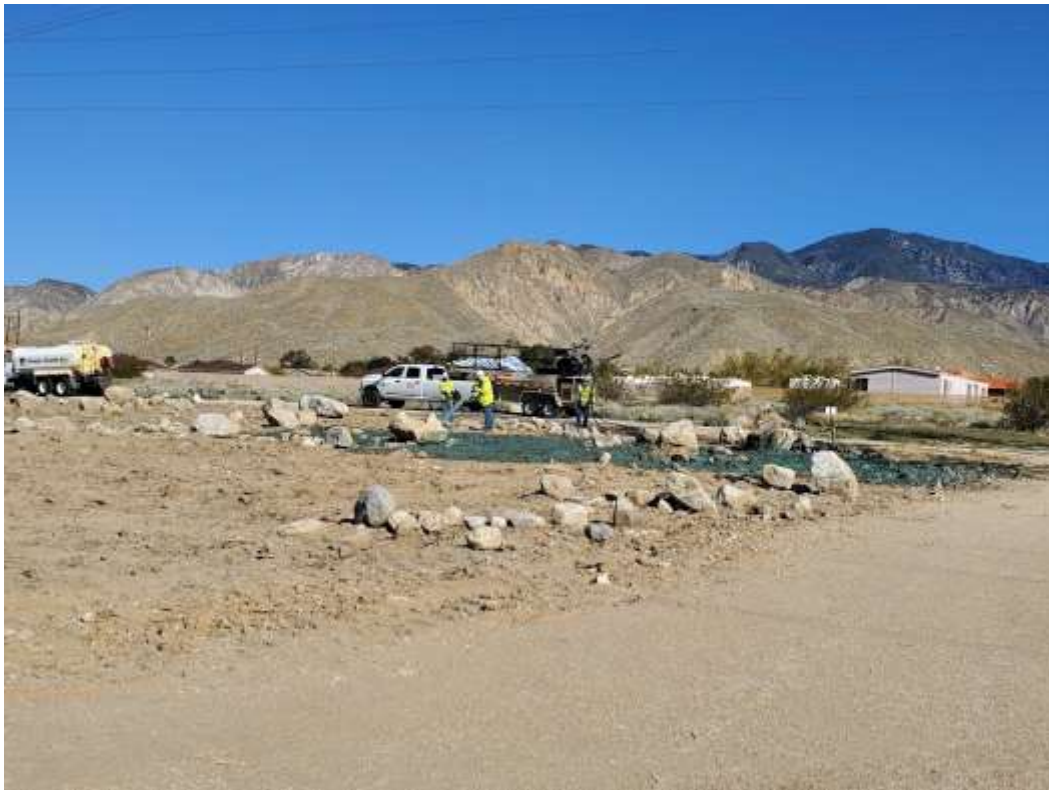
Photo 5 – Hydroseed application at Construction Area 5X01, Segment 5 (March 22, 2021).

6. Work associated with Segment 5 (including sites within Morongo lands as reported by SCE) included: Site restoration, foundation compaction, and site scarification activities at Construction Areas 5X01 through 5X14 (see Photo 5); hydroseed application at Construction Areas 5X01 through 5X03 and 5X05 through 5X13; access road maintenance from Construction Areas 5X48 to 5X49; and BMP maintenance at Construction Areas 5X01, 5X08, 5X10, and 5X54.

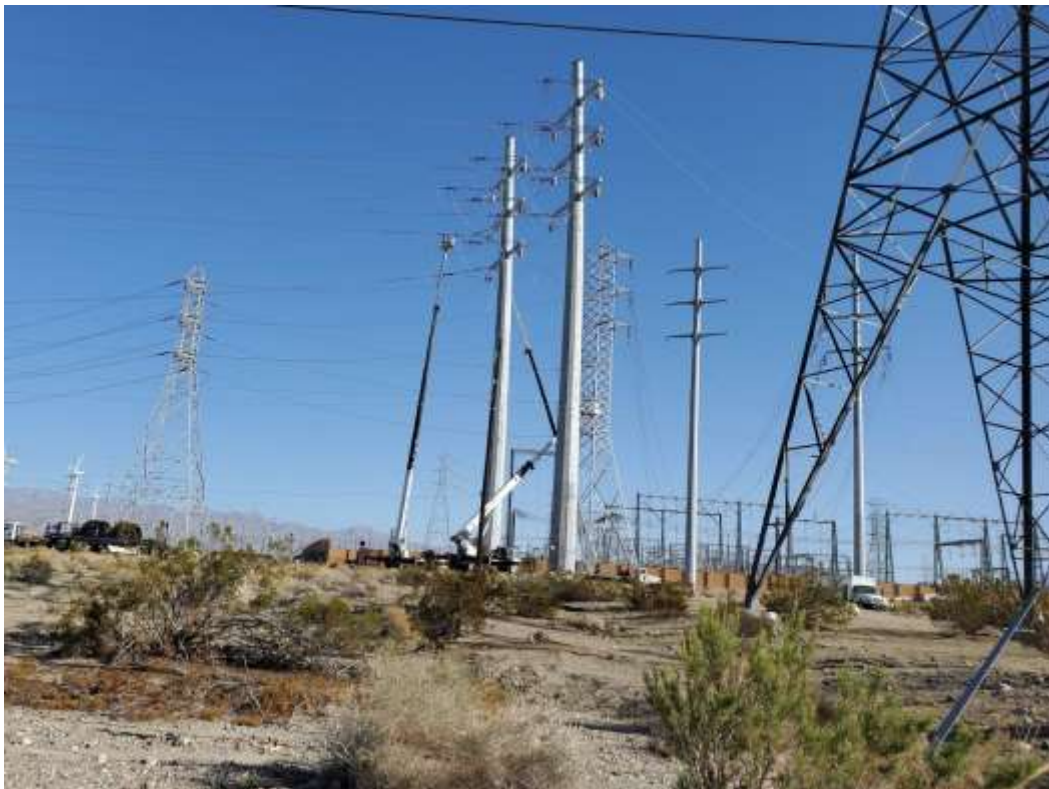
Photo 6 – Wire stringing activities at Construction Areas 6X07 and 6X08, Segment 6 (March 24, 2021).

7. Work associated with Segment 6 (non-BLM lands) included: Wire stringing activities (ground and helicopter) at Construction Areas 6X07 through 6X10 (see Photo 6); telecom fiber re-wrapping at Construction Area 6S26; and telecom testing and splicing at Construction Area 6X09-6X10.
