PROJECT MEMORANDUM
SCE WEST OF DEVERS UPGRADE PROJECT

To: John Forsythe, Project Manager, CPUC
From: Vida Strong, Aspen Project Manager
Date: June 4, 2021
Subject: Monitoring Report #163: May 24 to May 30, 2021

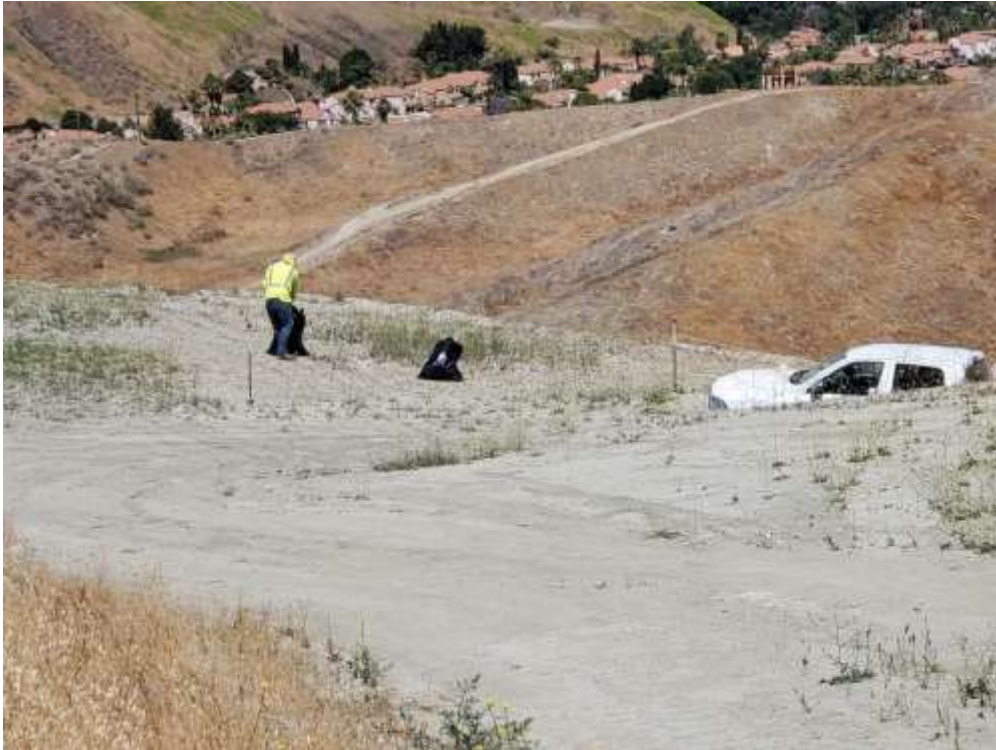
Photo 1 – Hand weeding at Construction Area 2N14, Segment 2 (May 24, 2021).

3. Work activities associated with Segment 2 included: Hand weeding at Construction Areas 2N14 (see Photo 1), 2N15, 2N17, 2N18; t-post removal at Construction Areas 2N23 through 2N32; vegetation removal and foundation removal at Construction Areas 2N01-WSS and 2N01; and hydroseed watering at Construction Areas 2N04, 2N06 through 2N11, 2N14 through 2N18, 2N22 through 2N32, and 2N35.

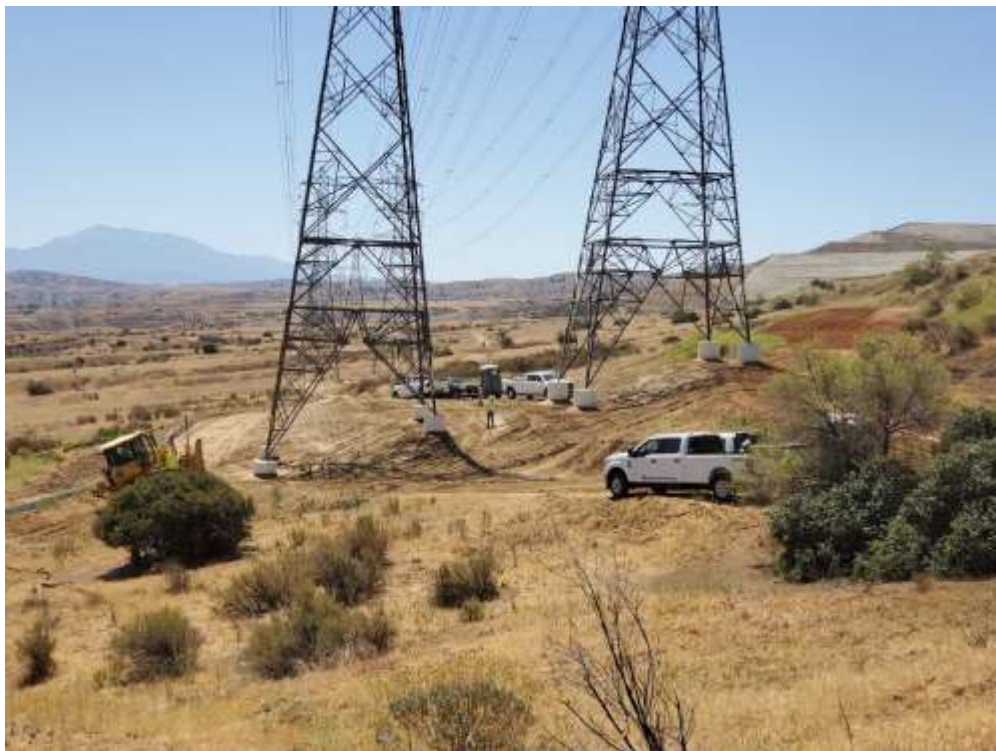
Photo 2 – Site restoration activities at Construction Area 3X61, Segment 3 (May 24, 2021).

4. Work activities associated with Segment 3 included: Site restoration at Construction Areas 3X57, 3X59, 3X61 (see Photo 2), 3X63, and 3X65; foundation removal at Construction Areas 3X63 and WSS-3-SBD-2; t-post removal at Construction Areas 3X48, 3X50, 3X51, 3X53, 3X55, 3X56, and 3X60; rip rap installation at Construction Area 3X36; and access road maintenance from Construction Area 3X59 through 3X63.

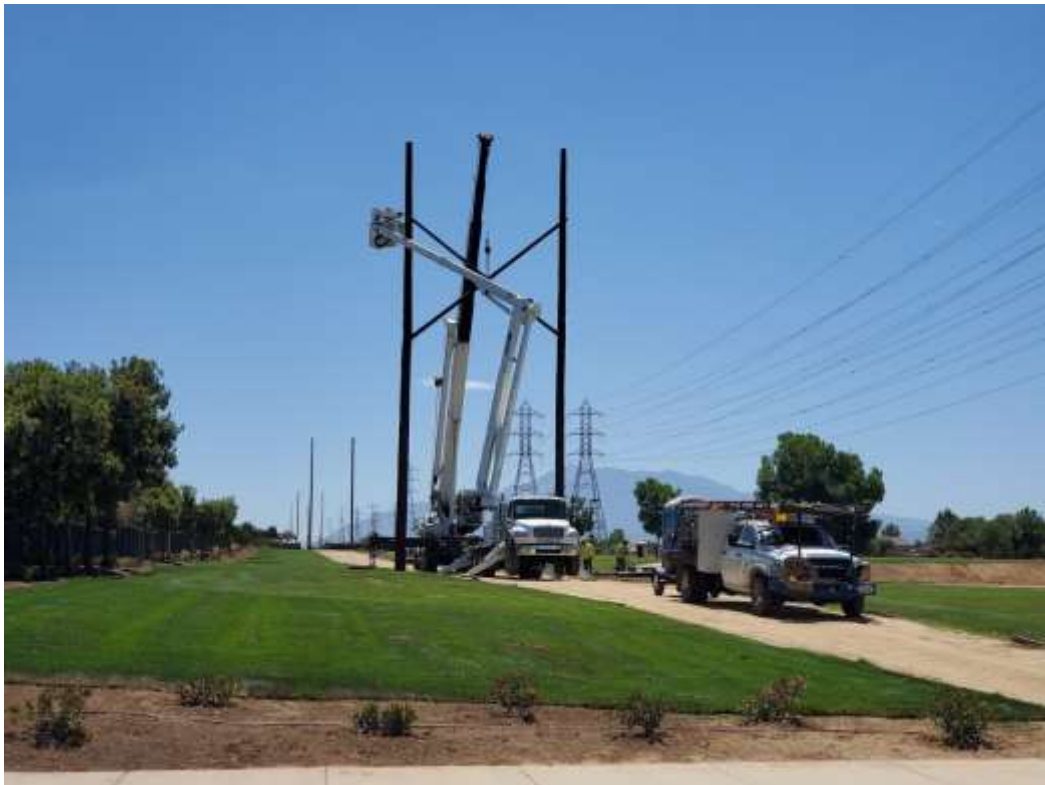
Photo 3 – Tower wreck-out activities at Construction Area PP123296, Segment 4 (May 26, 2021).

5. Work associated with Segment 4 (including Construction Areas 4X12 and 4X13 within Morongo Lands as reported by SCE) included: Wire wreck-out activities (ground and helicopter) at Construction Areas 4X07, 4X09 through 4X15, 4X35 through 4X44, PP123296 (see Photo 3), PP123299, PP123303, PP123305, PP123307, PP123319, PP123342, and PP123343; tower wreck-out and backfilling at Construction Areas 4X26 through 4X40, PP123303, PP123305, PP123307, PP123314, and M23-T2; vegetation clearing and grading at Construction Areas PP123347 and PP123348; and restoration activities at Construction Areas 4N59 through 4N63.

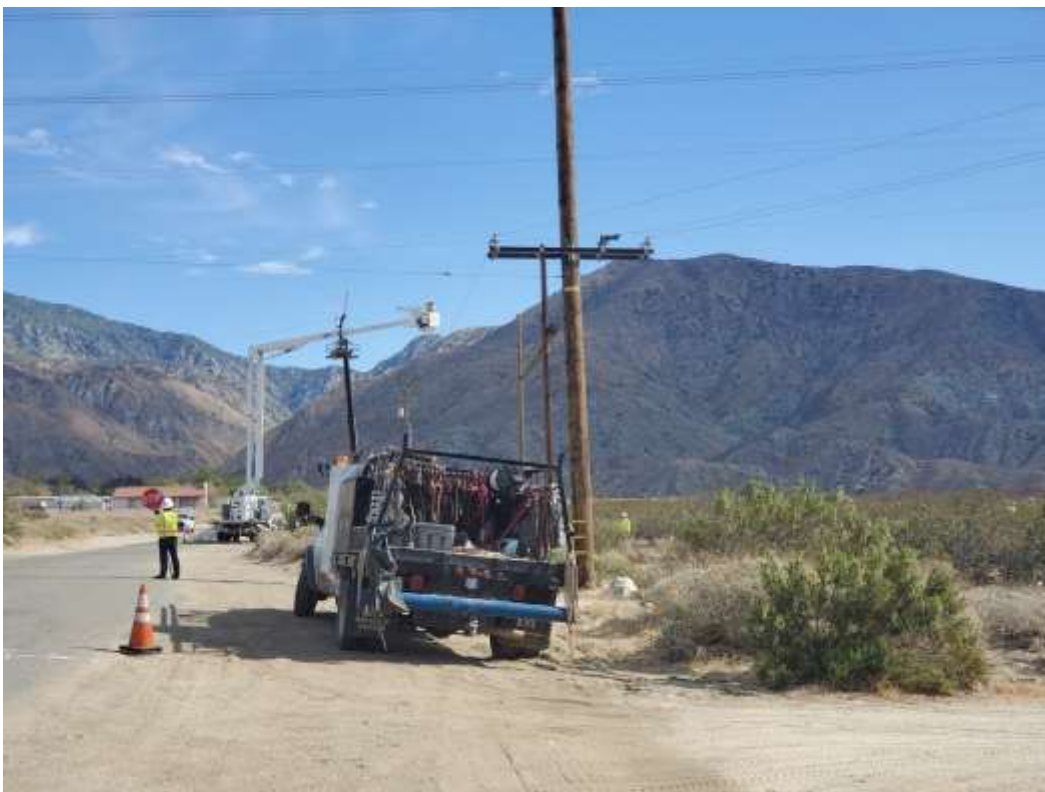
Photo 4 – Wire wreck-out activities between Construction Areas 5X01 and 6X48, Segments 5 and 6 (May 26, 2021).

6. Work associated with Segment 5 (including sites within Morongo lands as reported by SCE) included: Wire wreck-out activities (ground and helicopter) at Construction Areas 5X01 through 5X15 (see Photo 4), WSS-5-5X15-3-Morong0-MPR-3, WSS-5X15-5X16, 5X19, WSS-5X31-5X32, 5X54, PP123357 through PP123359, M10-T2, M12-T2, M13-T2, M15-T2, M15-T3, and M75-T1 (M14-T4); tower wreck-out activities at Construction Areas 5X18 and 5X19; BMP maintenance at Construction Area 5X54; and hydroseed watering at Construction Areas 5X01 through 5X03, 5X05 through 5X14, and 5X37 through 5X47.

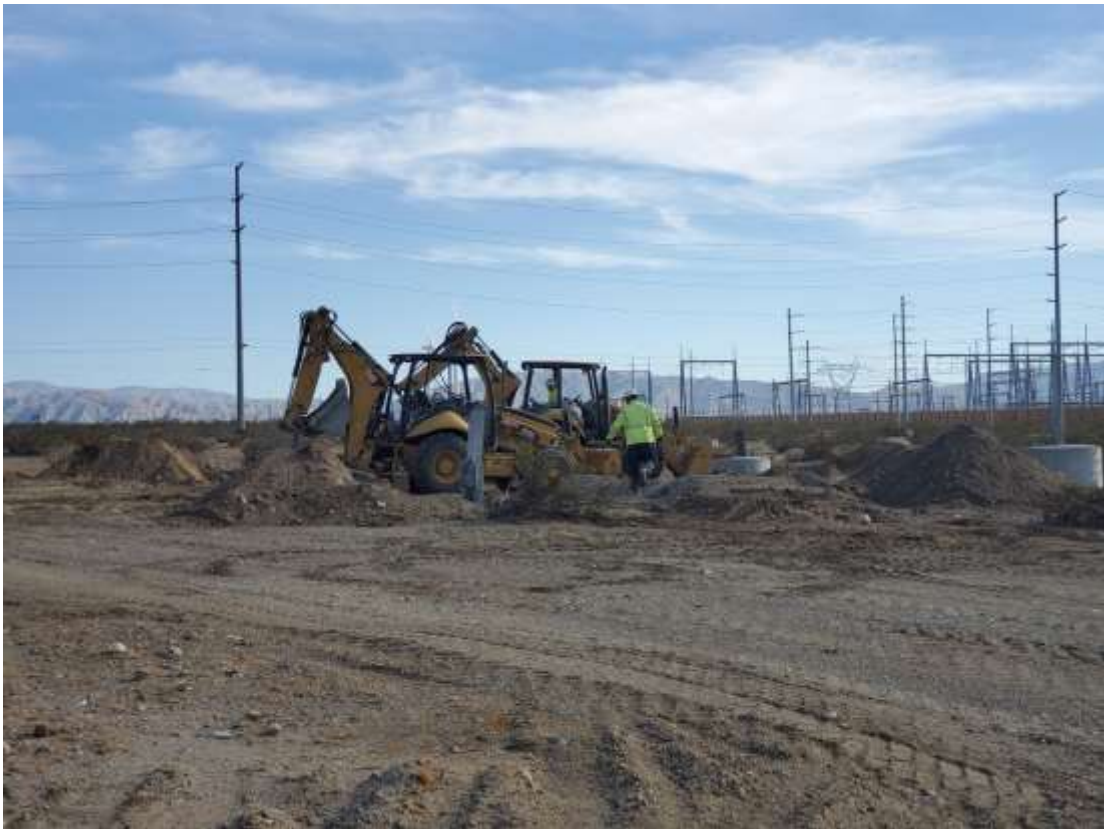
2. On May 27, an unmarked water line (property of SCE) was struck and damaged during foundation wreck-out at Construction Area M0-T2(1) on Segment 6. The site was secured, and dewatering began. Once the site is cleared of water, the needed repairs will be made to the line. Notification was made to the water district.

Photo 5 – Foundation wreck-out at Construction Area M0-T2(1), Segment 6 (May 25, 2021).

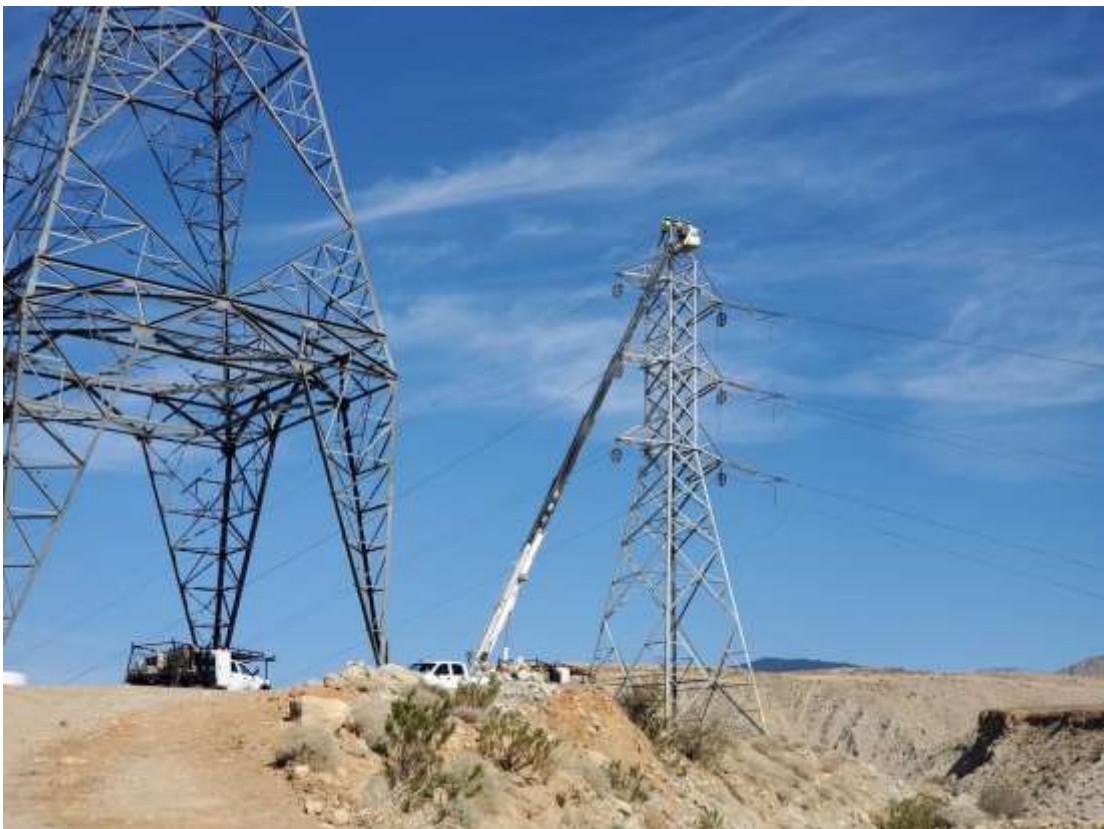
Photo 6 – Wire wreck-out activities at Construction Area 6N28, Segment 6 (May 25, 2021).

7. Work associated with Segment 6 (non-BLM lands) included: Wire wreck-out activities (ground and helicopter) at Construction Areas 6N28 (see Photo 5), 6X42 through 6X48 and M7-T3; tower shearing and foundation wreck-out at Construction Areas 6X08, 6X09-6X10, 6X21, M0-T2(1) (see Photo 6), M62-T3, and M62-T4; and hydroseed watering at Construction Areas 6X11 through 6X14, 6N15, 6S15,
