PROJECT MEMORANDUM
SCE WEST OF DEVERS UPGRADE PROJECT

To: John Forsythe, Project Manager, CPUC
From: Vida Strong, Aspen Project Manager
Date: June 24, 2021
Subject: Monitoring Report #166: June 14 to 20, 2021

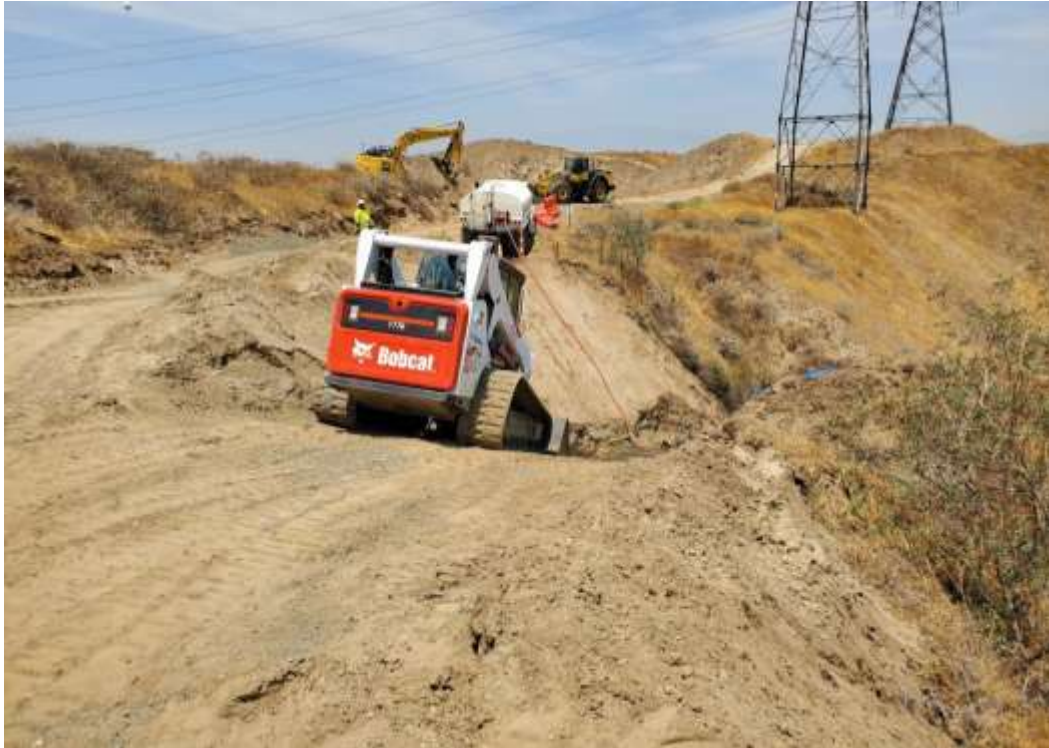
Photo 1 – Hilfiker wall excavation at Construction Area SWA-2-2N12-2-MPR-43, Segment 2 (June 16, 2021).

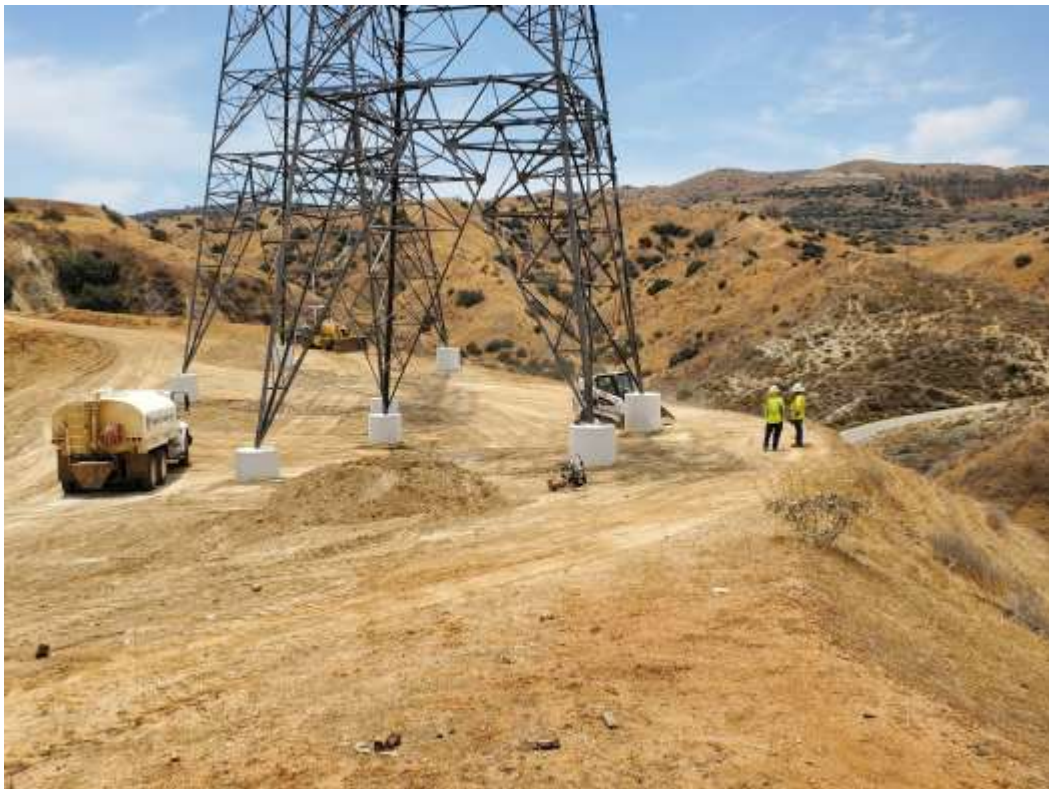
4. Work activities associated with Segment 3 included: Site restoration and foundation compaction at Construction Areas 3X39, 3X41, 3X44 (see Photo 2), 3X46, and 3X62; foundation removal at Construction Areas 3X53 and M37-T3; gabion basket installation at Construction Area 3X65; hand weeding at Construction Areas 3X48, 3X50, and 3X51; hydroseed watering at Construction Areas 3N03, 3N04, 3X10, 3X12, 3X14, 3X17, 3X20 through 3X27, 3X33, 3X37, 3X40 through 3X43, 3X48, 3X50, 3X60, WA-3-3N64-MPR-38, and 3X64; nest deterrent removal at Construction Areas 3X07, 3X08, 3X10, 3X12, 3X13, and 3X19; and v-ditch excavation and installation at Construction Area 3X46.

Photo 2 – Site restoration activities at Construction Area 3X44, Segment 3 (June 15, 2021).

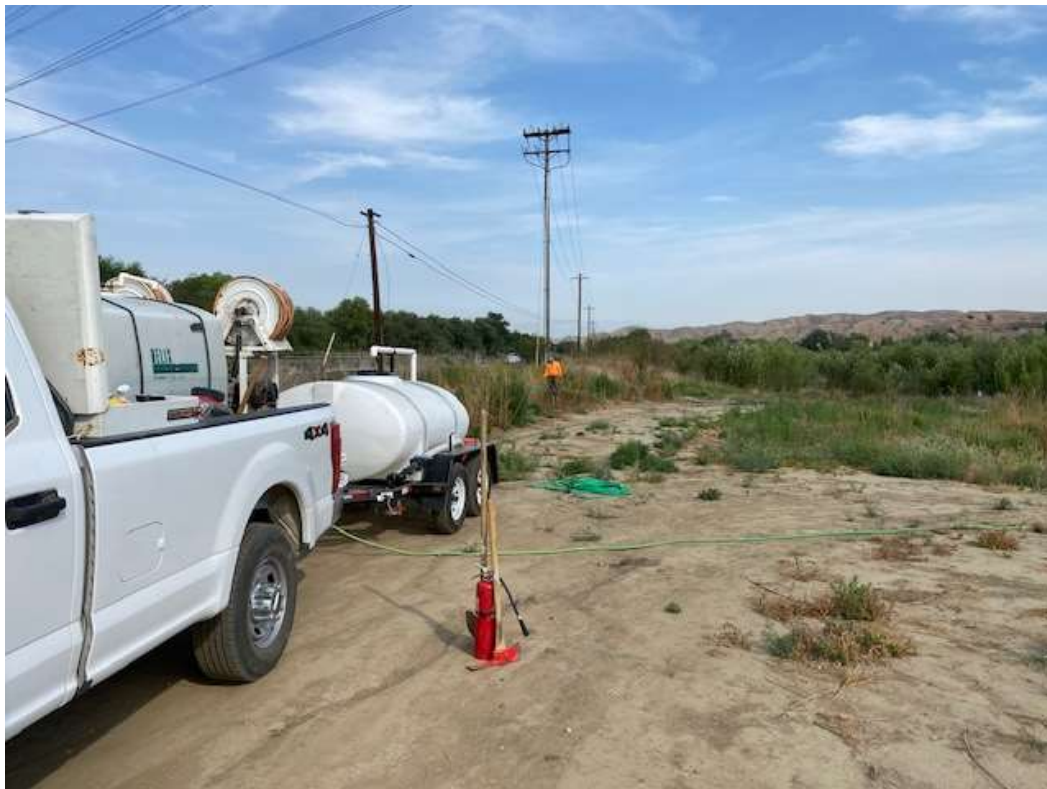
5. Work associated with Segment 4 (including Construction Areas 4X12 and 4X13 within Morongo Lands as reported by SCE) included: Wire wreck-out activities (ground and helicopter) and snub pole installation at Construction Areas SWA-4-PP123353-4-MPR-46, SWA-4-PP123353-2-MPR-43, PP123353, SWA-4-PP123353-3-MPR-43, SWA-4-PP123353-5-MPR-46, PP123354, PP123355, PP123356, and 4X55 through 4N58 (see Photo 3); right-of-way clean-up at Construction Areas M20-T3, 4X05 through 4X20, PP123342, PP123343, PP123352, and PP123353; H-frame hardware wreck-out at Construction Areas SWA-4-PP123353-4-MPR-46, SWA-4-PP123353-2-MPR-43, PP123353, SWA-4-PP123353-3-MPR-43, SWA-4-PP123353-5-MPR-46, PP123354, PP123355, and PP123356; and restoration watering and maintenance at Construction Areas 4N59 through 4N63 (see Photo 4).

Photo 4 – Restoration monitoring at Construction Area 4N63, Segment 4 (June 16, 2021) (Photo courtesy of SCE).

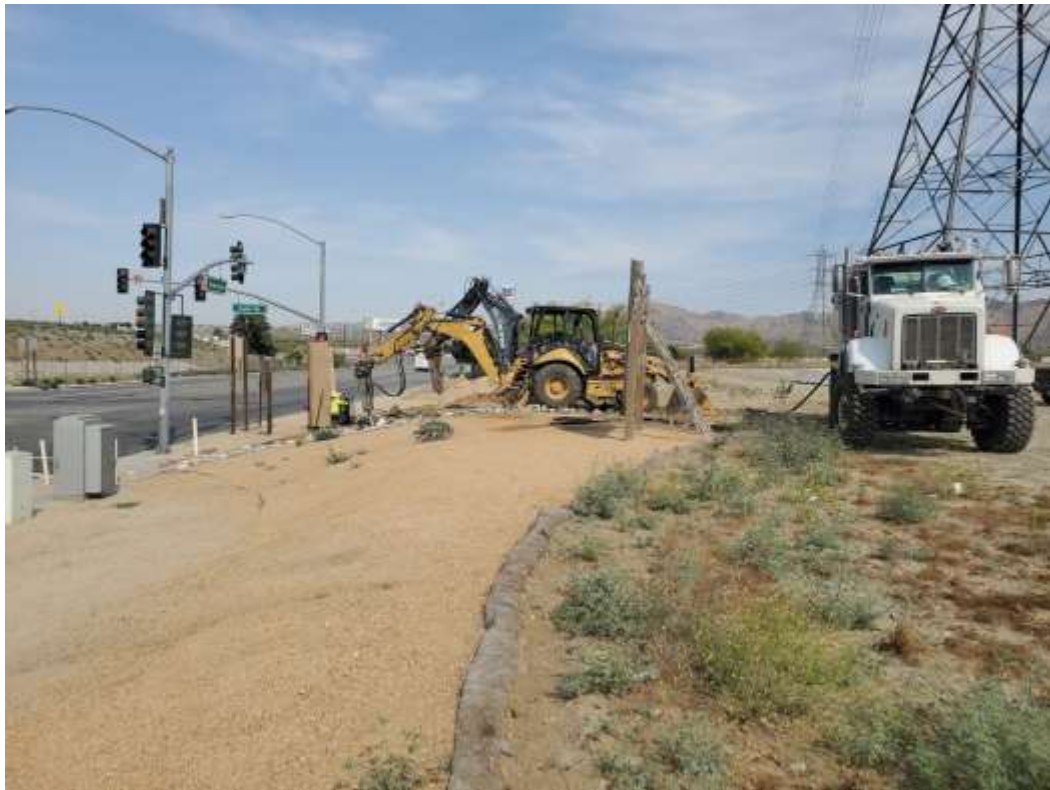
Photo 5 – Foundation wreck-out at Construction Area 4175193E (5X29), Segment 5 (June 15, 2021).

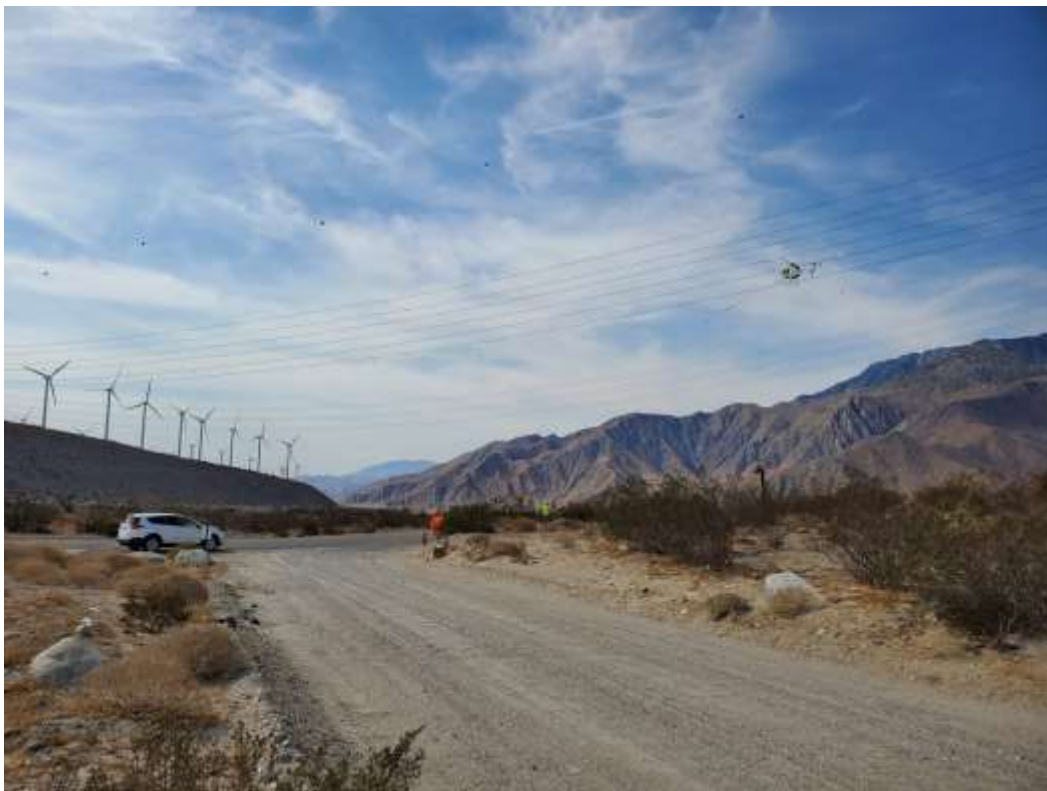
7. Work associated with Segment 6 (non-BLM lands) included: Wire wreck-out activities (ground and helicopter) at Construction Areas 6N26 through 6X43 (see Photo 6), M6-T2, and M65-T2; guard structure removal at Construction Areas GS-6N27-6N28-3 and GS-6N27-6N28-2; tower wreck-out activities

Photo 6 – Helicopter wire wreck-out activities and traffic control at Construction Area 6N28, Segment 6 (June 15, 2021).
